**RE: Pre-Demolition Property Conditions & Hazardous Materials Assessment
Brook Run Property— C.E.R.M. Project No. 11-0862-034
4770 North Peachtree Road
Dunwoody, Georgia**

DEMOLITION & FACILITY ASSESSMENT PLANS

for BROOK RUN PARK

DEKALB COUNTY PARKS AND RECREATIONS 4770 N PEACHTREE RD. & BROOK RUN AVE. DeKalb County, Georgia 30338 Commissioner District: 4

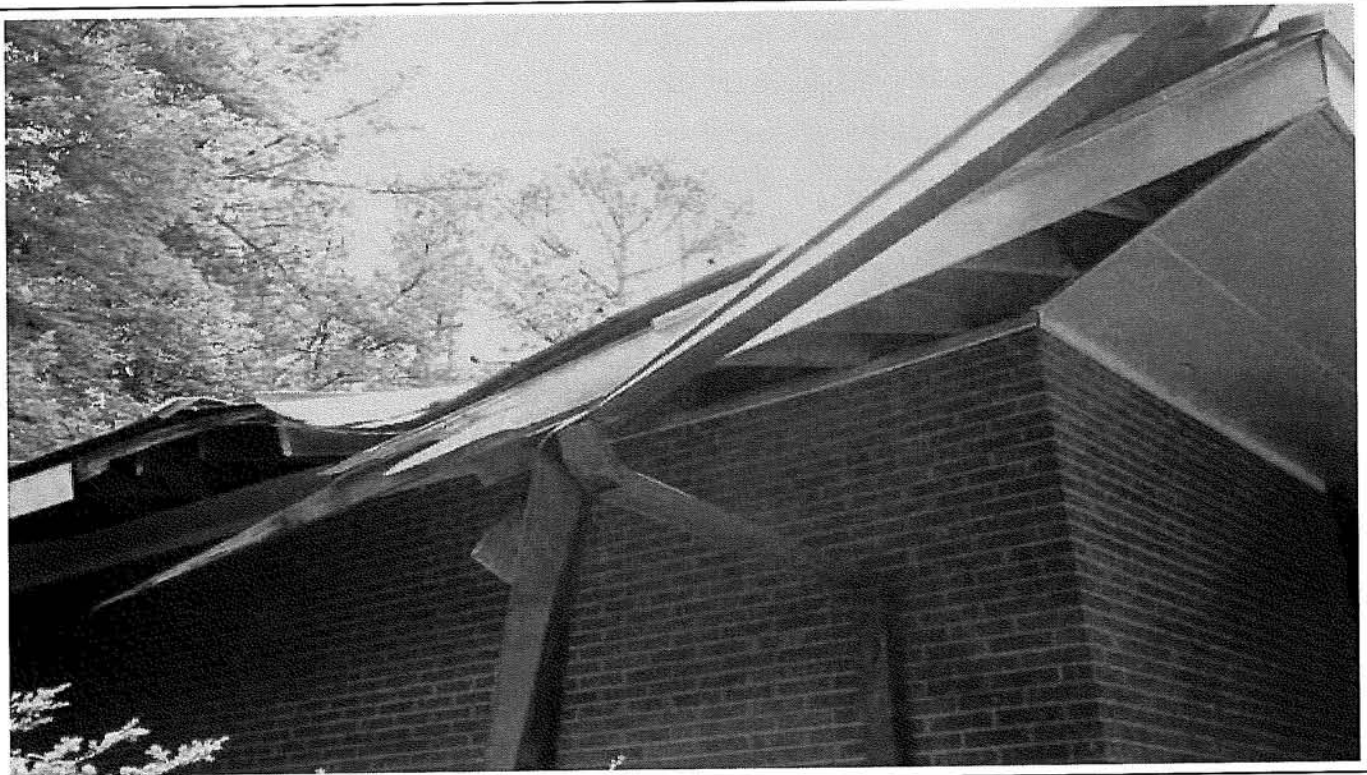
Photo 24: View of cottage No. 5 damage to roof section.

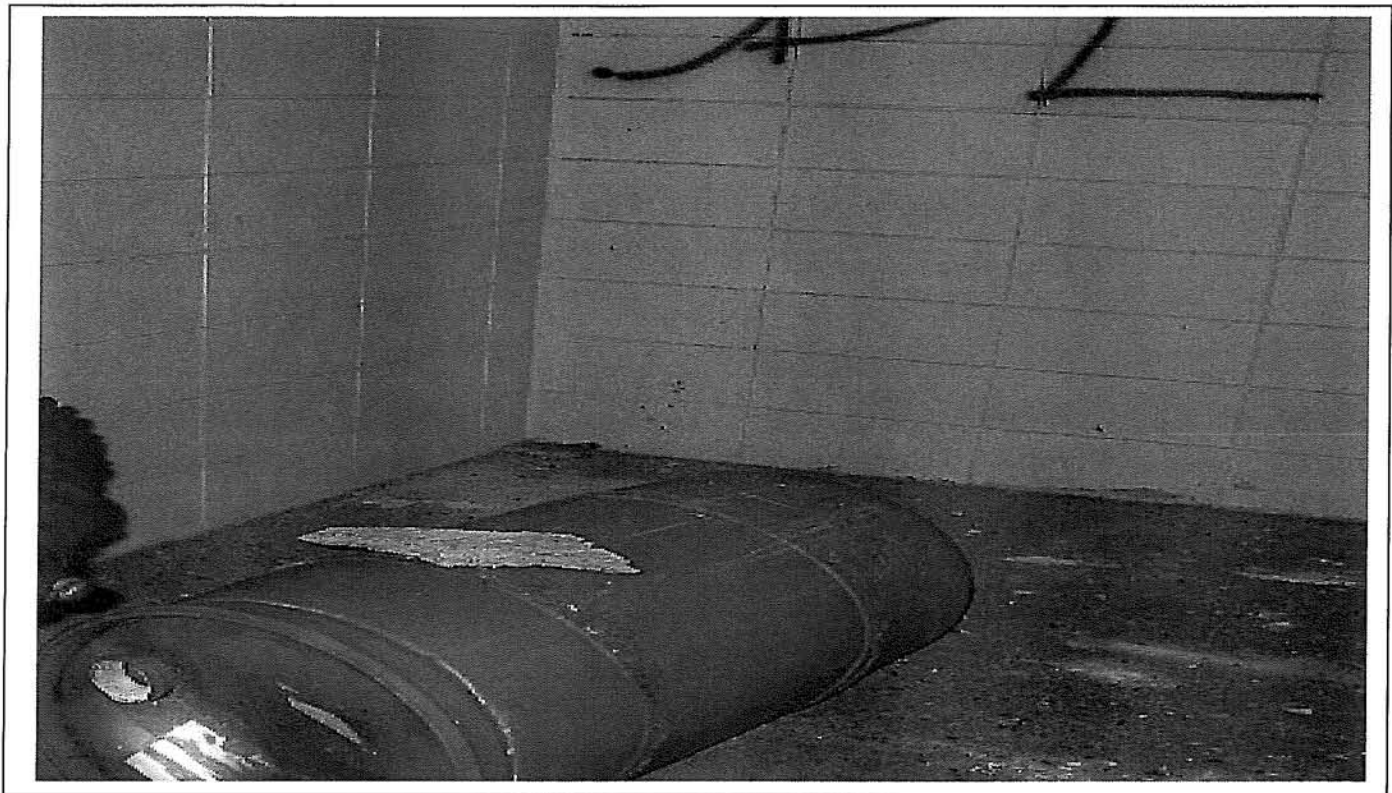
Photo 1: 55-gallon drum located in Therapy Building.

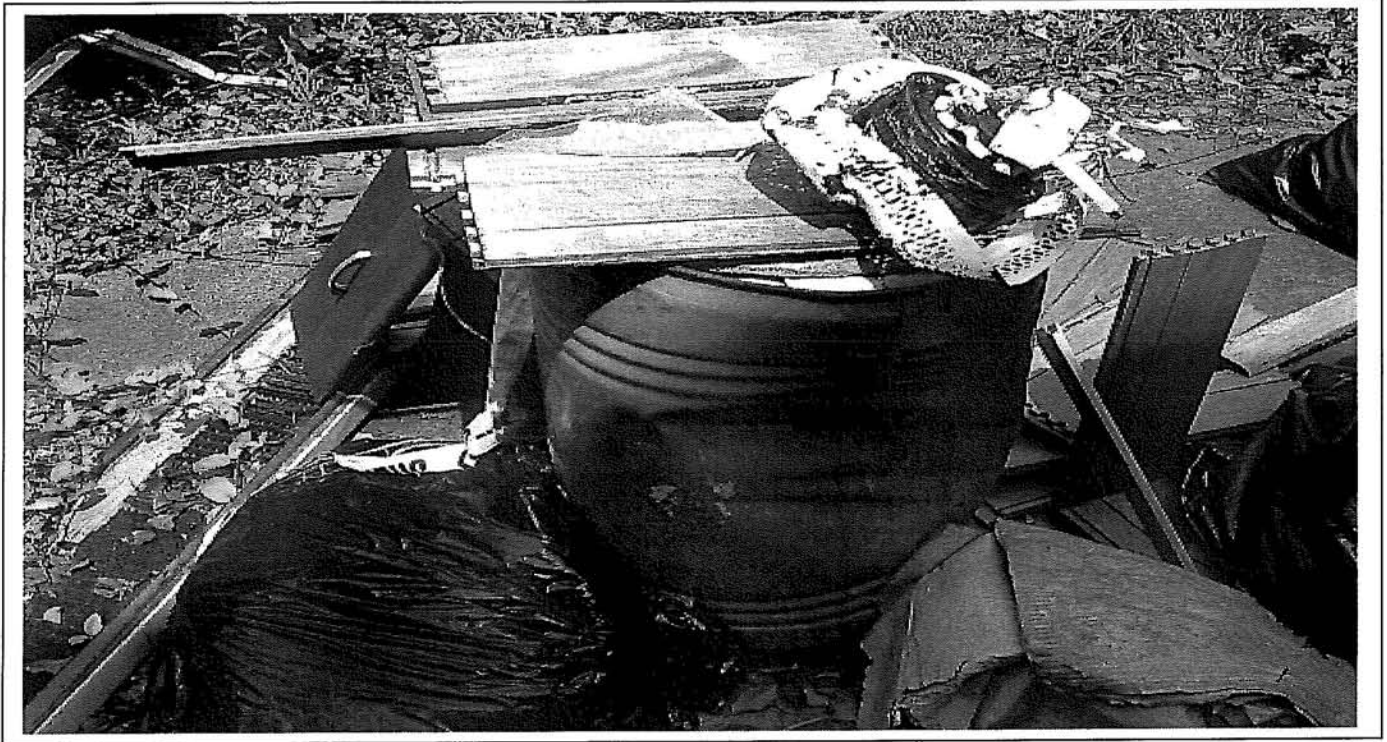
Photo 3: Debris observed outside of Therapy Building.

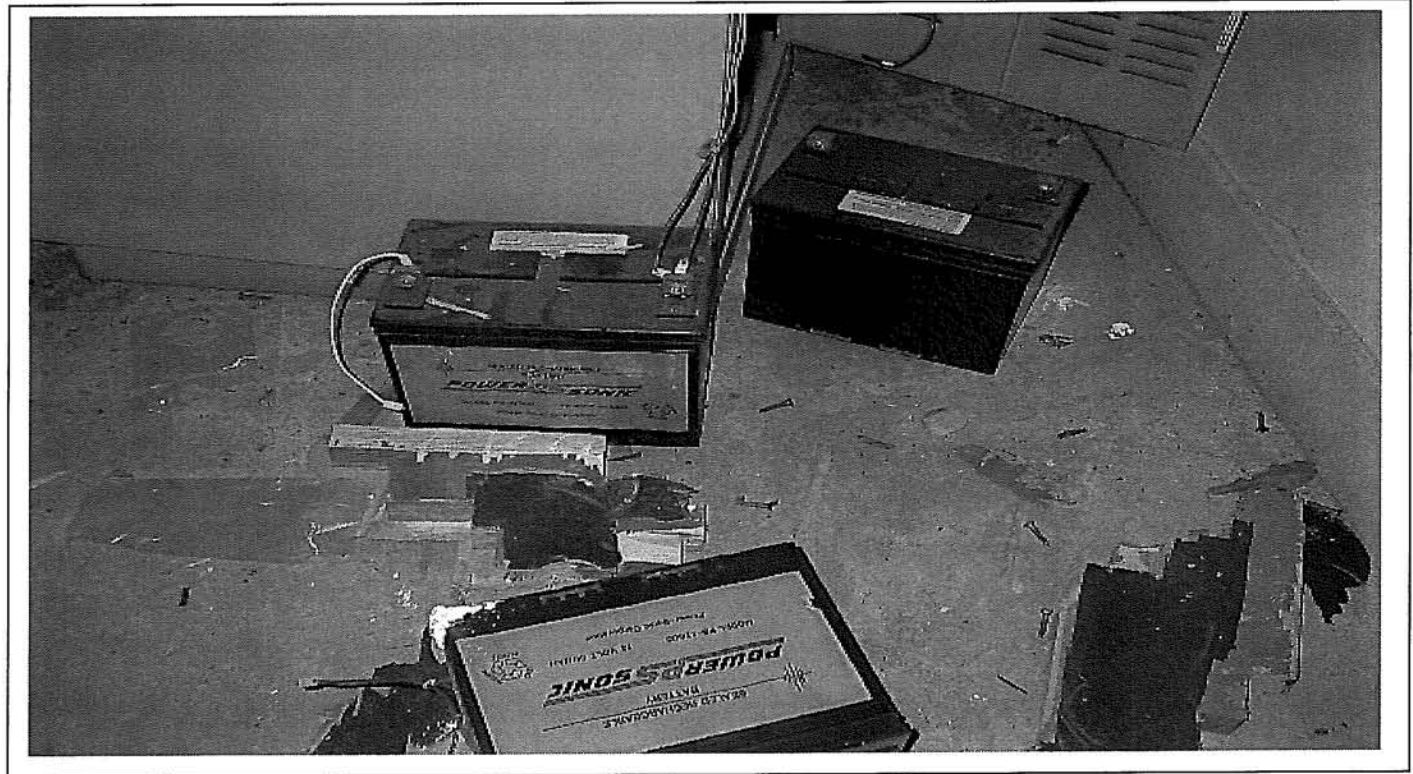
Photo 4: Batteries observed near reception area of Therapy Building.

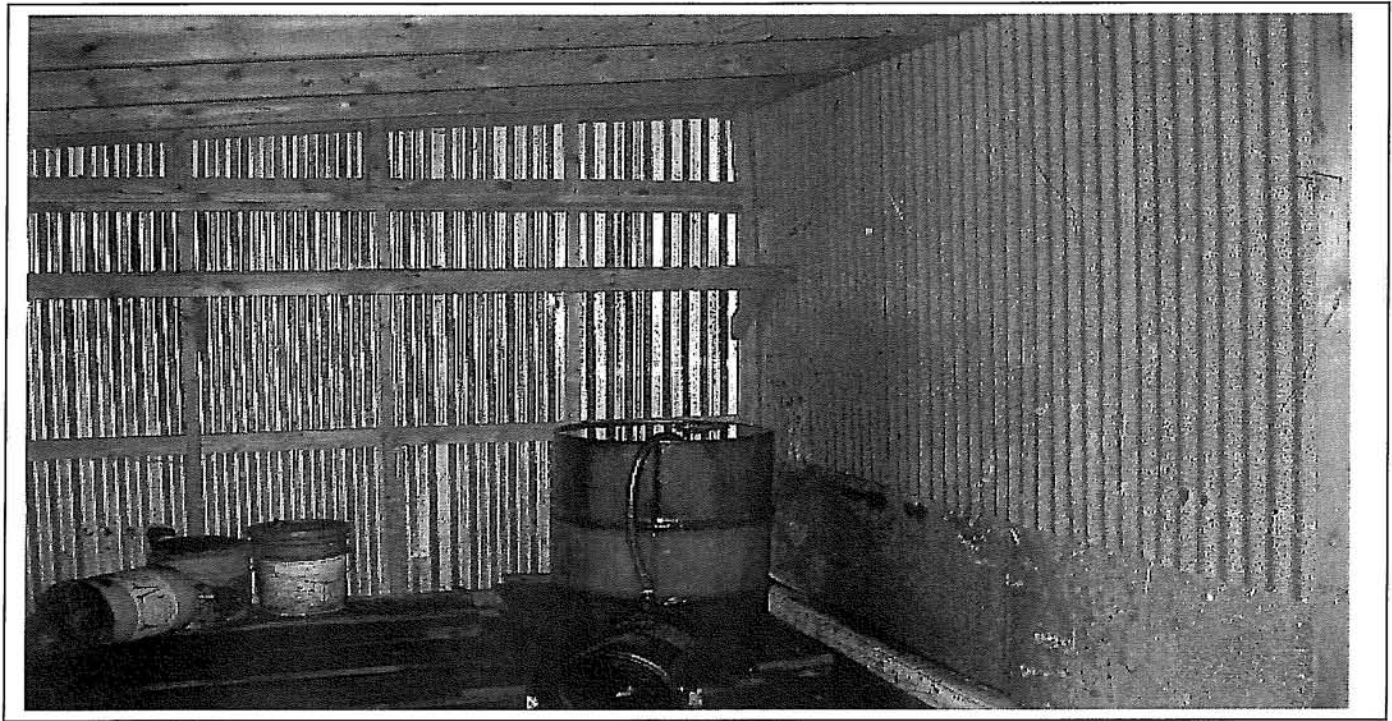
Photo 5: 55-gallon drum in storage shed.

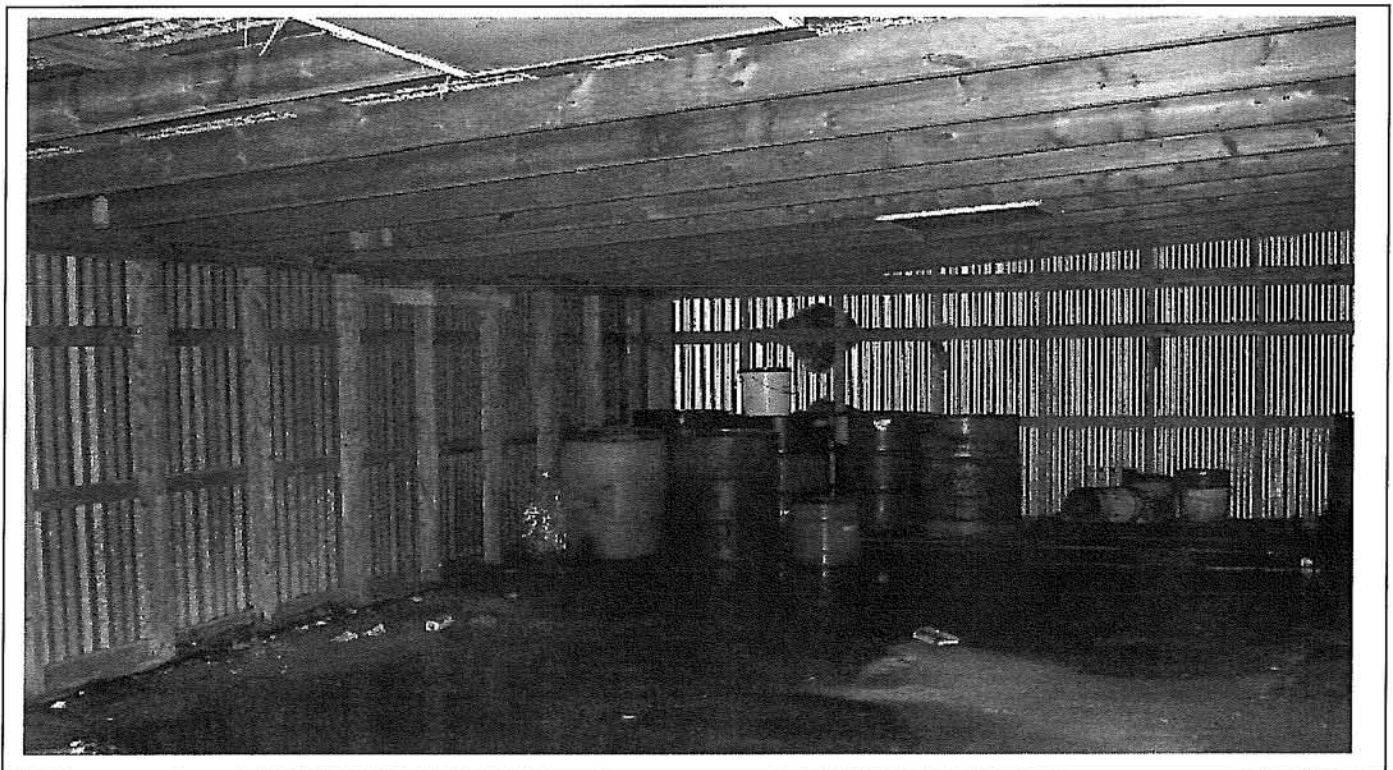
Photo 6: Various drums and buckets observed in storage shed.

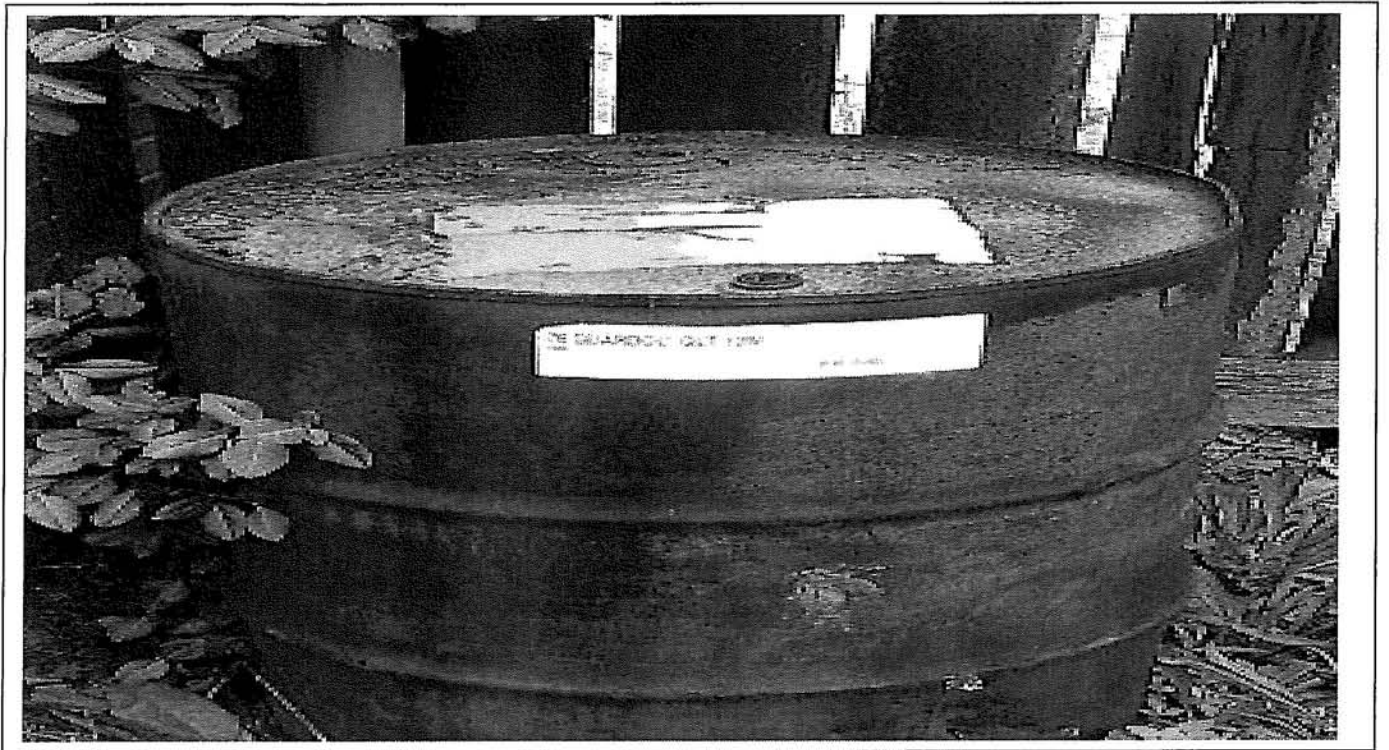
Photo 7: 55-gallon drum ^(observed) outside of Therapy Building.

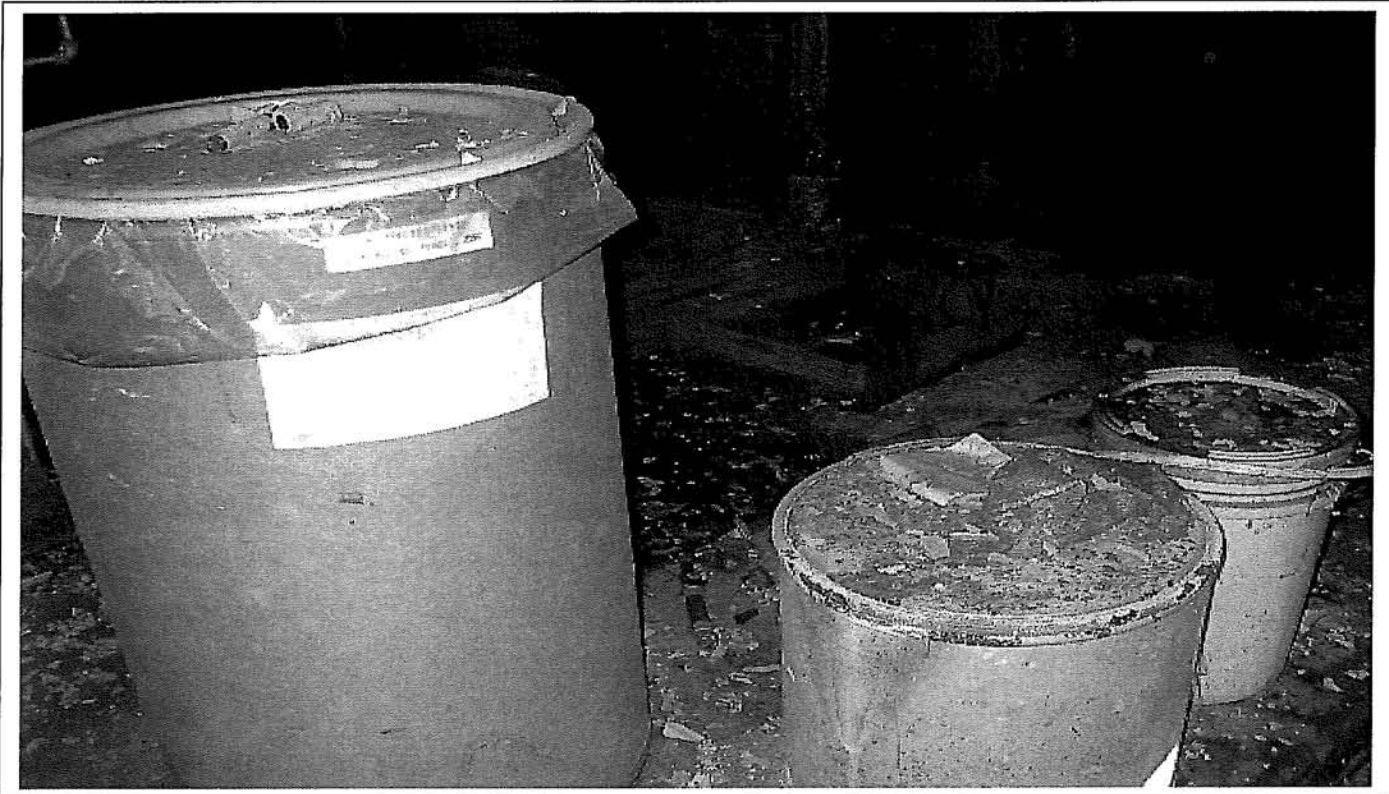
Photo 8: 55-gallon drum containing light ballasts and buckets located in Power Plant.

were two drums which contained light ballasts. One of the drums appeared to have been tampered with, as remnants of the ballasts were scattered outside of the container. The contents of the other drum seemed to be in fair condition.

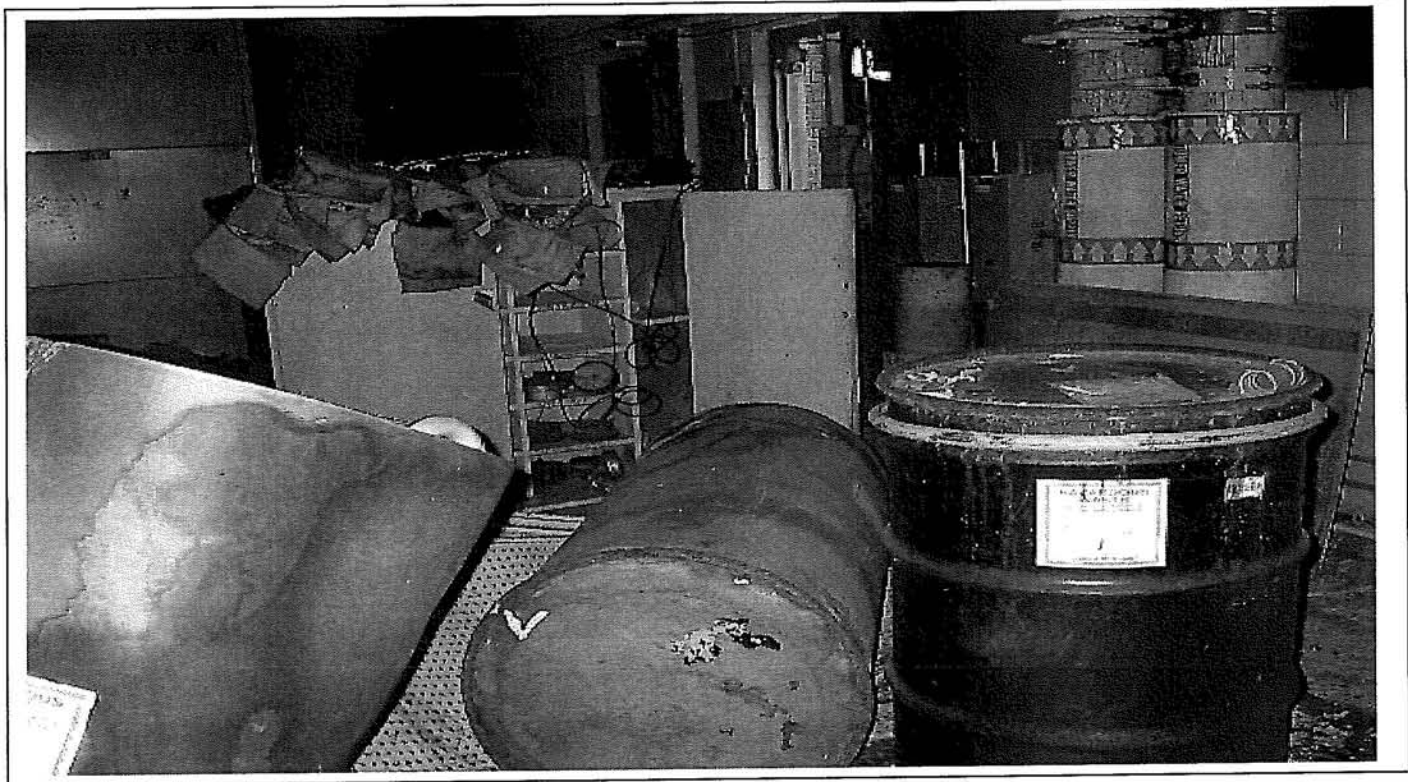
Photo 11: 55-gallon drums observed in Power Plant.

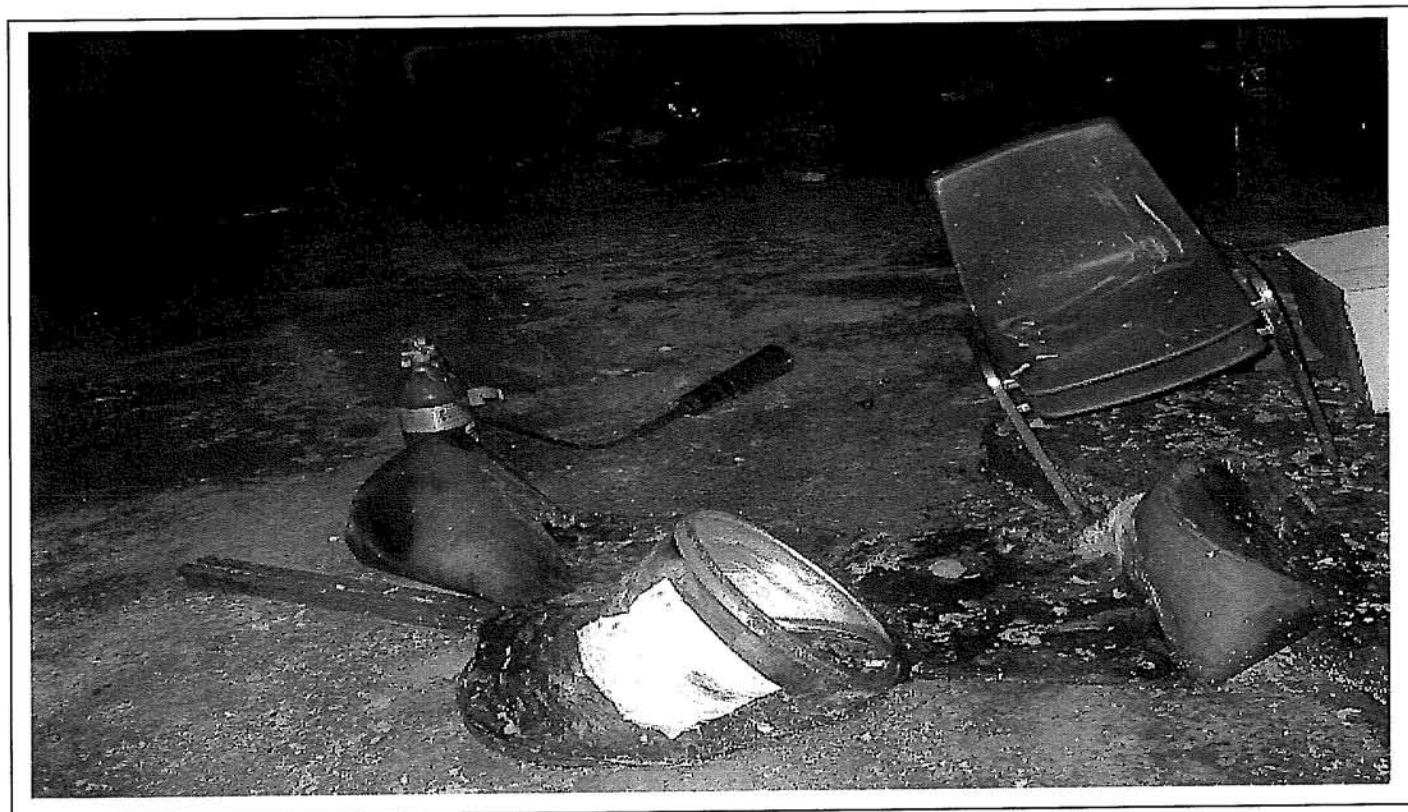
Photo 12: Debris observed in Power Plant.

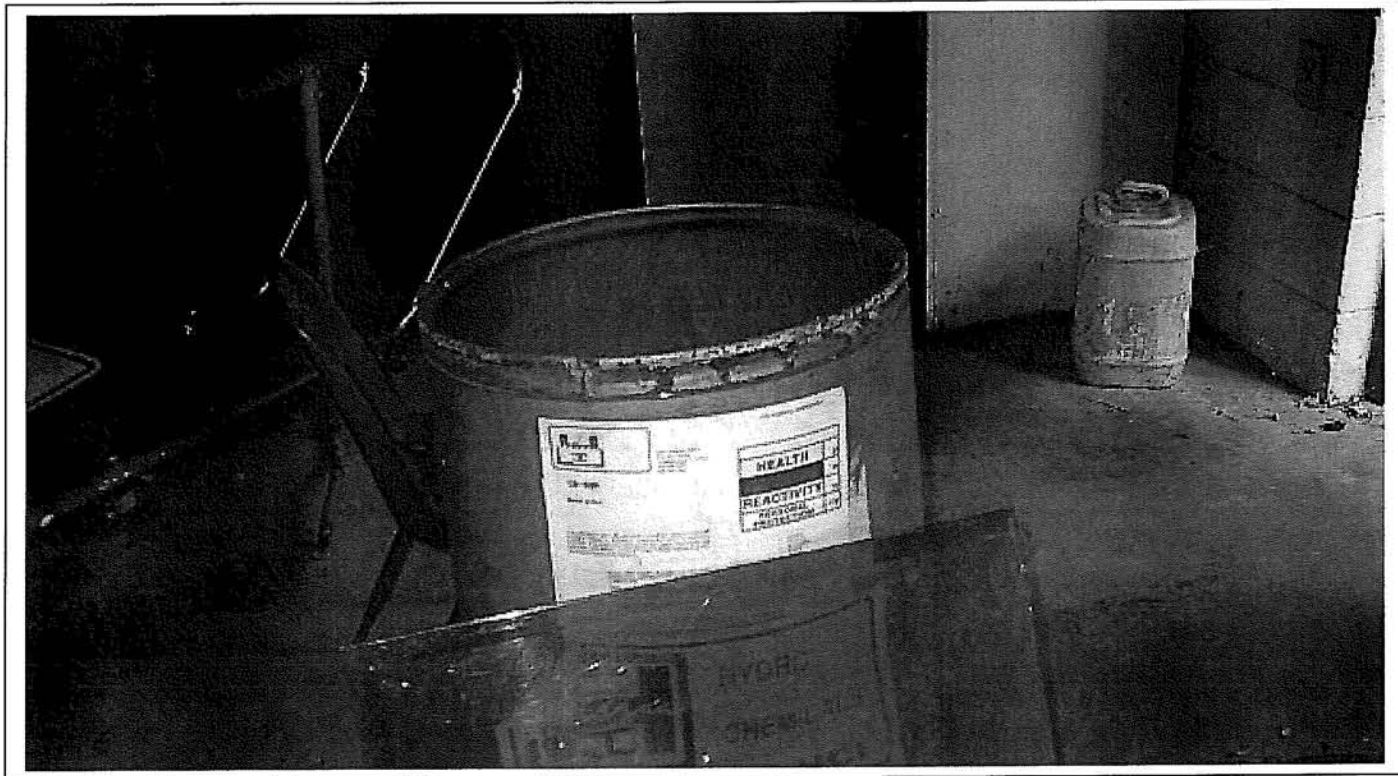
Photo 13: Additional 55-gallon drum containing light ballast.

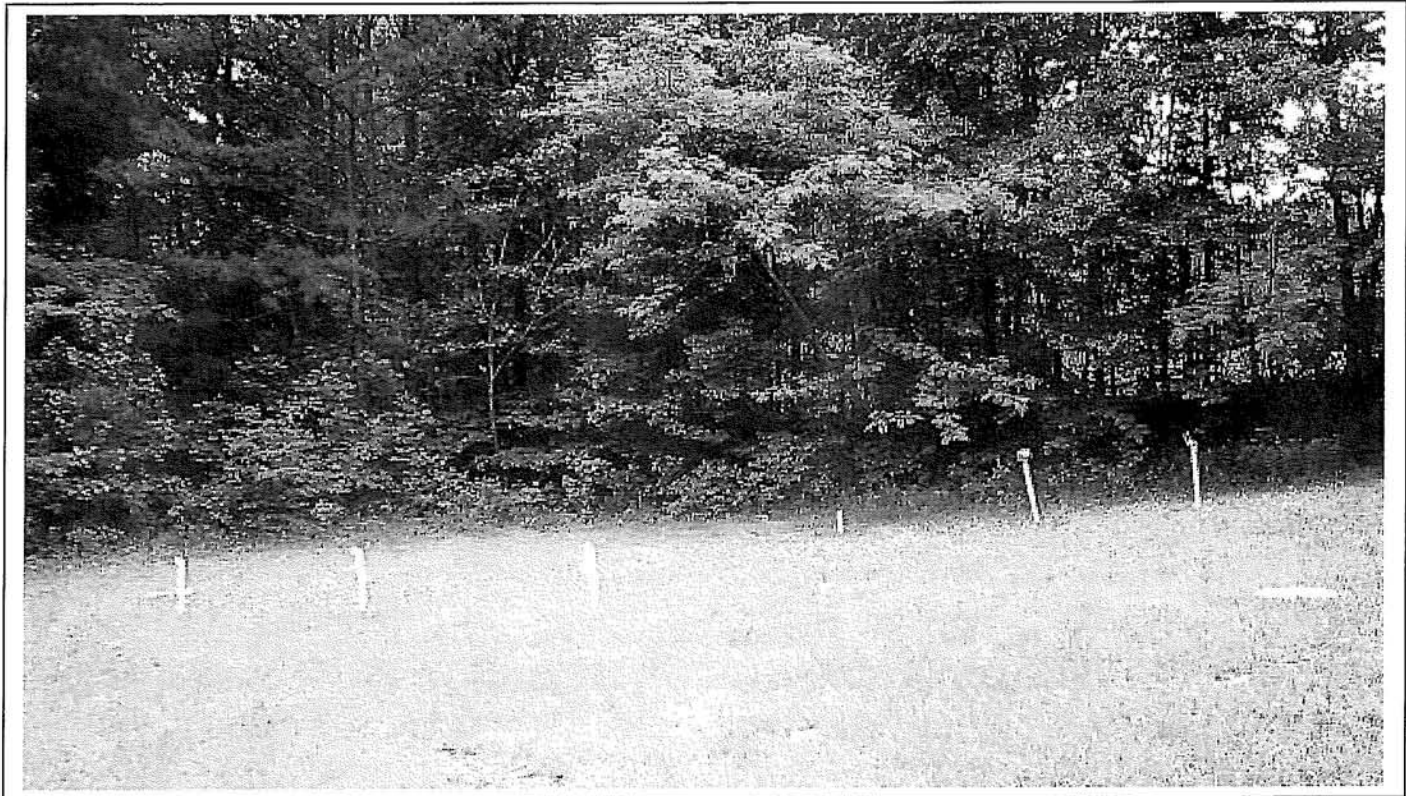
Photo 15: Former UST farm outside of Power Plant.

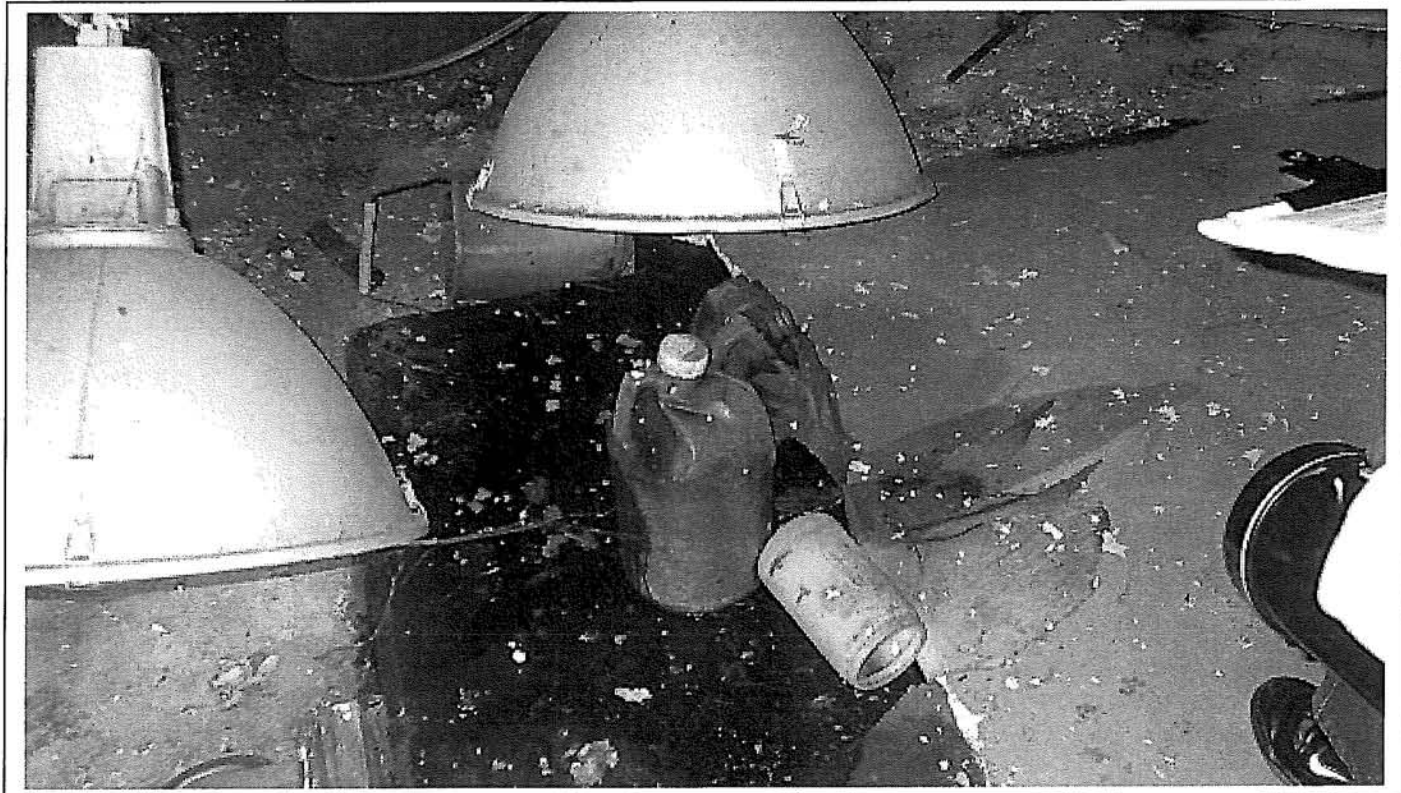
Photo 16: Oil leaking containers located in Power Plant.

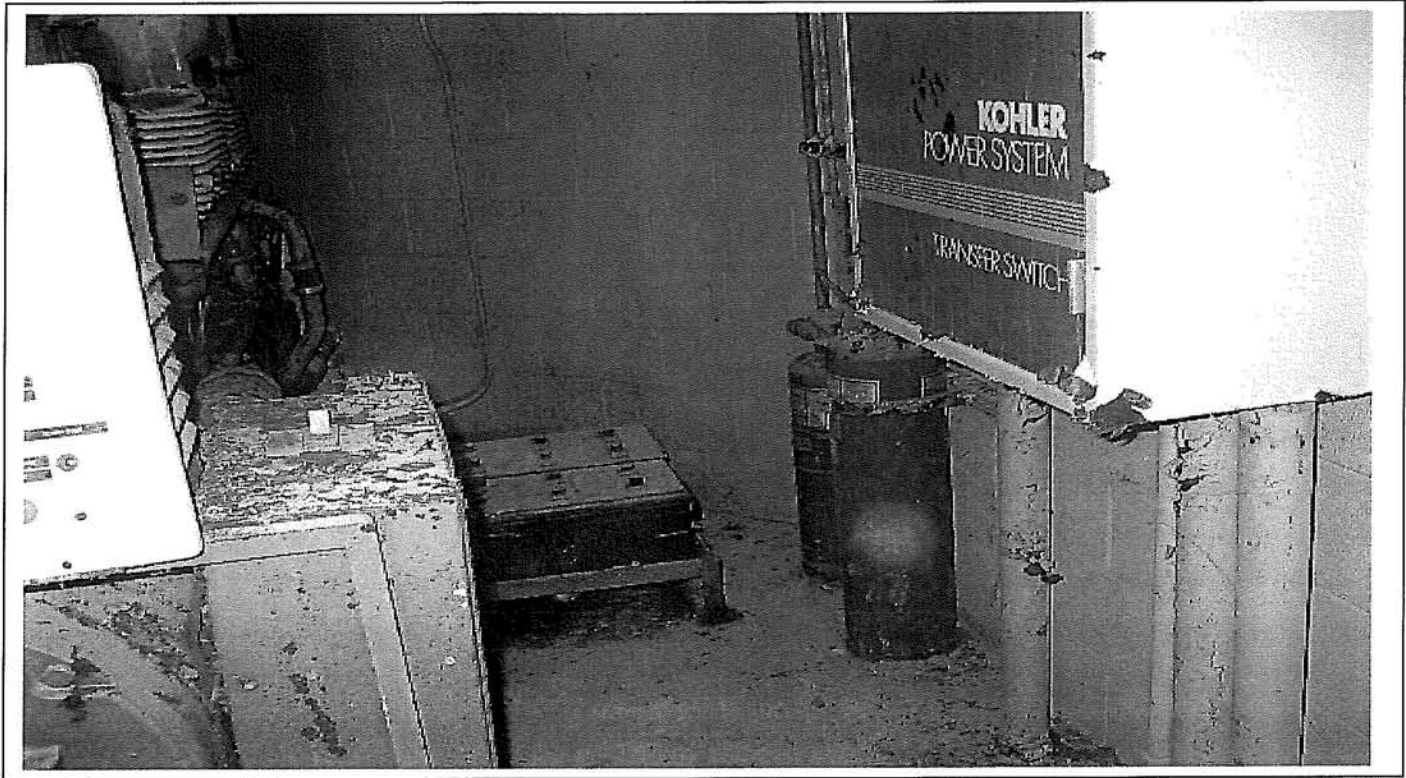
Photo 17: Industrial batteries and fire extinguisher located in Therapy Building.

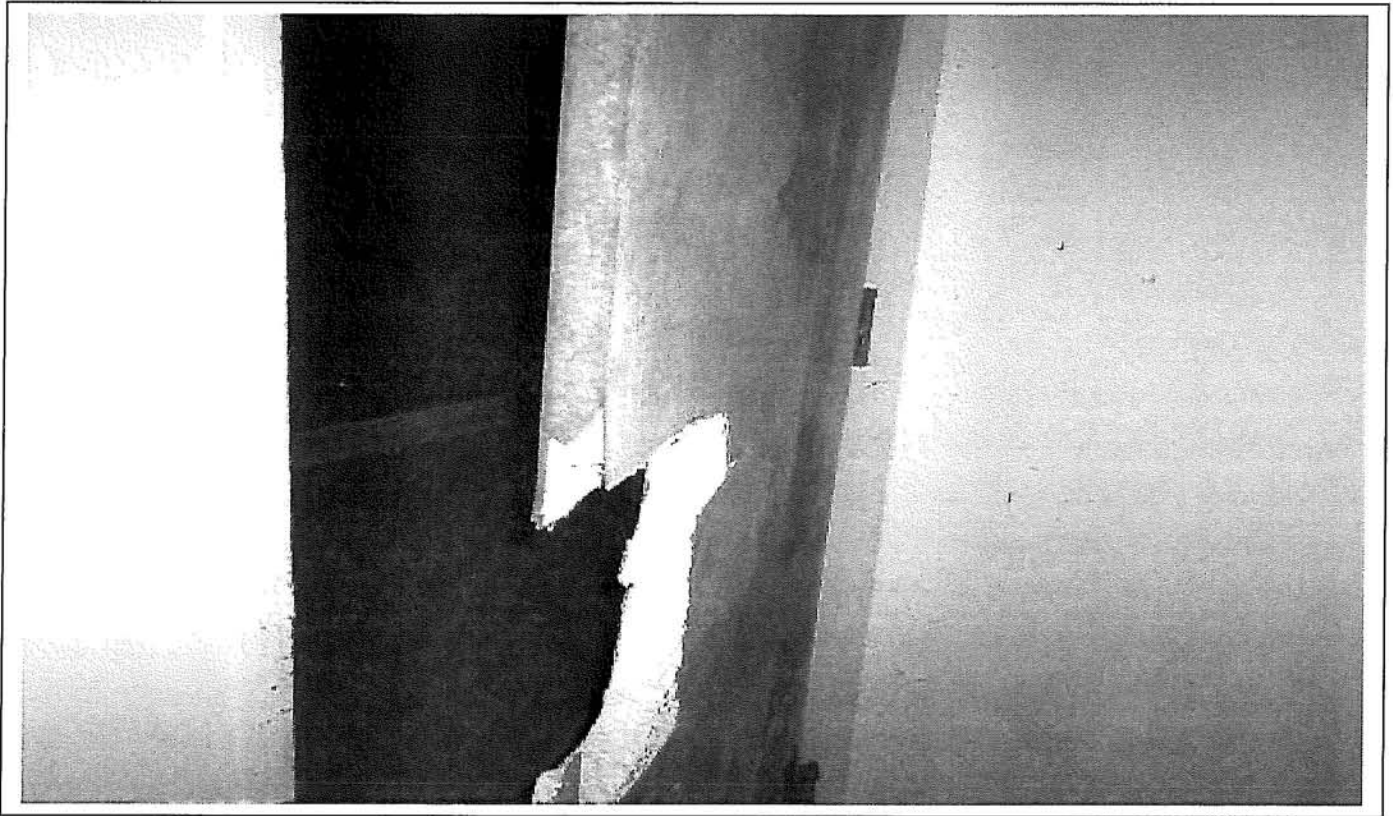
Photo 9: Typical Fire Door with Insulation containing ACM.

C.E.R.M. recommends that a licensed State of Georgia abatement contractor be retained to remove all ACM in accordance with applicable federal and state regulations prior to demolition of the structures. It is worth noting that limited (targeted) interior demolition should be performed by the asbestos contractor to expose, or investigate the potential presence of, hidden ACMs (i.e. thermal system pipe insulation, spray-applied fireproofing for removal).
