FACILITY REPORT

City of Dunwoody
Brook Run Park Theater

June 16, 2011

Facility Study

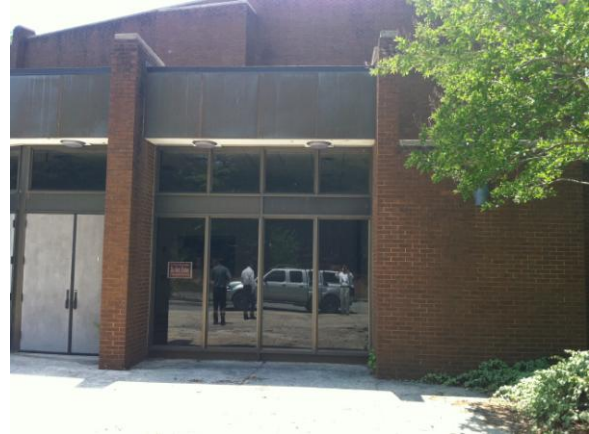
Original Glazing in Aluminum Storefront

Concerning the exterior skin of the facility and how it measures up to the current energy code, the age of the existing roof and the thickness/condition of the existing roof insulation will determine if it should be considered for replacement. The existing aluminum windows, storefront and curtainwall should be replaced with thermally broken systems including energy efficient low-e, tinted and insulated glazing.

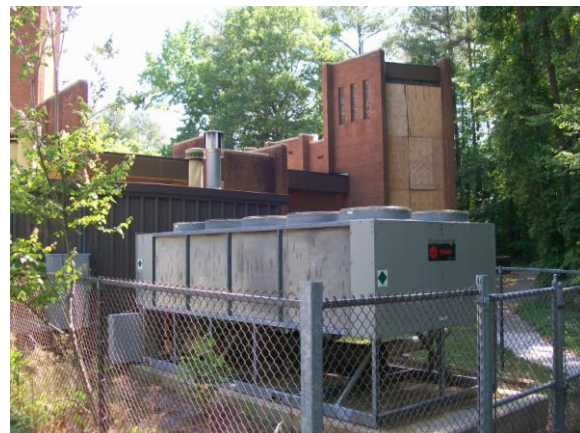
The average useful life of an air-cooled chiller is approximately 20 years. The existing chiller is 11-years-old and appears to be in good condition. As the chiller has not been run recently, CPL recommends that a factory-trained technician be contacted to inspect the chiller, start-up the unit, and provide a condition report on the chiller. This chiller could potentially be utilized for another 10 years.

Chiller at Rear of Facility

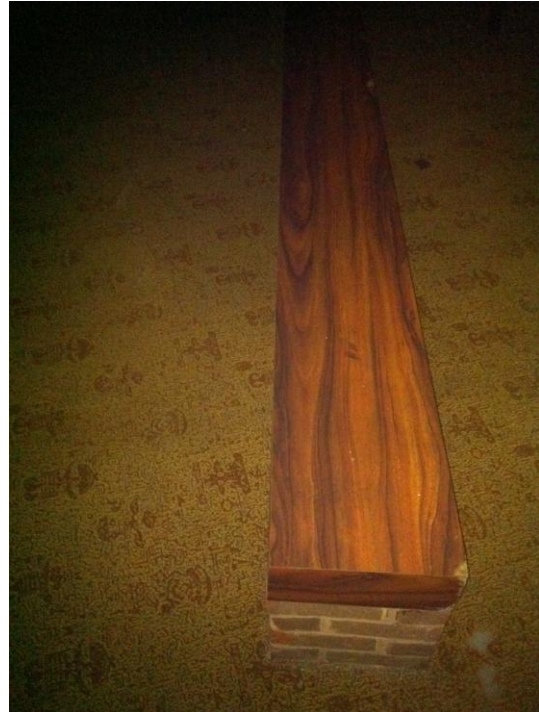
Raised Platform at Front of Theater

An accessible ramp or a platform lift will need to be added to the front of the stage to provide an accessible route between the seating area and the performance area. The current ramp does not have the required 1:12 slope to make it accessible. Based on the floor height difference of 3'-4" between the stage and the theater floor, 40 linear feet of ramp excluding landings would be needed. A platform lift may be more feasible given the space requirements for an accessible ramp.

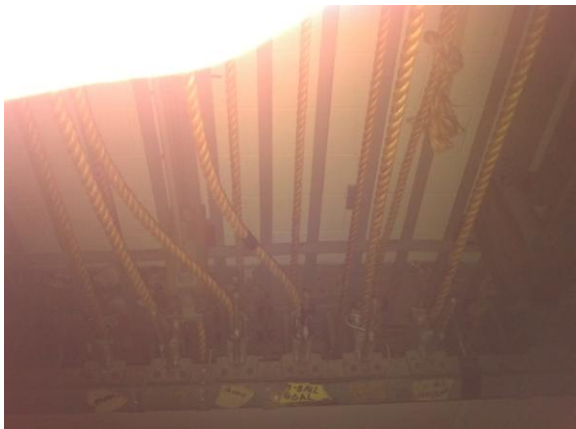
Theatrical Rigging System: Existing theatrical rigging system is in fair condition showing typical wear from age. Existing theatrical rigging system is a conventional manual counterweight system. Due to the high cost of new theatrical rigging systems, reconditioning the existing system, including all battens, lines, blocks, counterweights, arbors and hoists, should be considered.

Theater Rigging System

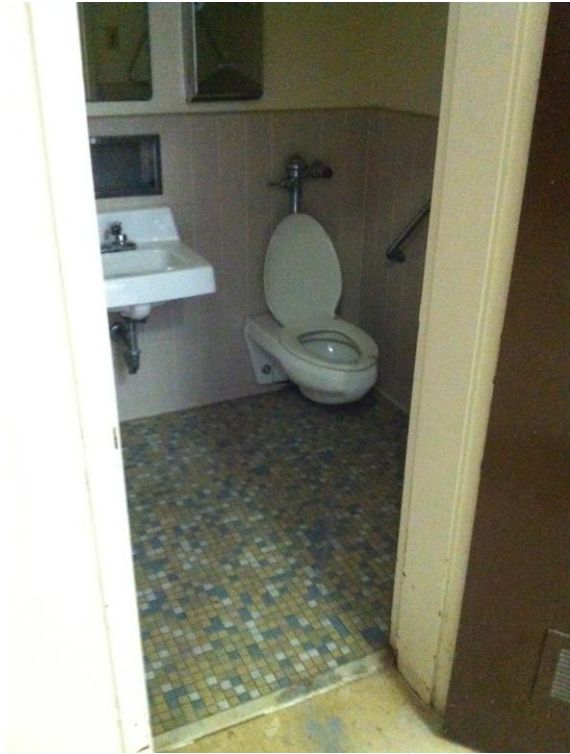
Restroom

Currently there are 6 male WC's and 6 Female WC's to serve the building. Existing restrooms at the Theater would need to be enlarged to accommodate the required number of fixtures. Also, restrooms would need to be added in close proximity to both the Lecture Hall and the Chapel. All existing restrooms will need to be enlarged to provide for accessibility requirements.

All of the existing toilet rooms should receive new fixtures should the facility be renovated. A number of the toilet rooms will be required to be brought up to current accessibility codes. The building plumbing fixture count is addressed in the architectural portion of this narrative.

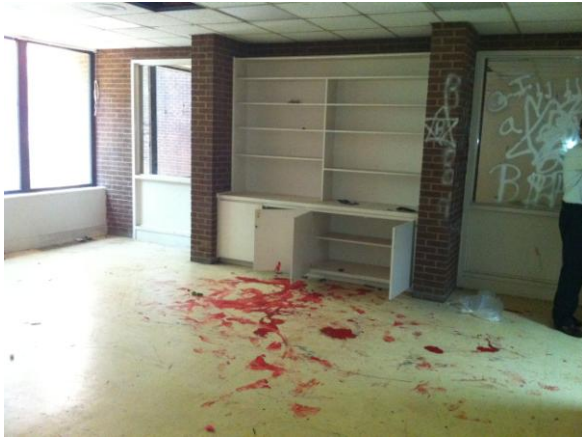
Vandalism at Classroom

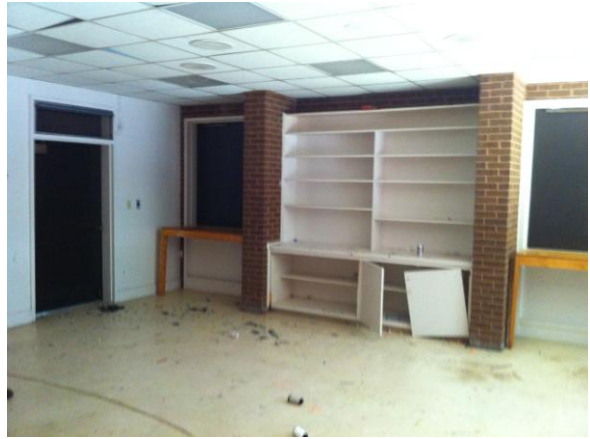
Damaged Flooring & Millwork

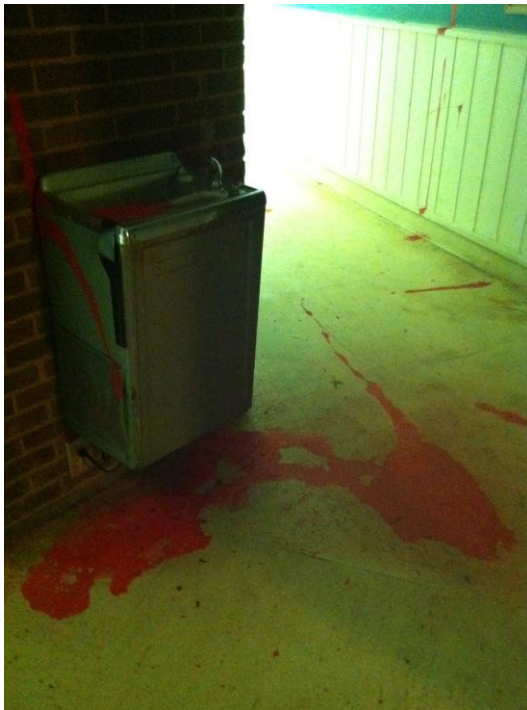
Vandalism at Corridor

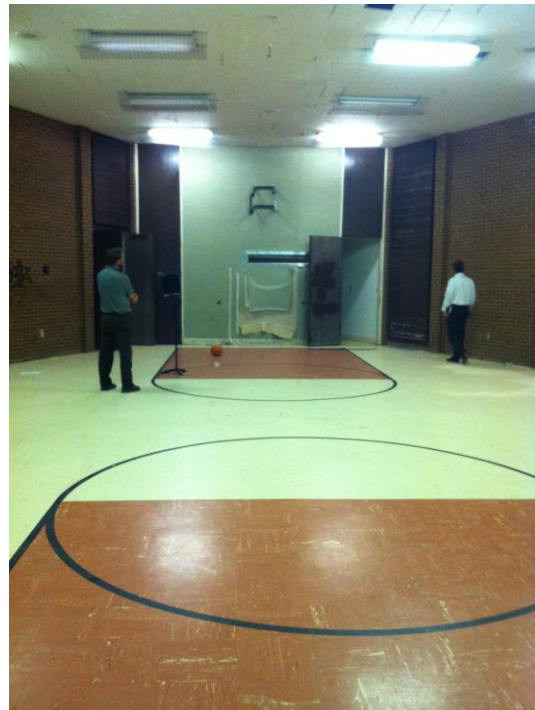
Damaged Walls at Recreation Room

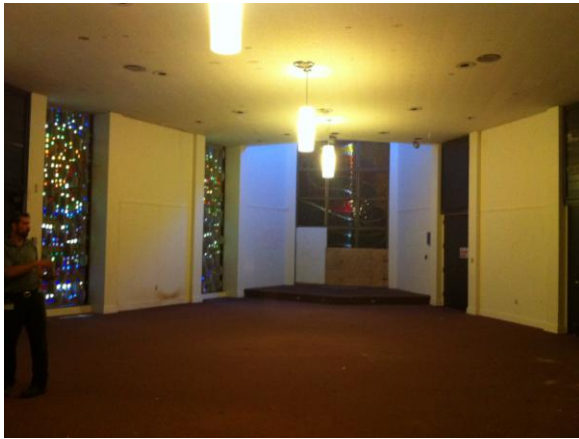
Vandalism at Chapel Windows

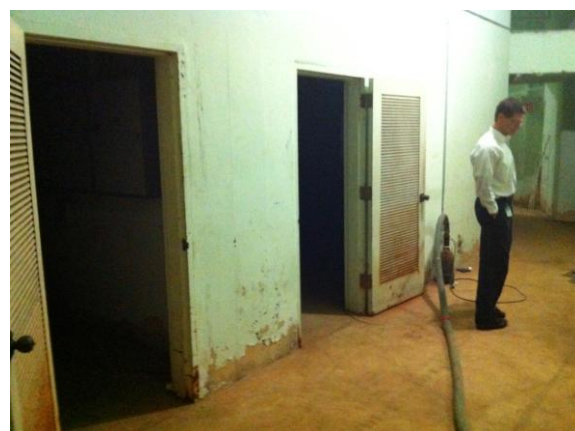
Damaged Wall at Basement

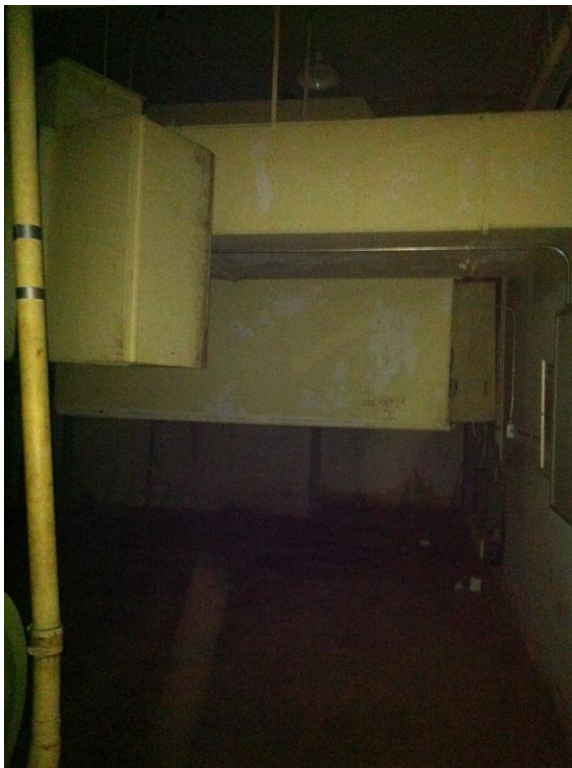
Ductwork in Basement

Both existing air-handling units will need to be replaced should the facility be renovated. The existing ductwork for the theater and front lobby does not appear to be lined, and if this is the case, the ductwork could potentially be cleaned and reused. Schematic level load calculations confirm that, should the seating capacity not change greatly, the existing ductwork is of sufficient size for the air volumes required for the theater. Currently the stage area has no air outlets.

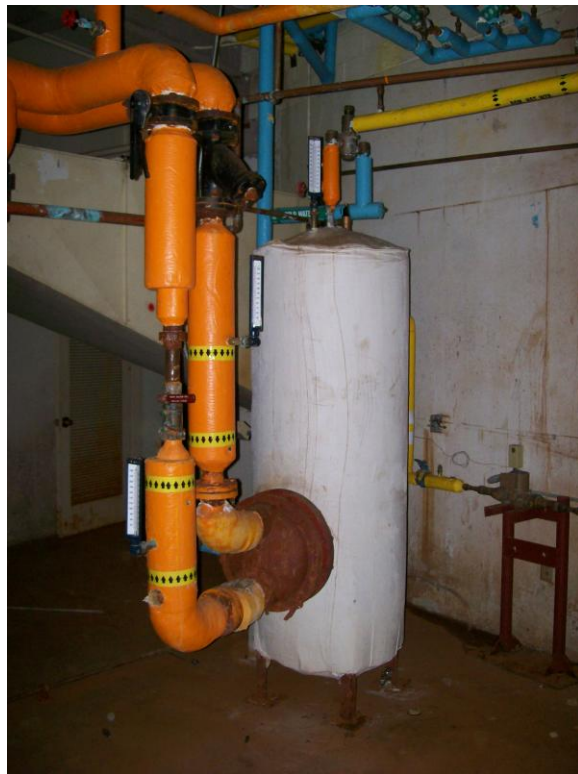
Domestic Water Heat Exchanger

The existing domestic water heat exchanger should be removed and replaced with a tank-type water heater that will not require the boilers to be running in order to provide hot water for domestic purposes.

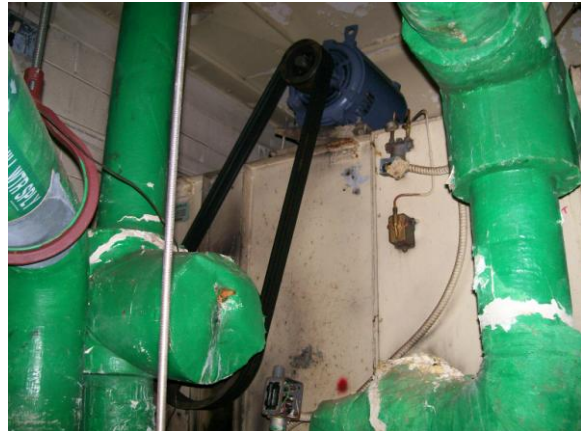
The Theater is served by two constant-volume air-handling units. The unit manufacturer is Air Therm. The model and serial number could not be obtained during our visit, but the units appeared to be original to the building. AHU-L1 serves the theater and front lobby. Ductwork for the theater is routed from the basement mechanical room up to above the ceiling in the theater and runs out to the front lobby above the ceiling. AHU-L2 serves the classroom/office portion of the building. AHU-L2 is a constant-volume re-heat system, meaning each classroom or zone has a duct-mounted hot water re-heat coil to regulate temperature. The ductwork and piping is routed in the crawl space of the building to registers mounted in the floor of each space.

Air Handling Unit

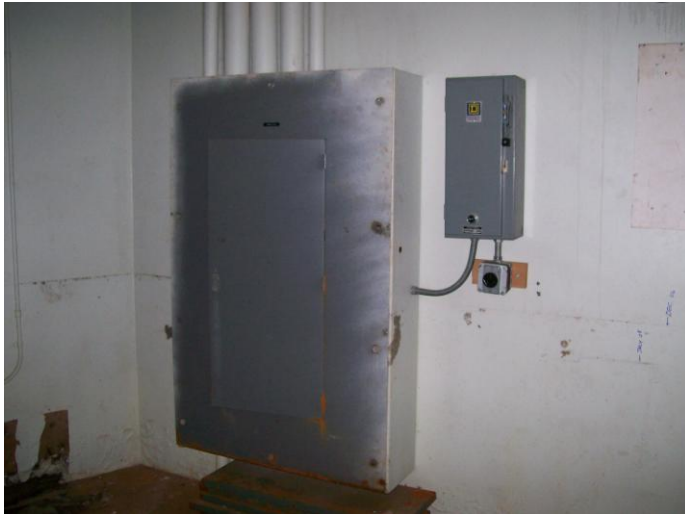
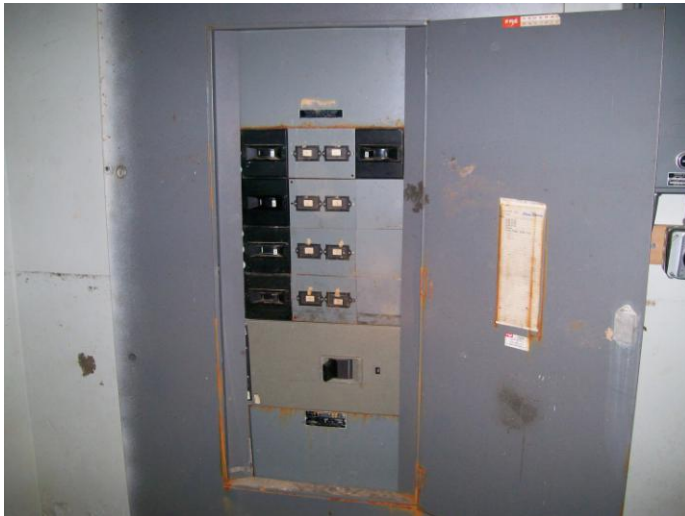
The original electrical service equipment appears to have been installed sometime in the late 1960’s. The electrical equipment shows signs of water damage and is outdated and it would be difficult to find the required new parts, such as internal panel parts, breakers, and fuses, etc for restoration of the existing Theater building.

Water Damage at Main Distribution Panel “PP-L”

Installation of a new main Distribution Panel and branch circuit panels is recommended. The existing 600 amp service should be more than adequate for the renovation of the existing Theater building and some of the main feeders may be able to be re-used in the renovation depending on exact conductor type, size, condition, and location.

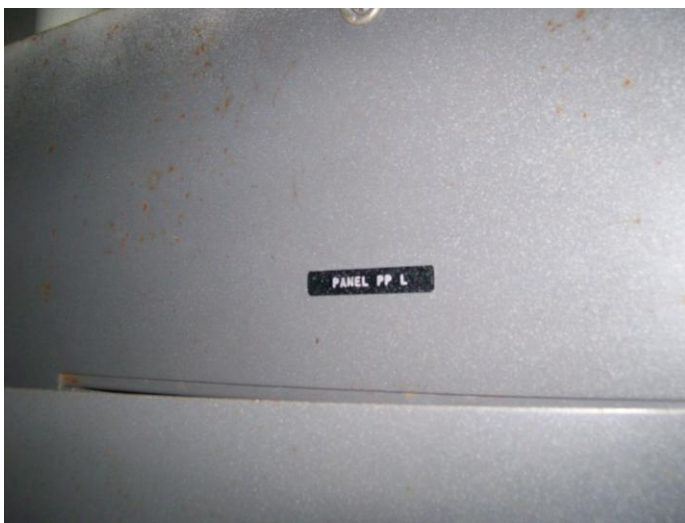
Main Distribution Panel “PP-L”
