Landscape Architecture

November 27, 2013

Ms. Laine Sweezey
President, Brook Run Dog Park Association, Inc.
1424 Vernon Ridge Close
Dunwoody, GA 30338

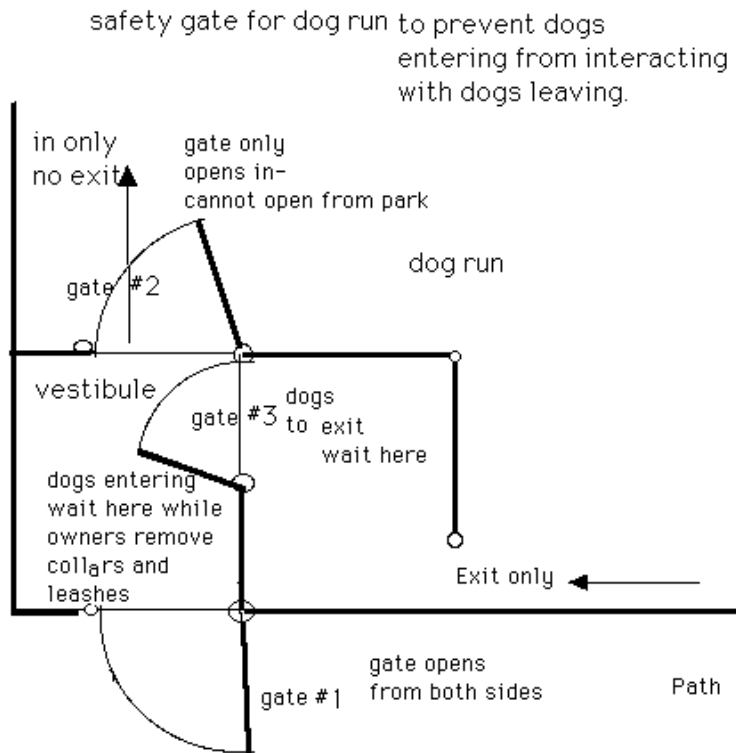
Fig. 1

Since the site generally slopes toward the existing ditch (described below in item #4) toward the east side of the existing site, the ditch would make a natural dividing line between a large and small dog area and would impede fence running between areas.

This would also be a logical location for a new safety gate to accommodate both areas. A new gate in this location would be close to existing parking and would accommodate future handicap accessibility should the need arise. I would leave the existing entry gate in place for secondary access. The asphalt path to the existing entry gate should be repaved.

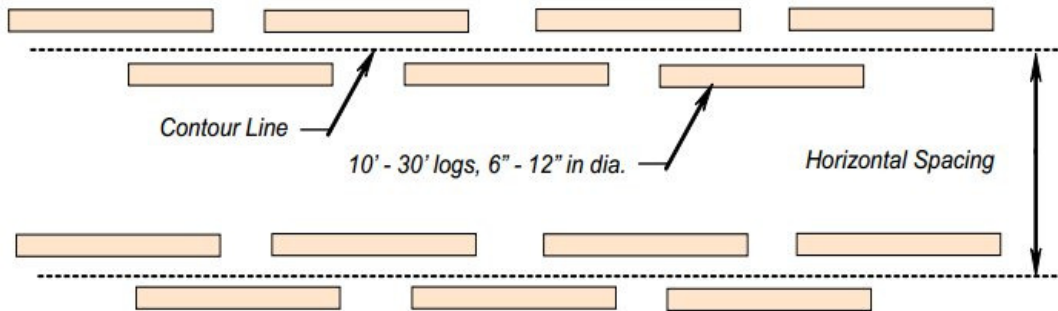
FIGURE 1 - Theoretical log terracing pattern

- One of the primary activities TheBrook Run Dog Park Association and local Boy Scouts of America have accomplished is the installation of downed logs perpendicular to the water flow throughout the slope. This is a highly affective method of decreasing loss of topsoil on a slope. Since I see no evidence of erosion, my only suggestion would be to stagger the logs along the slope to impede water from creating a channel. Currently, the logs run the entire length of the slope. By removing some of the logs, it would allow for easier access for the dogs while still accomplishing the erosion control intent.

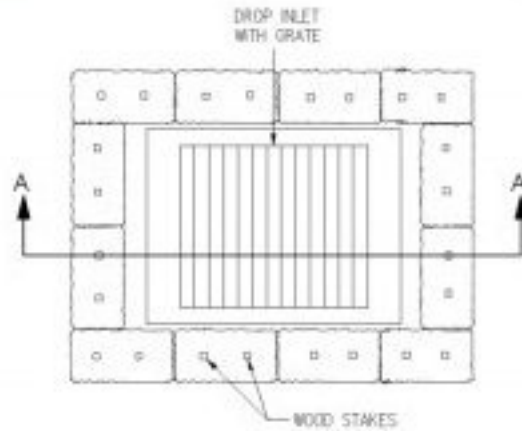
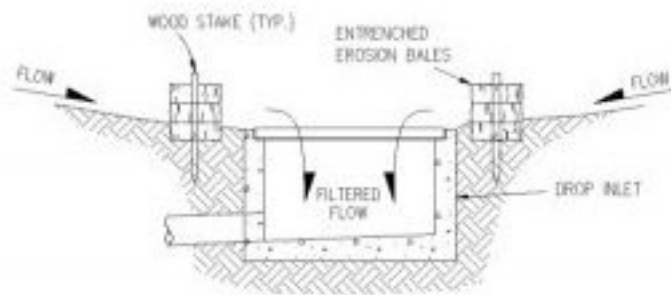
EROSION BALE FILTER AT DROP INLET

Another essential accomplishment of the volunteers has been the establishment of a dry stream bed/drainage ditch in the valley of the site which runs from the outlet of the storm water pipe in the existing parking lot through the entire length of the site to the creek. This swale prevents unnecessary erosion from the parking lot as well as catching the water from the majority of the site and directs it toward an outlet control basin at the rear fence of the site. I have two recommendations regarding this drainage system: I would add some large boulders and add some curves to the channel so the velocity of the storm water will be slowed during a large rain event. I would also add a “trash rack” or an erosion bale filter to prevent clogging of the structure.

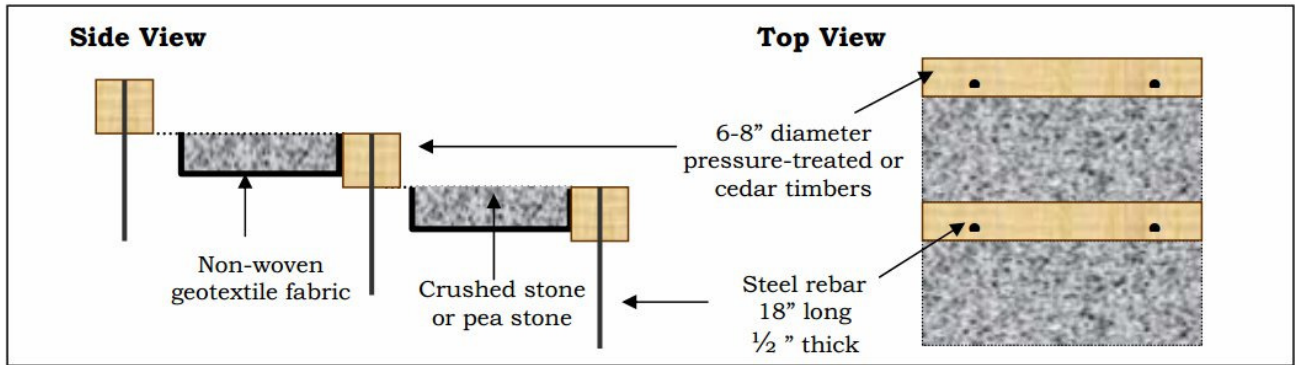
Currently there is a path which runs parallel to the dry stream bed described above. In order to prevent this path from diverting water runoff prior to entering the dry stream bed, I would recommend adding landscape timber steps periodically on the path to prevent erosion.

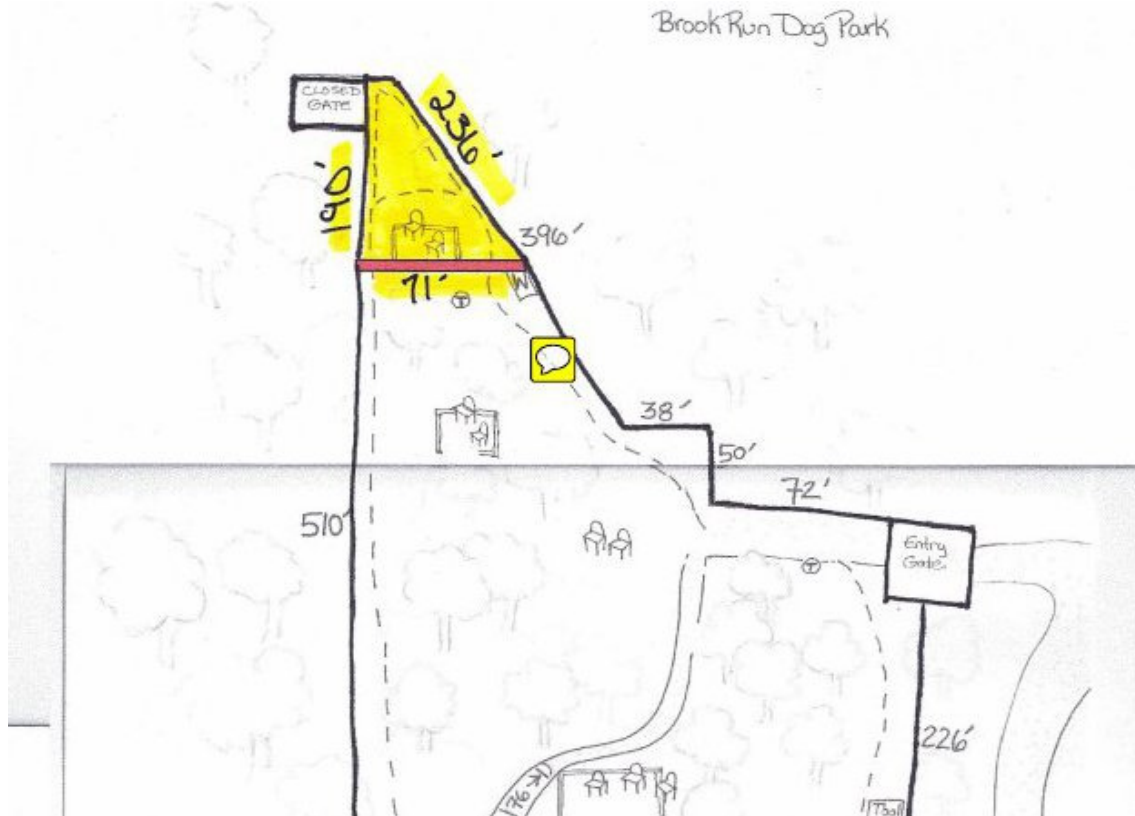
When the concern was raised that noise may be an issue for the residential neighborhood located to the Northwest of the two lane road and 12' multi use trail separating them from the Brook Run Dog Park, the drawing below indicates the willingness of BRDA to relocate the existing fence and create a planted buffer.

I suggest native Southern Magnolias (*Magnolia grandiflora*) and fast growing and dense Leyland Cypress (*Cupressocyparis leylandii*) be planted along the outside of the fence to reduce noise and to visually screen the park from the road.
