FACILITY REPORT

City of Dunwoody
Brook Run Park Theater

June 16, 2011

City of Dunwoody: Brook Run Park Theater

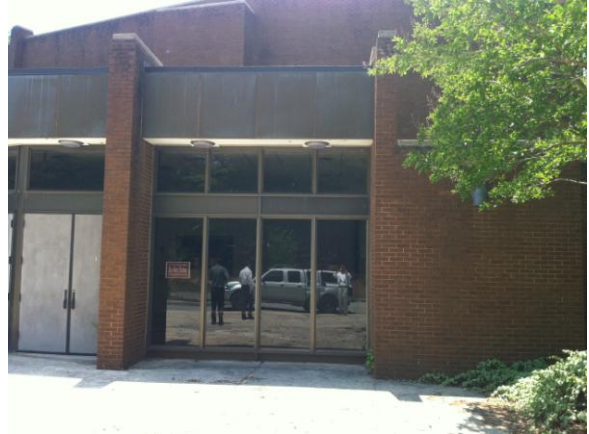
Concerning the exterior skin of the facility and how it measures up to the current energy code, the age of the existing roof and the thickness/condition of the existing roof insulation will determine if it should be considered for replacement. The existing aluminum windows, storefront and curtainwall should be replaced with thermally broken systems including energy efficient low-e, tinted and insulated glazing.

Original Glazing in Aluminum Storefront

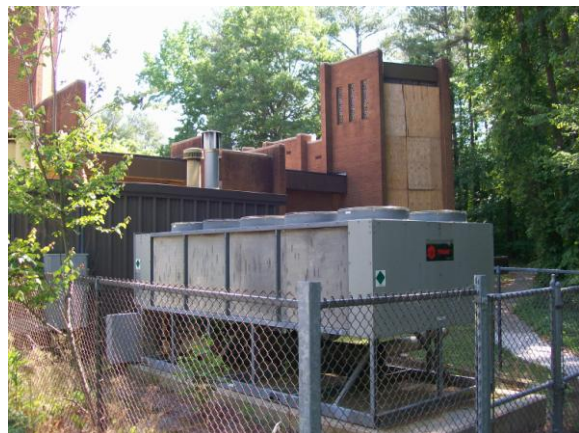
The average useful life of an air-cooled chiller is approximately 20 years. The existing chiller is 11-years-old and appears to be in good condition. As the chiller has not been run recently, CPL recommends that a factory-trained technician be contacted to inspect the chiller, start-up the unit, and provide a condition report on the chiller. This chiller could potentially be utilized for another 10 years.

Chiller at Rear of Facility

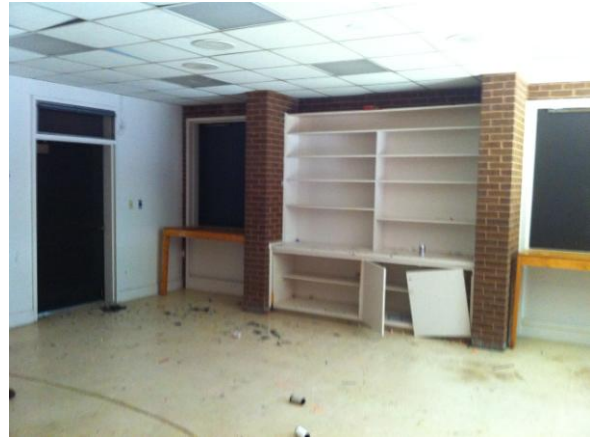
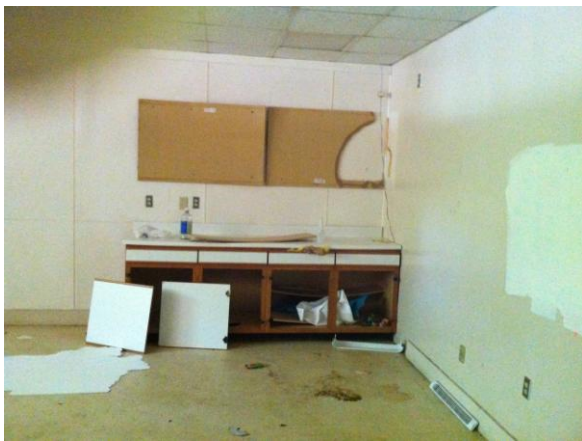
Existing built-in millwork including base cabinets, upper cabinets, shelving, and countertops are in very poor condition with broken and missing components, and damage from humidity and vandalism. All existing millwork should be removed and replaced with AWA “Premium or Custom” grade materials that meet ADA requirements.

Damaged Flooring & Millwork

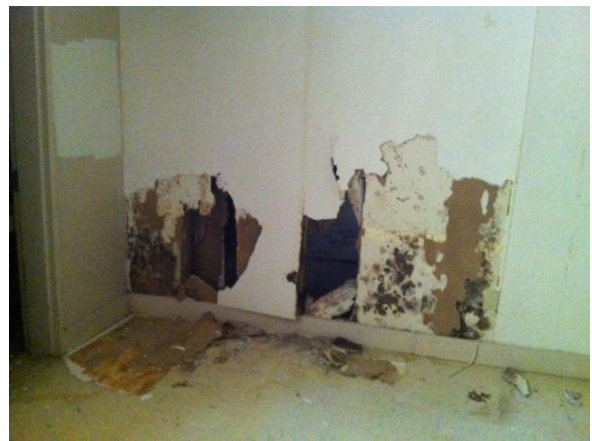
Water Damage & Mold at Wall

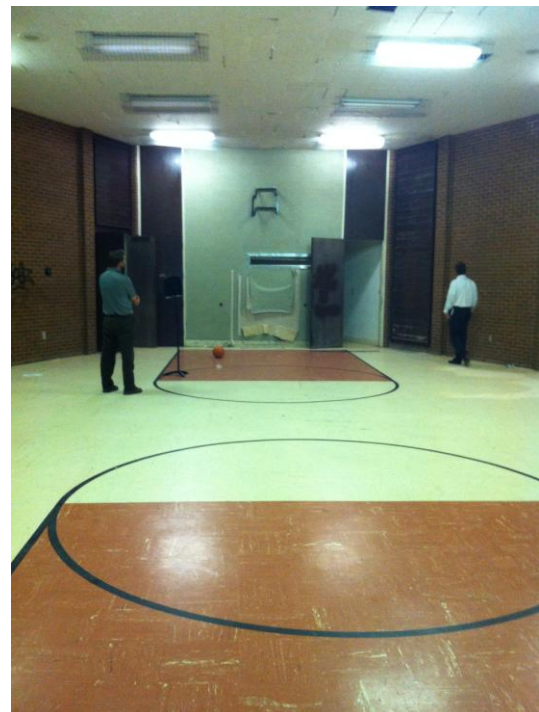
Damaged Walls at Recreation Room

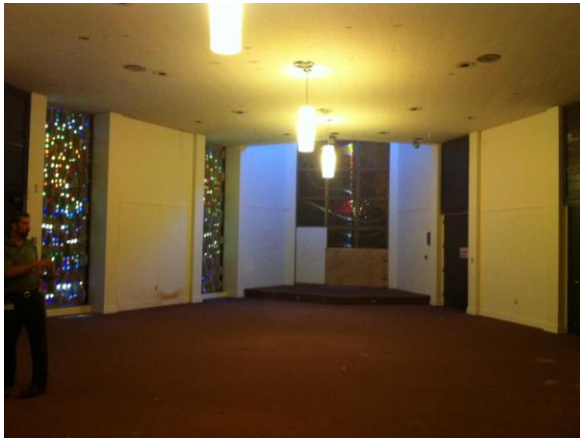
Vandalism at Chapel Windows

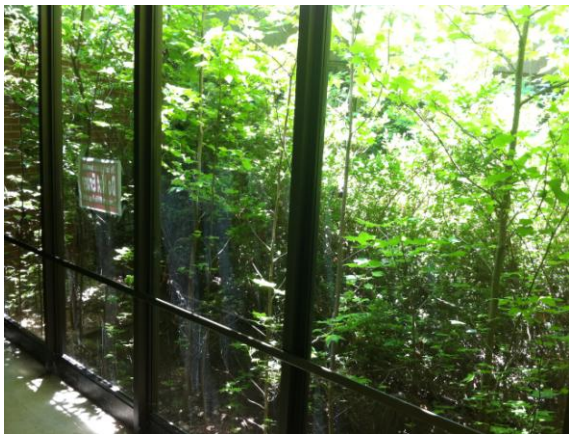
Overgrown Weeds at Interior Courtyard

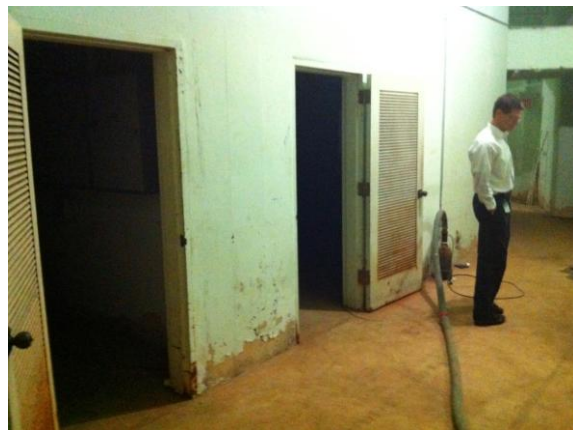
Damaged Wall at Basement

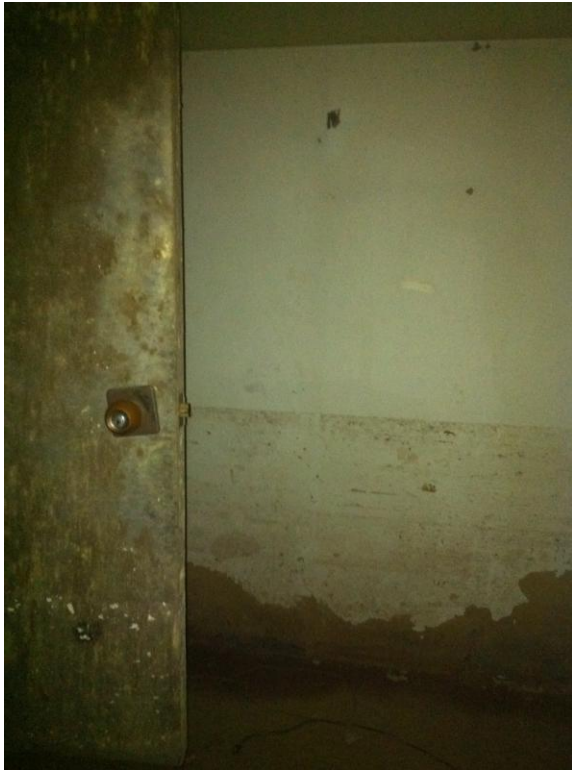
Deteriorated Basement Door & Hardware

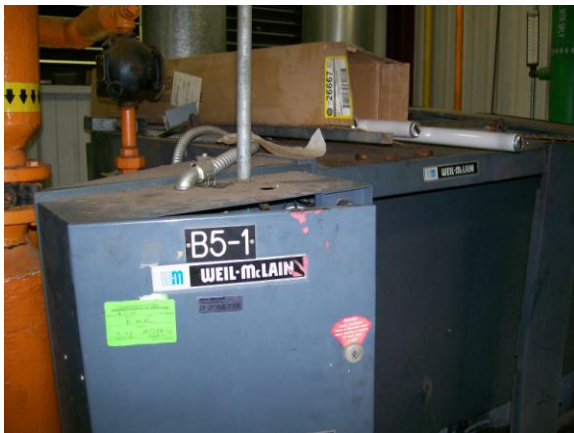
Heating potential is generated by two Weil McLain gas-fired hydronic boilers. Each boiler has an input of 1,950,000 Btu and an output of 1,579,500 Btu. Under perfect conditions these boilers are 81 percent efficient. Currently only one of the boilers is operational and has been run throughout the winter to temper the building. These boilers were manufactured in 1987 and installed in 1990. Distribution is accomplished by one base-mounted pump sized for 138 gallons-per-minute (gpm).

Gas-Fired Hydronic Boiler

Clark Patterson Lee (CPL) recommends that the existing boilers and associated pump be replaced should the facility be renovated. The boilers are past their average useful life span and

by today's standards are inefficient. CPL recommends new modular condensing boilers be utilized. These boilers can have efficiencies from 92-96 percent.

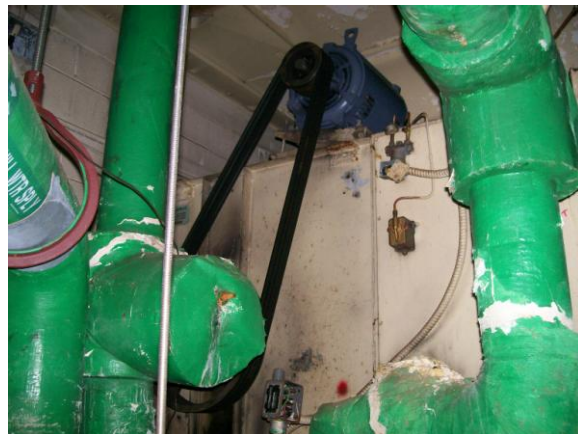
The Theater is served by two constant-volume air-handling units. The unit manufacturer is Air Therm. The model and serial number could not be obtained during our visit, but the units appeared to be original to the building. AHU-L1 serves the theater and front lobby. Ductwork for the theater is routed from the basement mechanical room up to above the ceiling in the theater and runs out to the front lobby above the ceiling. AHU-L2 serves the classroom/office portion of the building. AHU-L2 is a constant-volume re-heat system, meaning each classroom or zone has a duct-mounted hot water re-heat coil to regulate temperature. The ductwork and piping is routed in the crawl space of the building to registers mounted in the floor of each space.

Air Handling Unit

Both existing air-handling units will need to be replaced should the facility be renovated. The existing ductwork for the theater and front lobby does not appear to be lined, and if this is the case, the ductwork could potentially be cleaned and reused. Schematic level load calculations confirm that, should the seating capacity not change greatly, the existing ductwork is of sufficient size for the air volumes required for the theater. Currently the stage area has no air outlets.

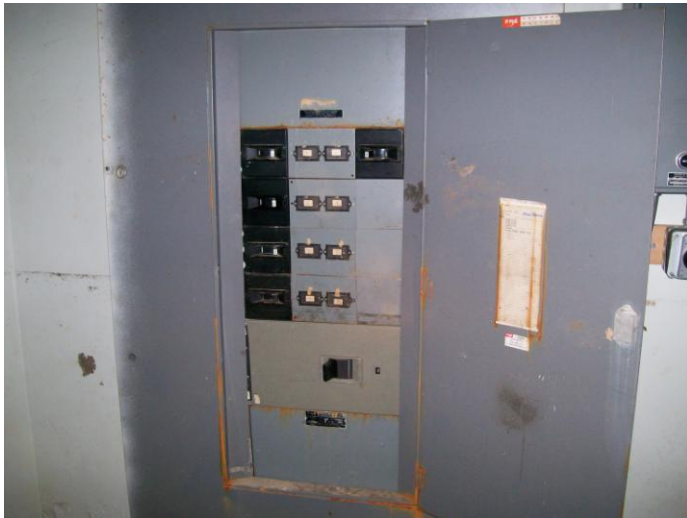
The original electrical service equipment appears to have been installed sometime in the late 1960’s. The electrical equipment shows signs of water damage and is outdated and it would be difficult to find the required new parts, such as internal panel parts, breakers, and fuses, etc for restoration of the existing Theater building.

Water Damage at Main Distribution Panel "PP-L"

Installation of a new main Distribution Panel and branch circuit panels is recommended. The existing 600 amp service should be more than adequate for the renovation of the existing Theater building and some of the main feeders may be able to be re-used in the renovation depending on exact conductor type, size, condition, and location.
