**The Brook Run Theater
Feasibility Study**

**Report of Findings and Recommendations
Regarding Rehabilitation, Adaptive Re-Use and Operations**

Tomlinson-Graham Group

January 2016

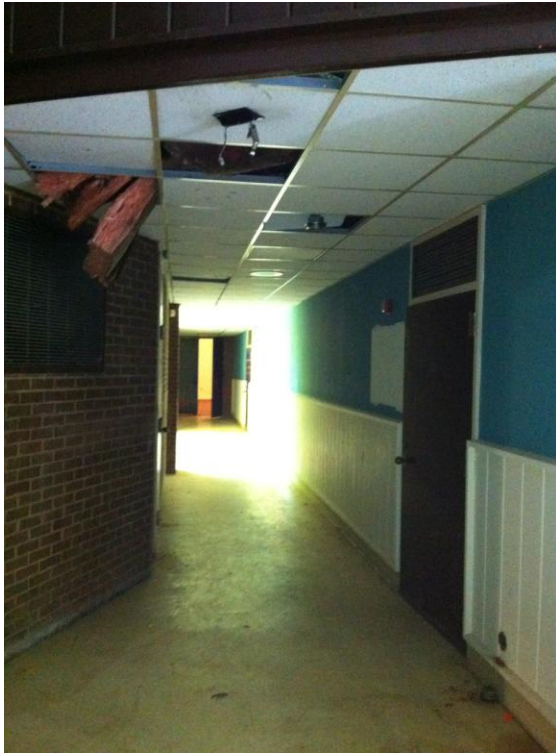
Typical Condition at Corridors

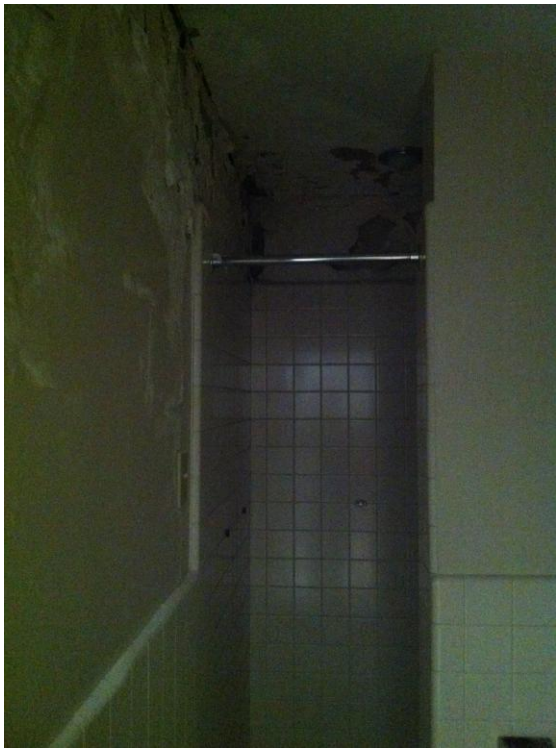
Damaged Wall at Restroom/Shower

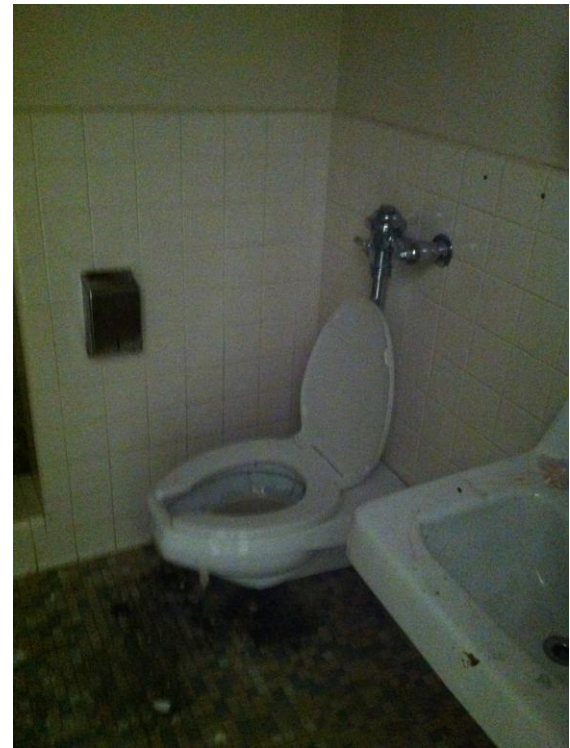
Damaged Flooring at Restroom

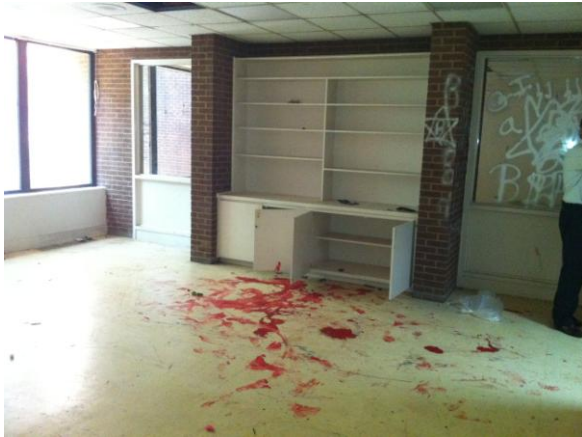
Vandalism at Classroom

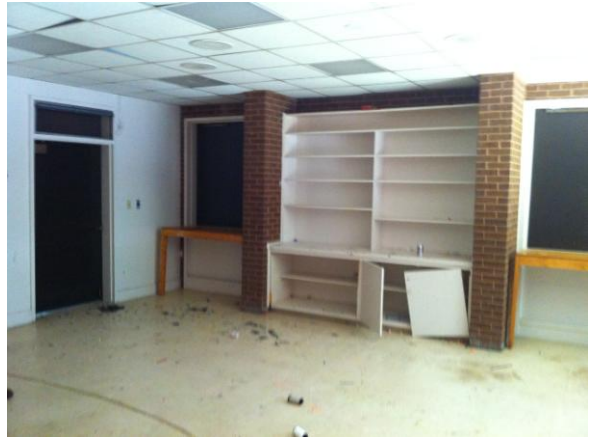
Damaged Flooring & Millwork

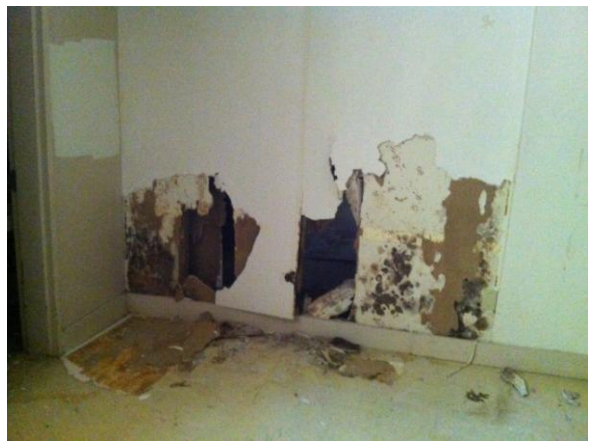
Water Damage & Mold at Wall

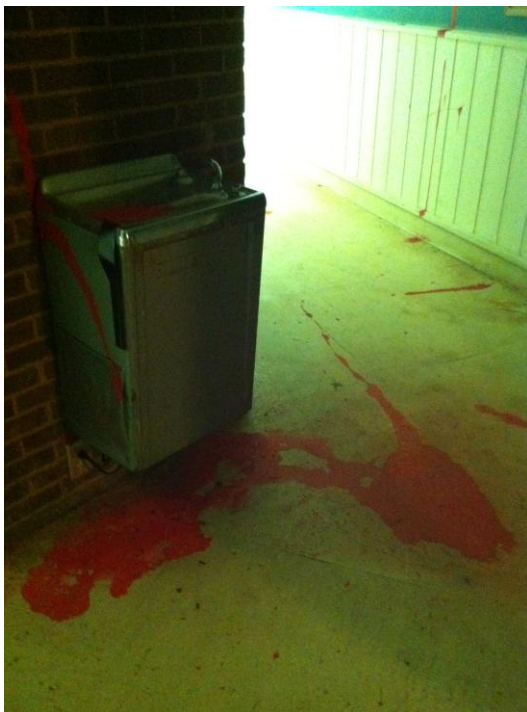
Vandalism at Corridor

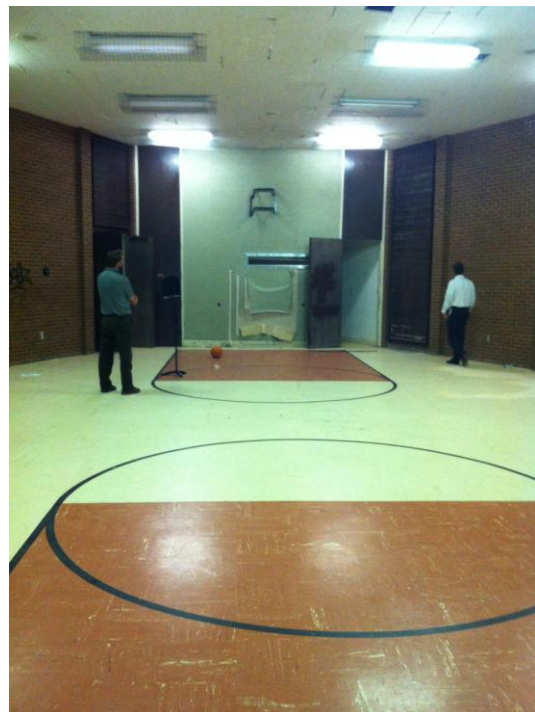
Damaged Walls at Recreation Room

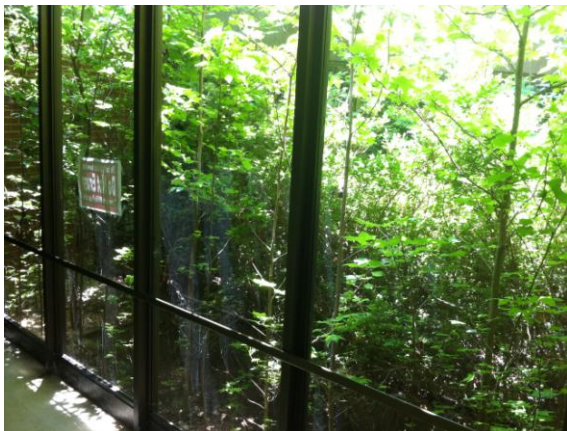
Overgrown Weeds at Interior Courtyard

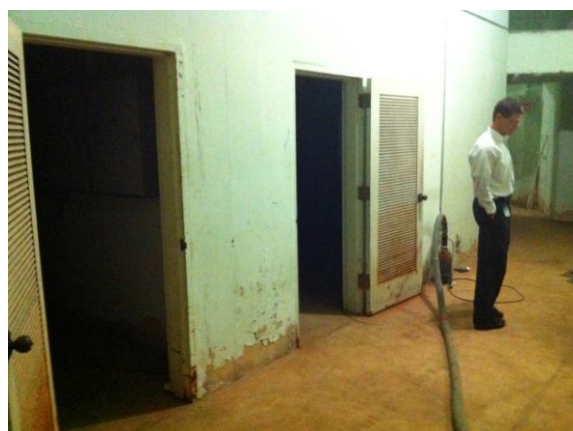
Damaged Wall at Basement

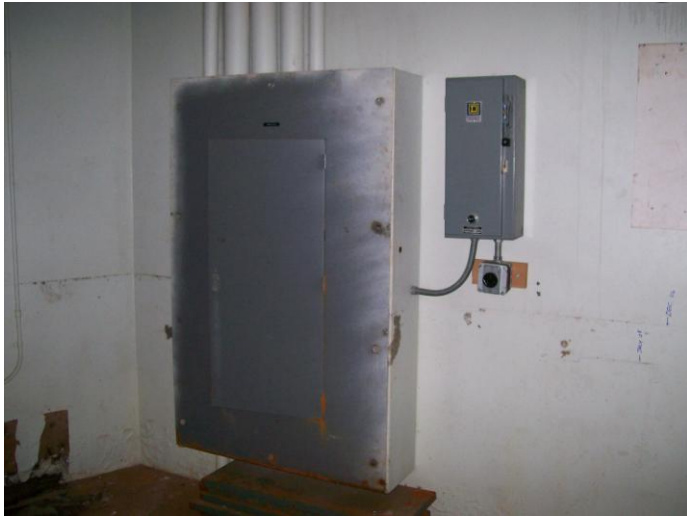
Water Damage at Main Distribution Panel "PP-L"

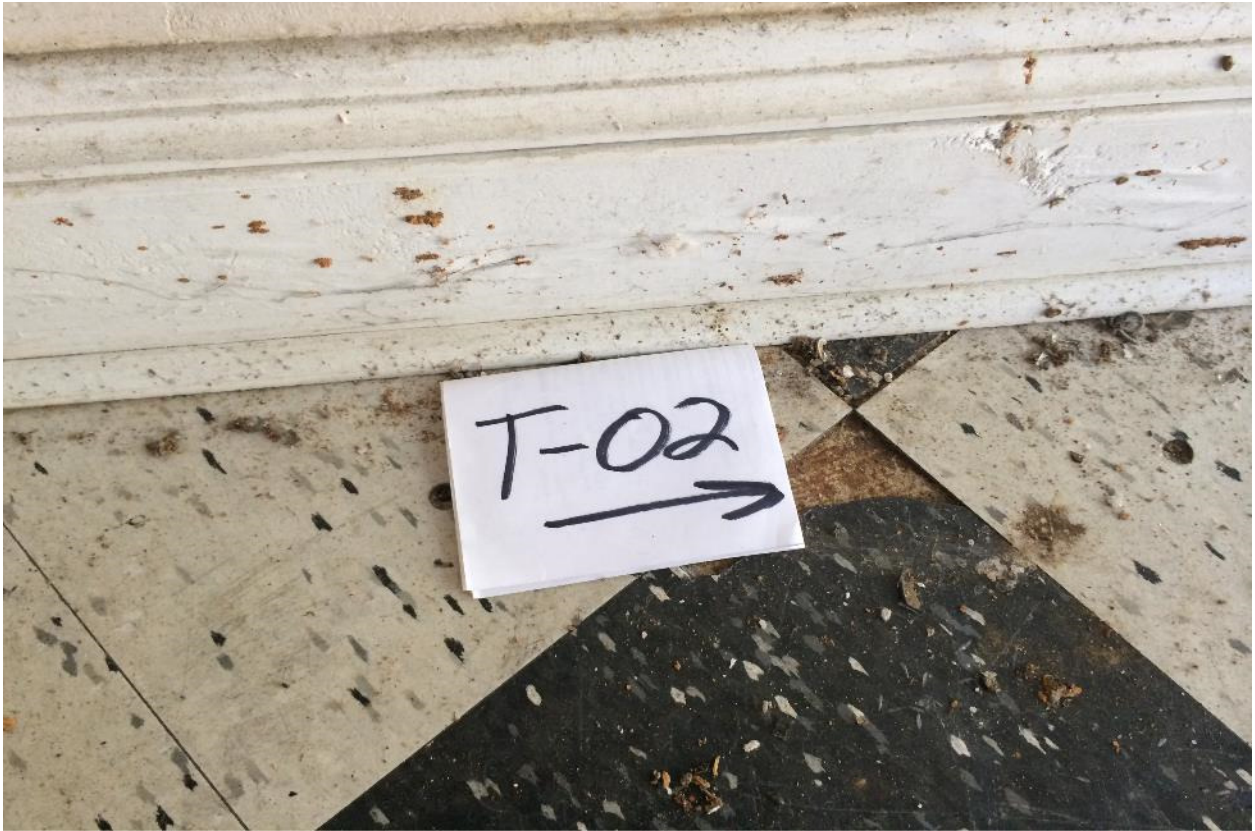
Plate 53: Laboratory analyses did not detect asbestos minerals within the black floor tile from sample TS-02 but did detect 5% chrysotile asbestos in the mastic from sample TS-02 collected from the Theatre Building lobby area.

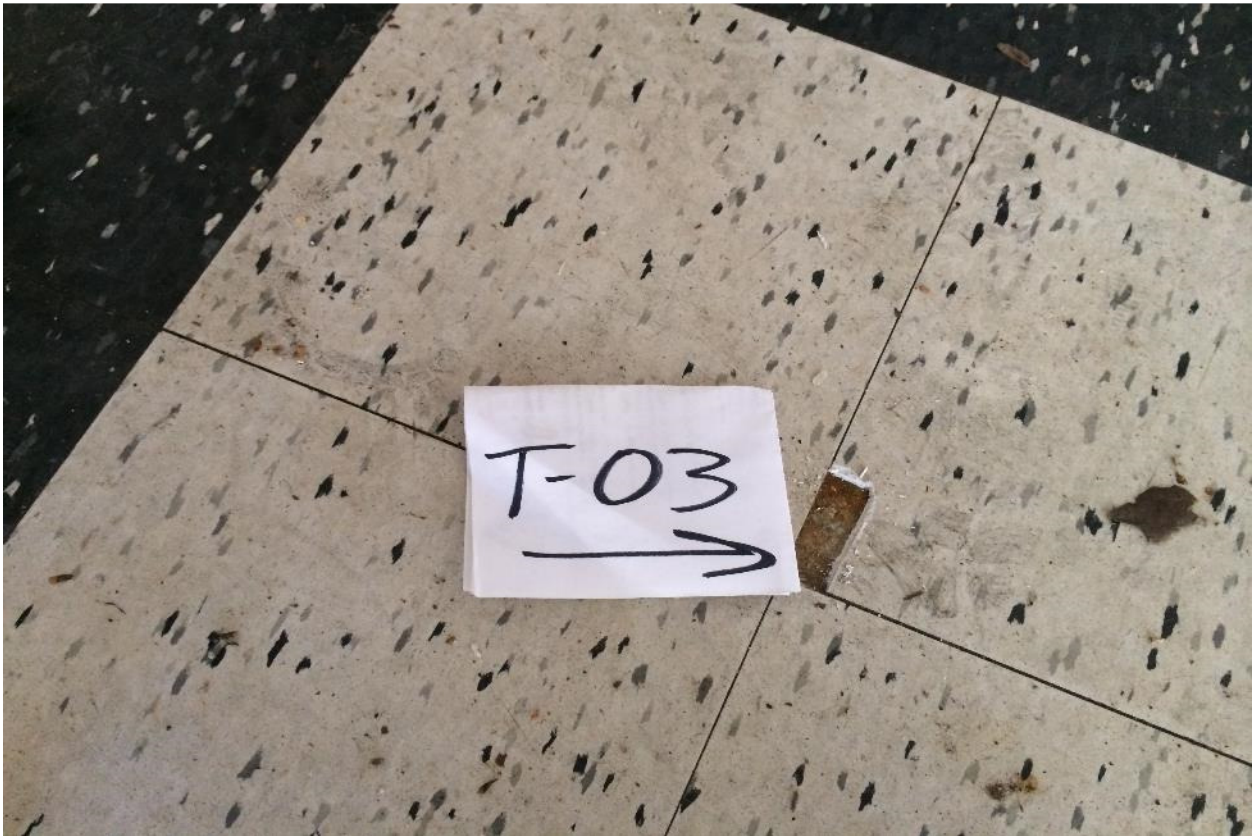
Plate 54: Laboratory analyses did not detect asbestos minerals within the white floor tile from sample TS-03 but did detect 5% chrysotile asbestos in the mastic from sample TS-03 collected from the Theatre Building lobby area.

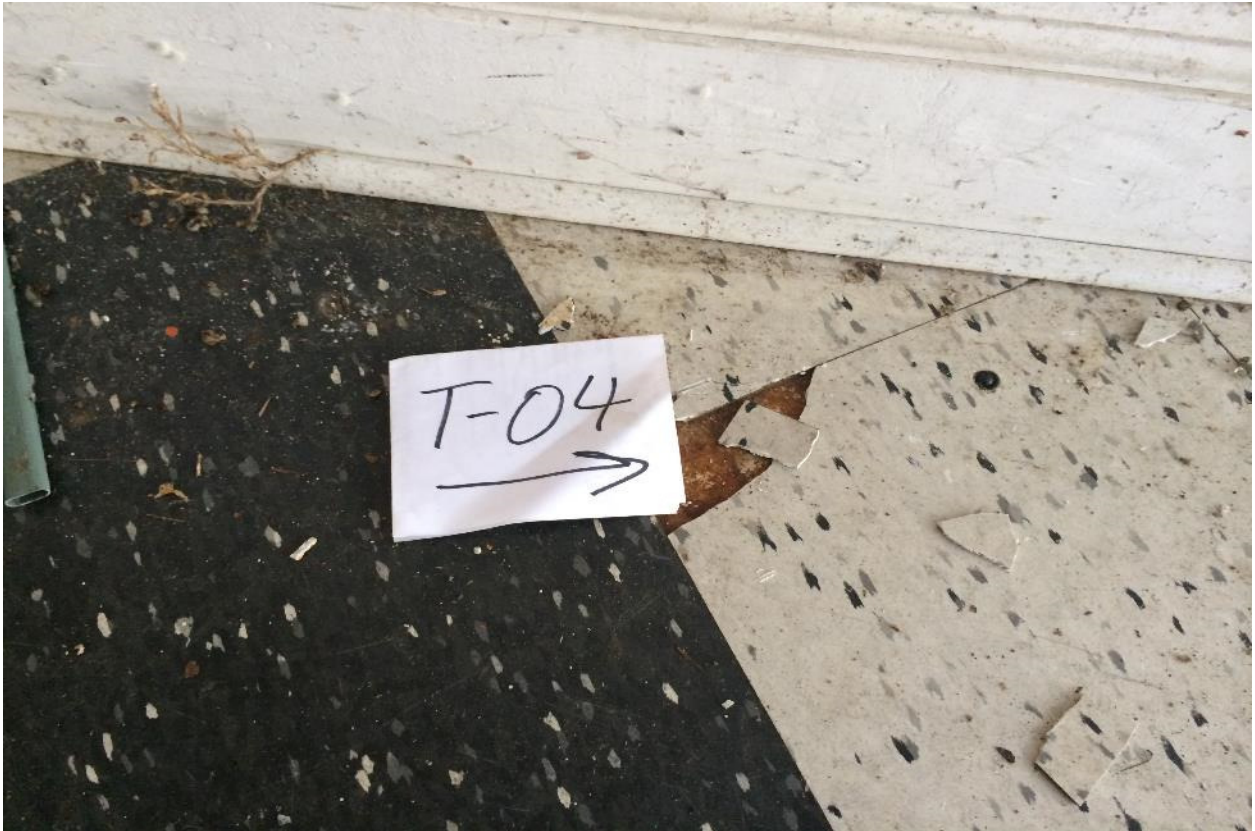
Plate 55: Laboratory analyses did not detect asbestos minerals within the white floor tile from sample TS-04 but did detect 5% chrysotile asbestos in the mastic from sample TS-04 collected from the Theatre Building lobby area.

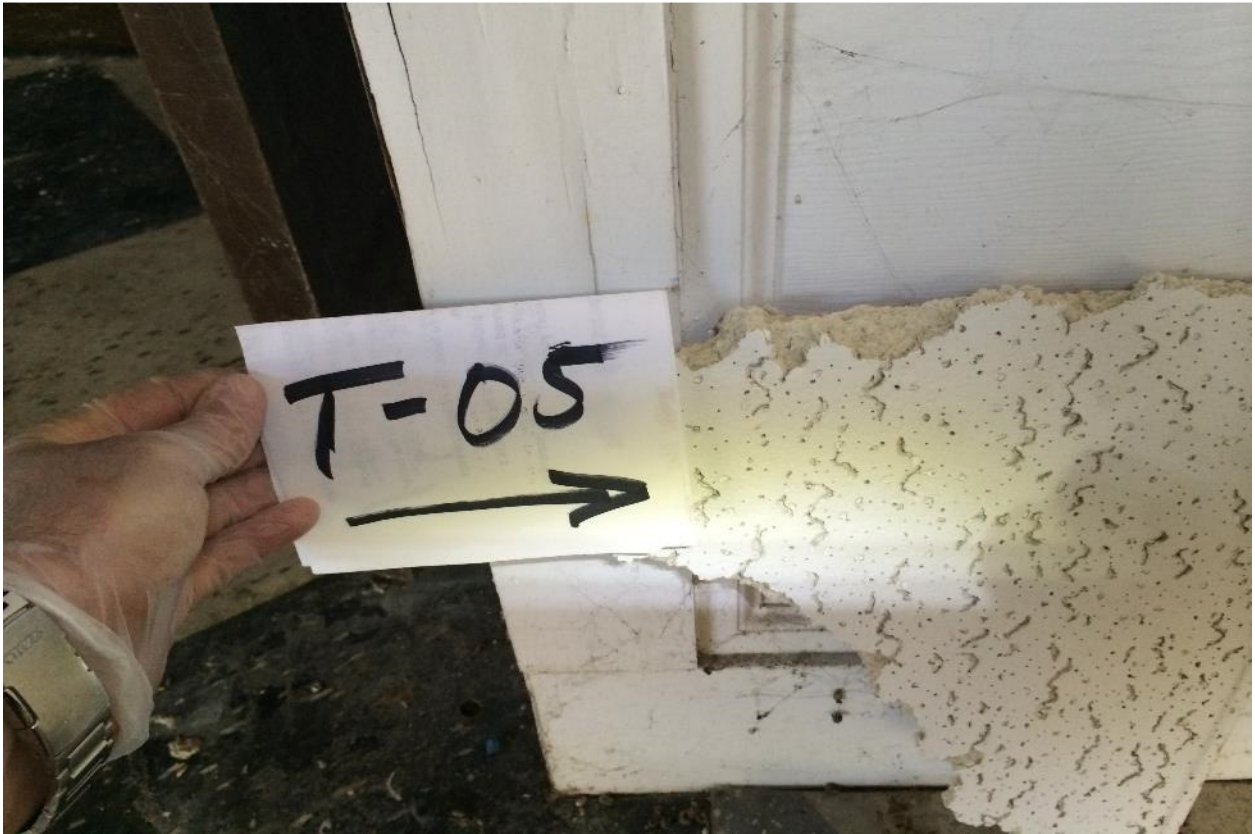
Plate 56: Laboratory analyses detected 2% chrysotile asbestos within suspended ceiling tile sample TS-05 collected from the Theatre Building lobby area.

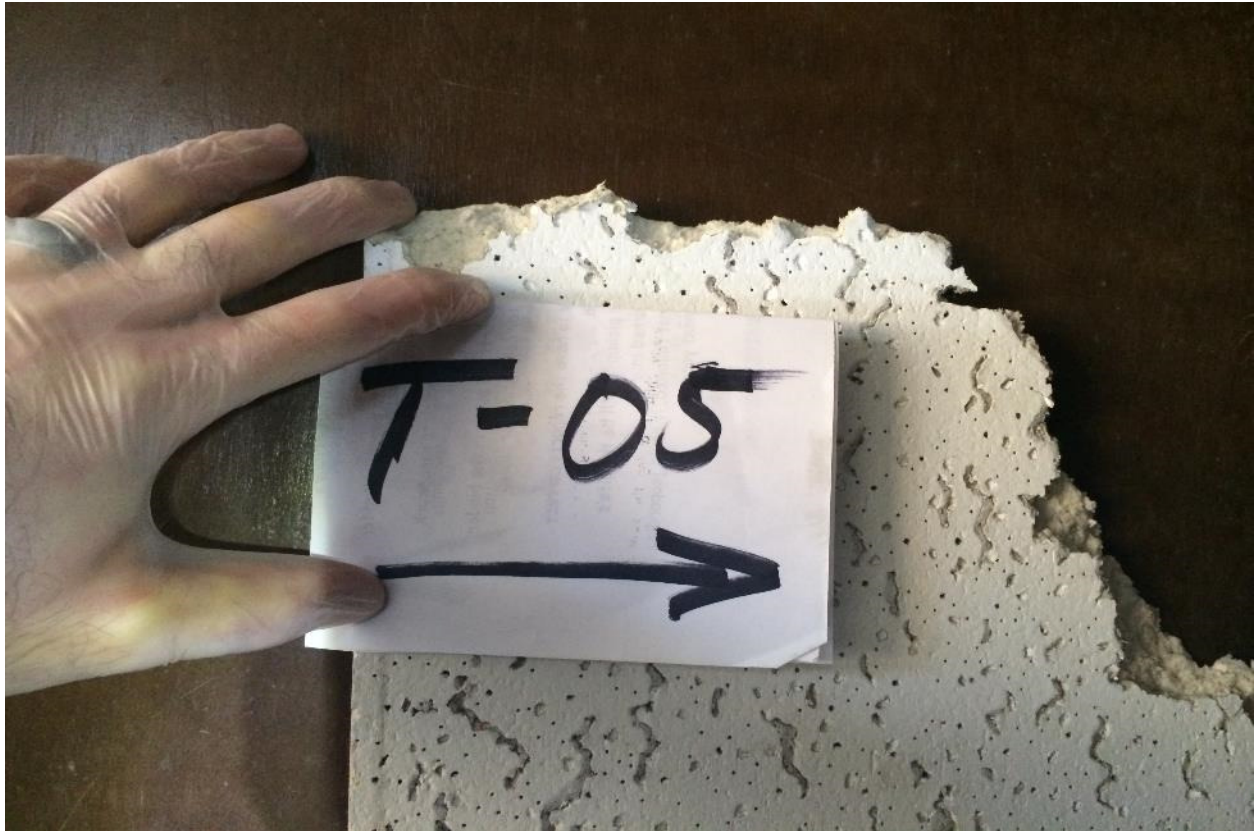
Plate 57: Laboratory analyses detected 2% chrysotile asbestos within suspended ceiling tile sample TS-06 collected from the Theatre Building hallway (sample should be labeled TS-06).

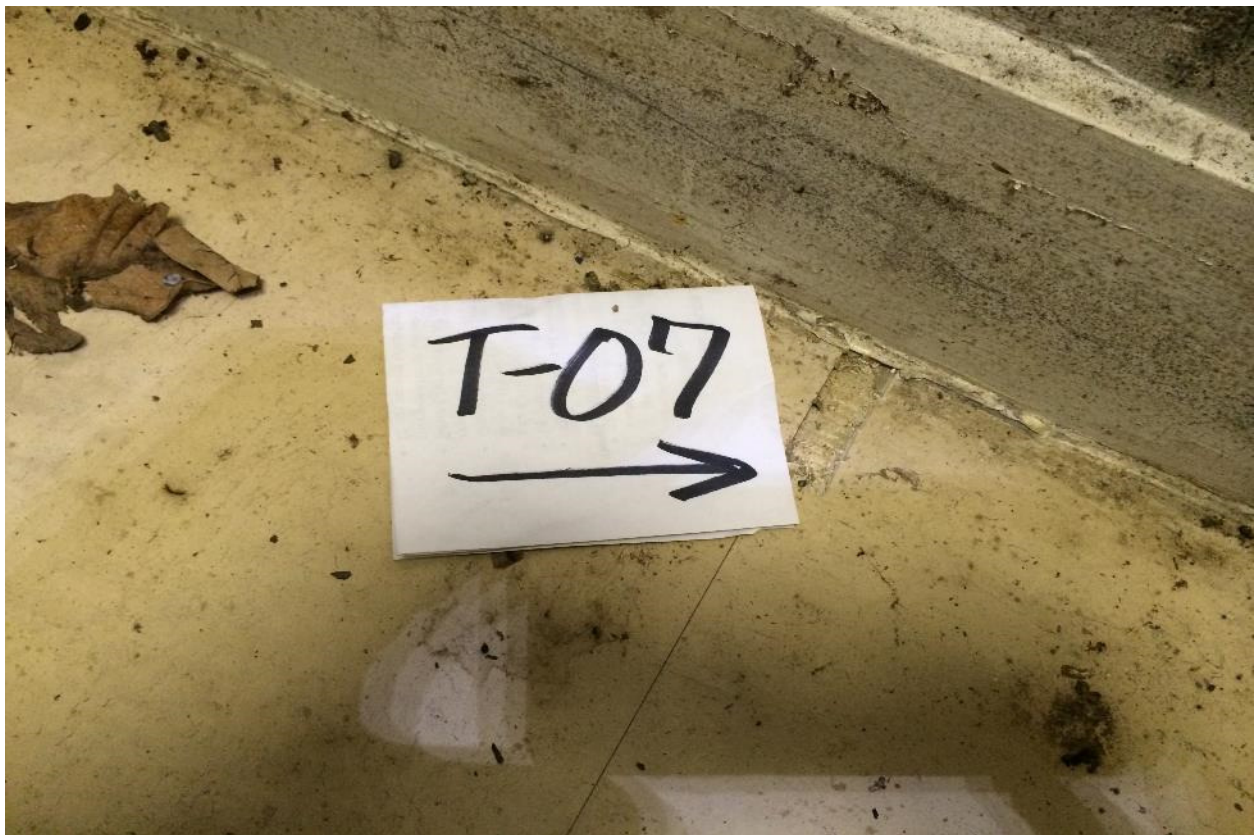
Plate 58: Laboratory analyses did not detect asbestos minerals within the beige floor tile or mastic sample TS-07 collected from the Theatre Building hallway.

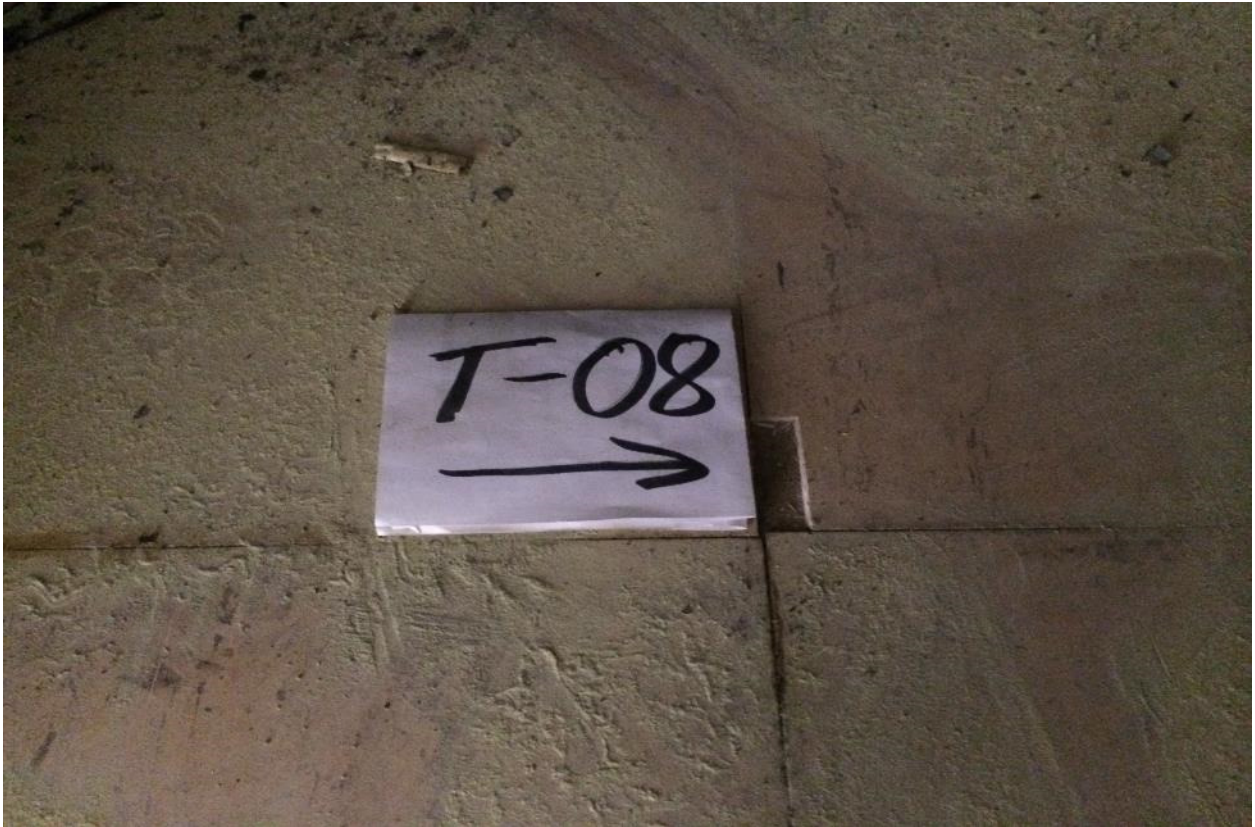
Plate 59: Laboratory analyses did not detect asbestos minerals within the beige floor tile or mastic sample TS-08 collected from the Theatre Building lobby storage room.

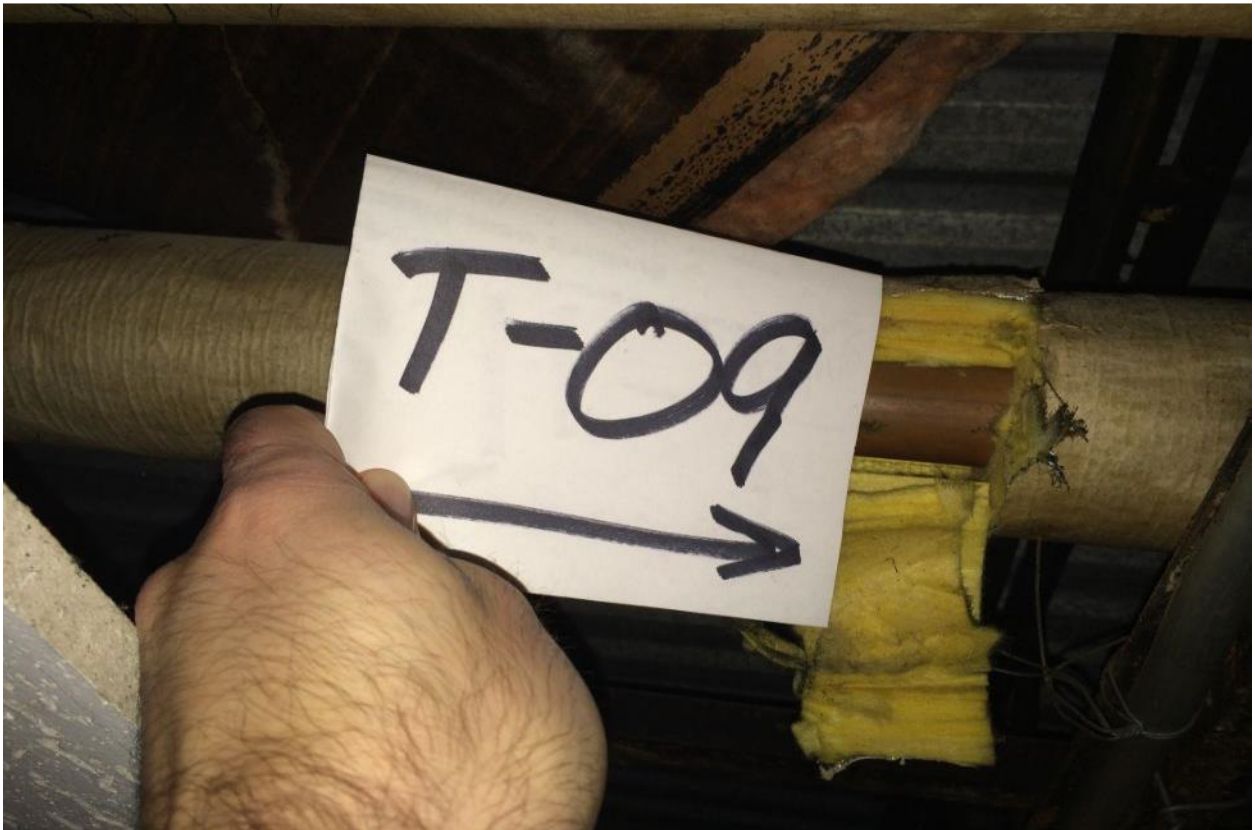
Plate 60: Laboratory analyses did not detect asbestos minerals within plumbing insulation sample TS-09 collected from the Theatre Building lobby ceiling.

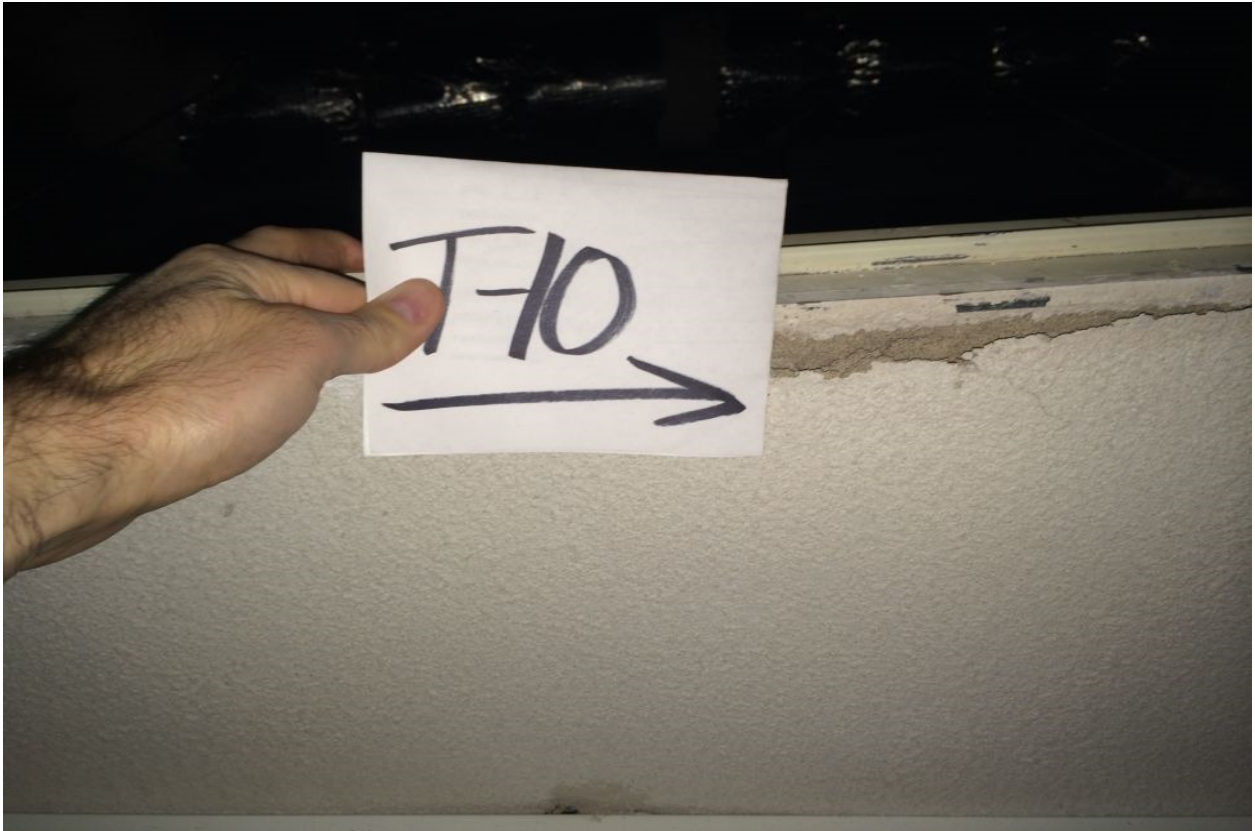
Plate 61: Laboratory analyses detected 20% chrysotile asbestos within spray on surfacing material sample TS-10 collected from the Theatre Building upstairs projection room ceiling.

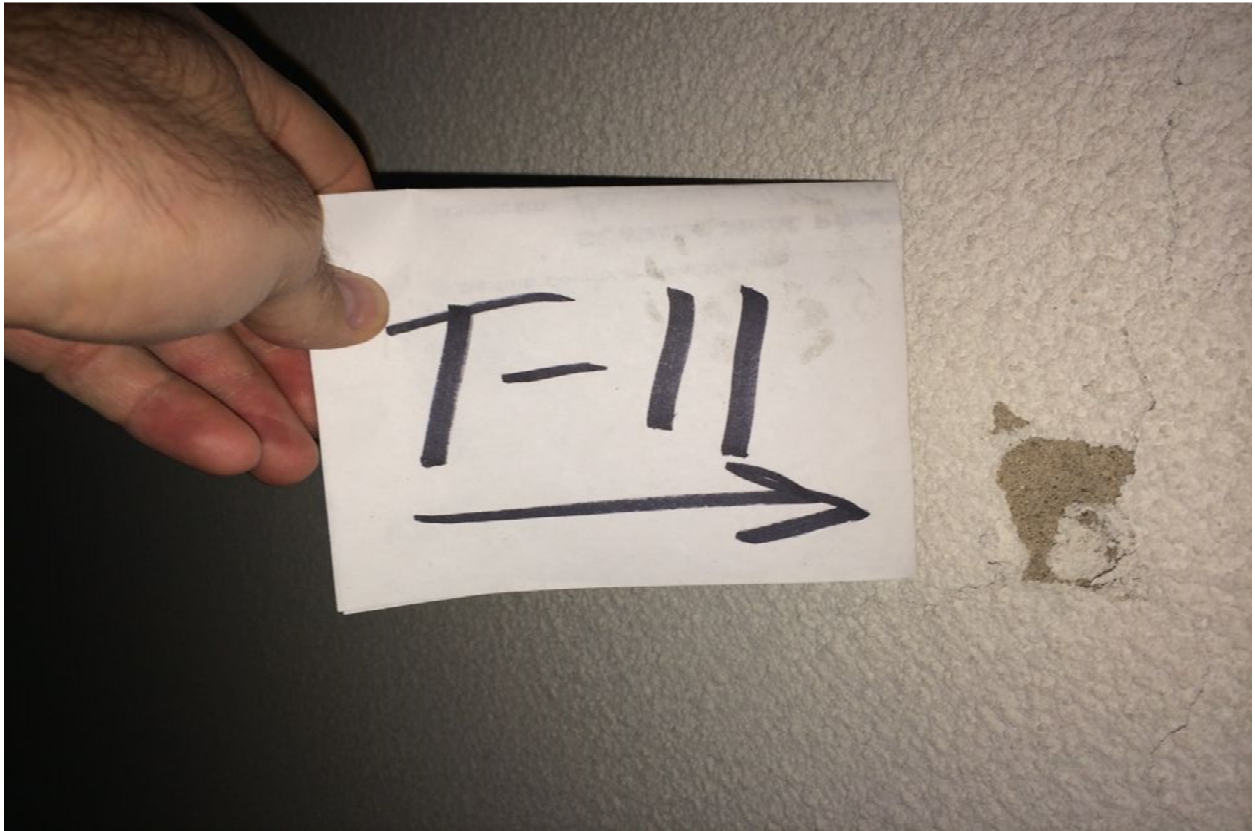
Plate 62: Laboratory analyses detected 20% chrysotile asbestos within spray on surfacing material sample TS-11 collected from the Theatre Building upstairs projection room ceiling.

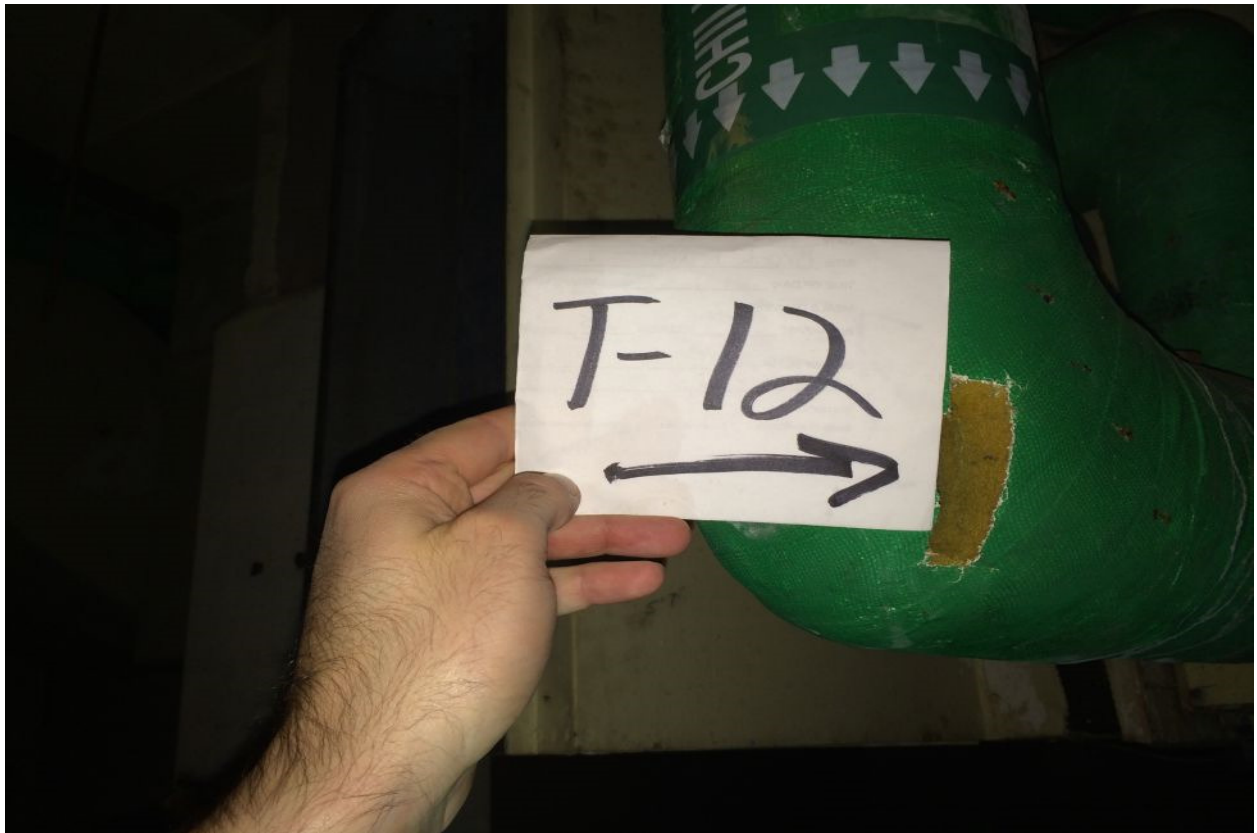
Plate 63: Laboratory analyses did not detect asbestos minerals within plumbing insulation sample TS-12 collected from the Theatre Building basement boiler room.

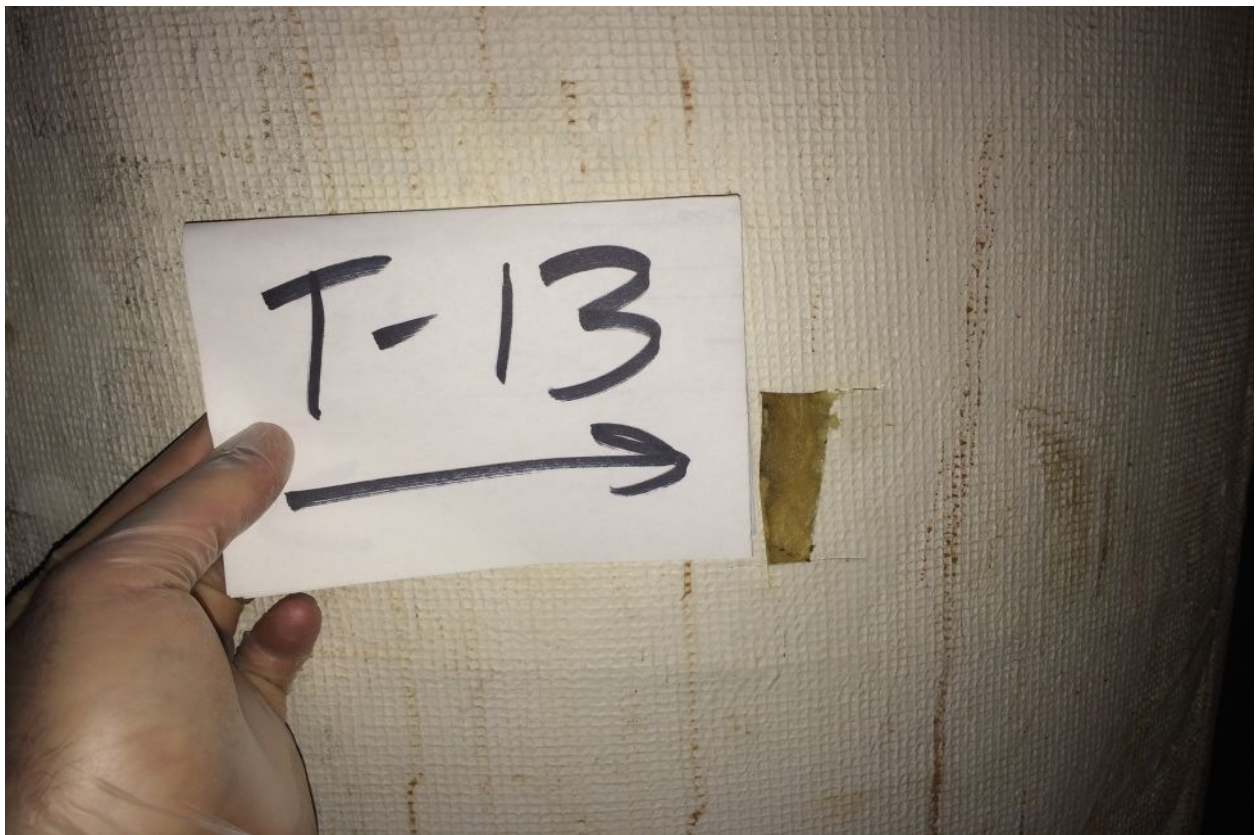
Plate 64: Laboratory analyses did not detect asbestos minerals within boiler wrap insulation sample TS-13 collected from the Theatre Building basement boiler room.

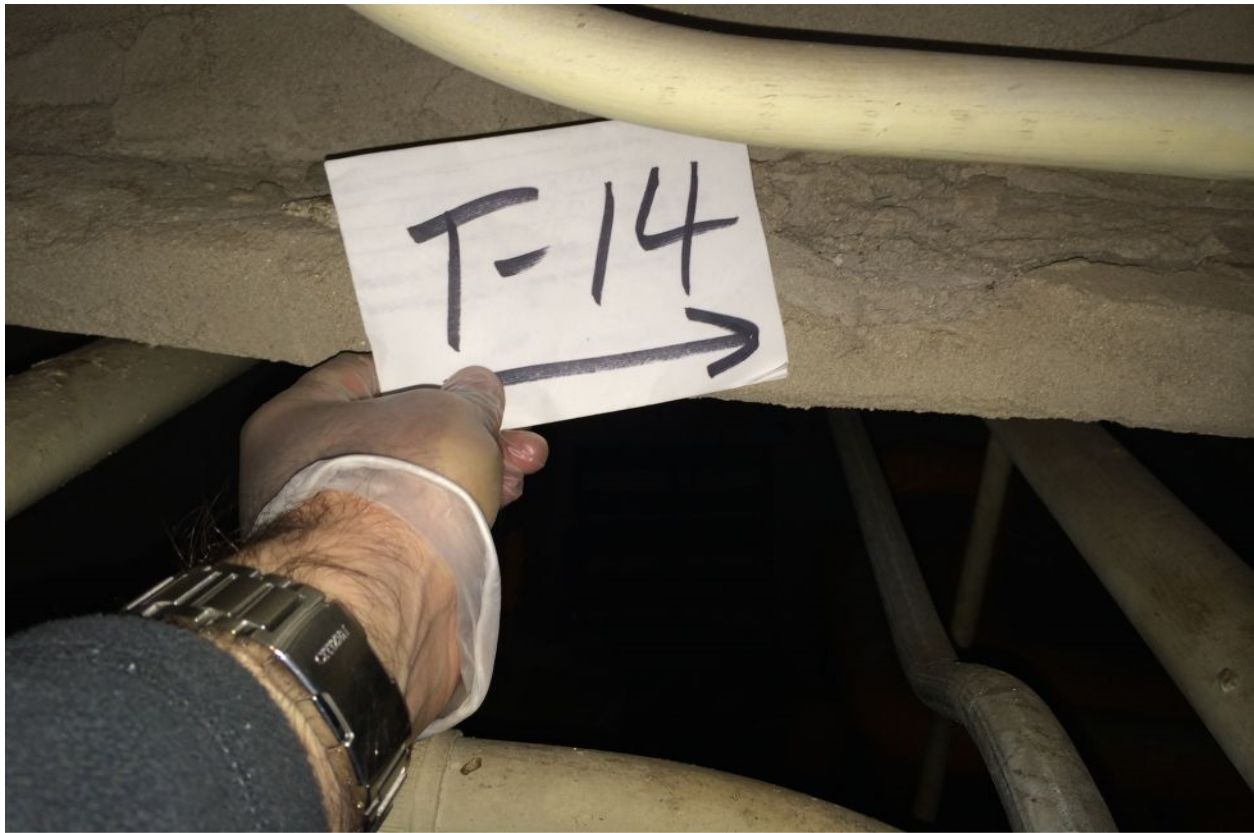
Plate 65: Laboratory analyses detected 20% chrysotile asbestos within spray on surfacing material sample TS-14 collected from the Theatre Building basement structural steel.

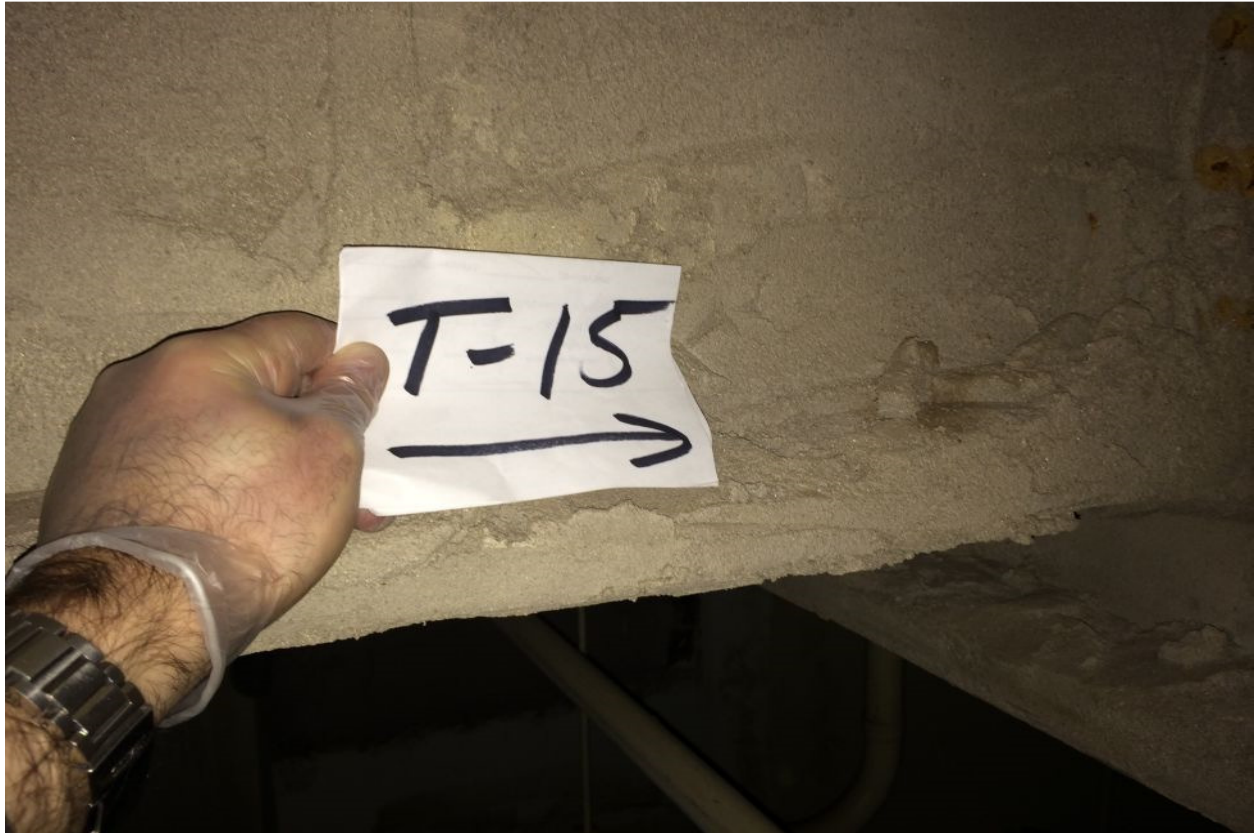
Plate 66: Laboratory analyses detected 20% chrysotile asbestos within spray on surfacing material sample TS-15 collected from the Theatre Building basement structural steel.

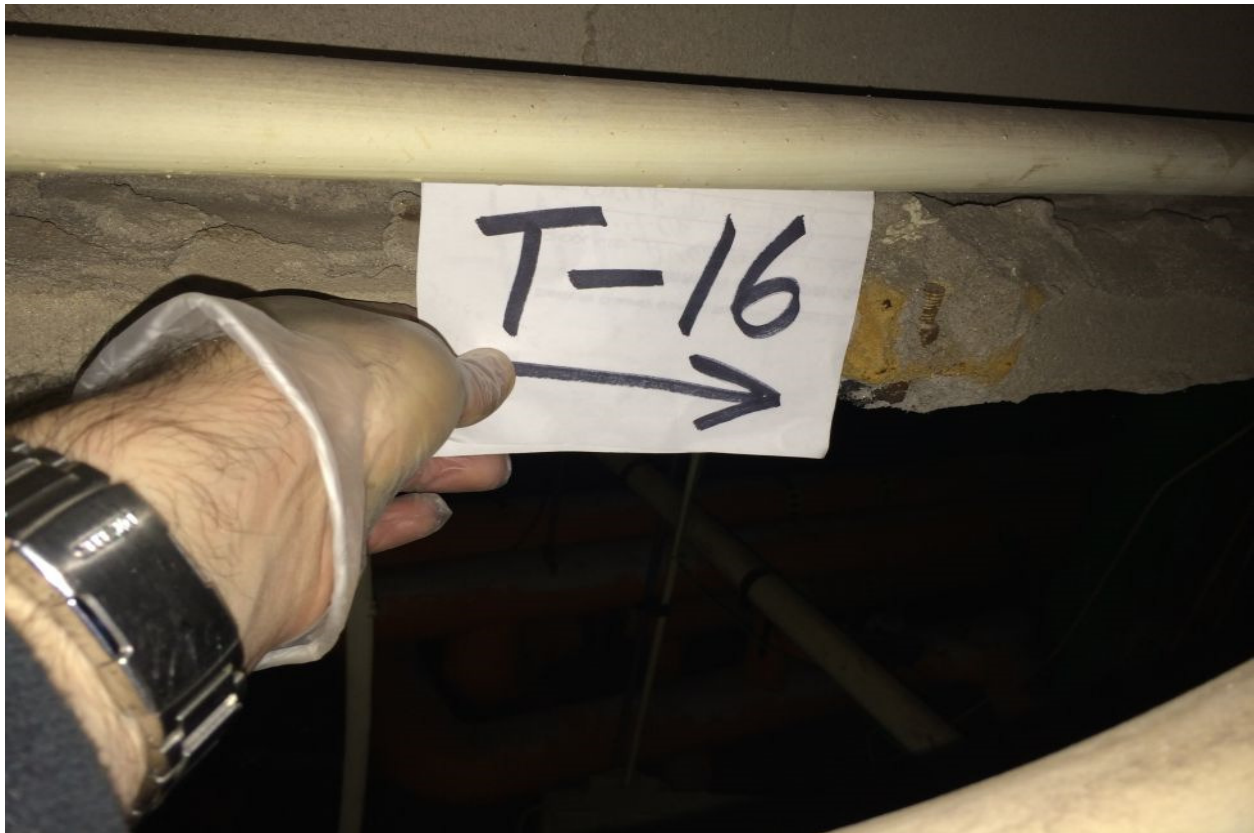
Plate 67: Laboratory analyses detected 20% chrysotile asbestos within spray on surfacing material within sample TS-16 collected from the Theatre Building basement structural steel.

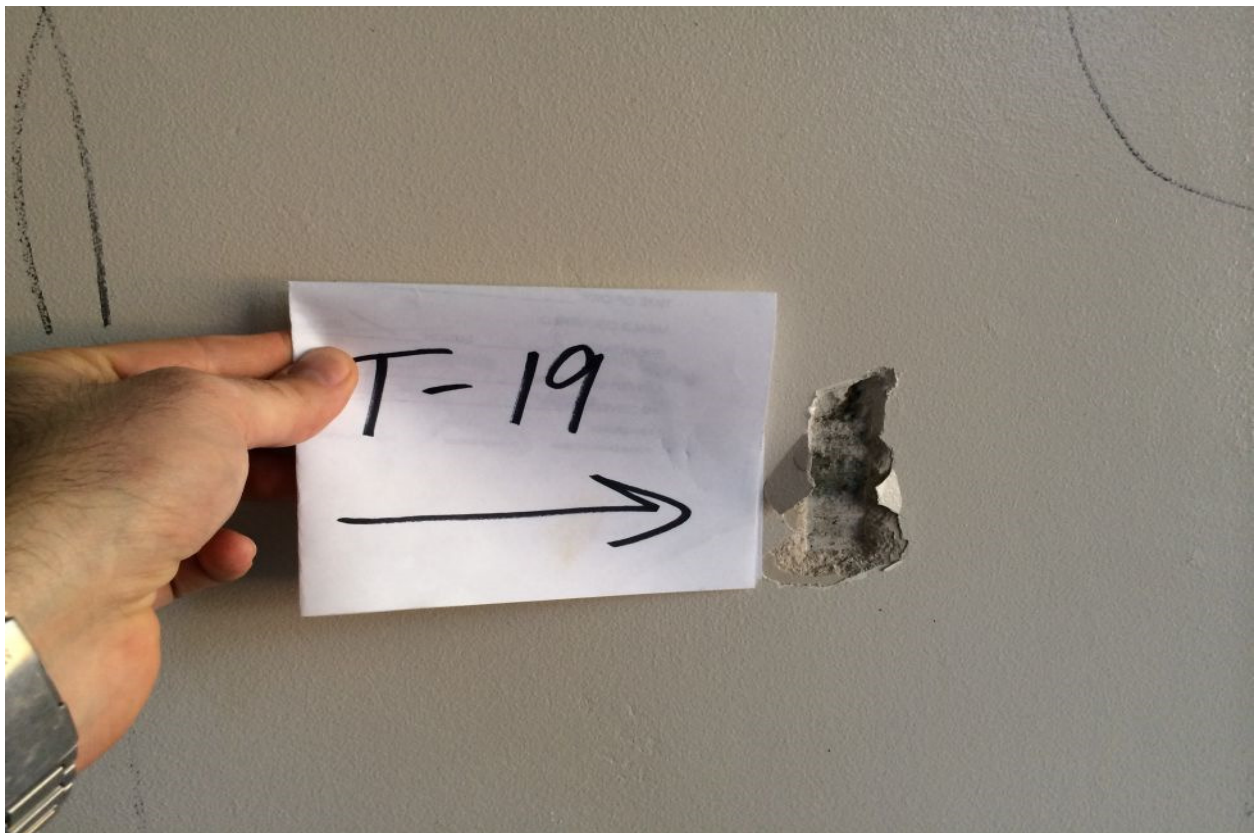
Plate 68: Laboratory analyses did not detect asbestos minerals within troweled on surfacing material within sample TS-19 collected from the Theatre Building basement hall wall.

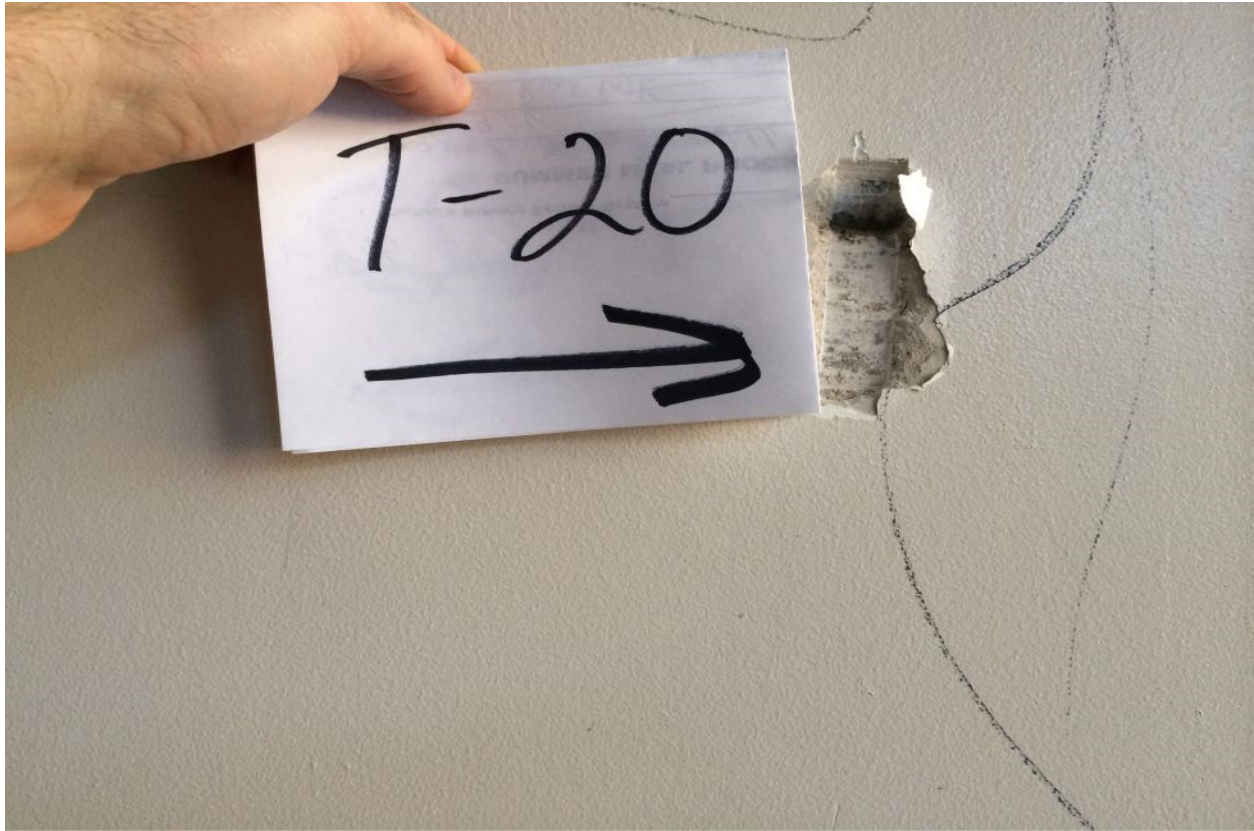
Plate 69: Laboratory analyses did not detect asbestos minerals within troweled on surfacing material sample TS-20 collected from the Theatre Building lobby wall.
