**The Brook Run Theater
Feasibility Study**

**Report of Findings and Recommendations
Regarding Rehabilitation, Adaptive Re-Use and Operations**

Tomlinson-Graham Group

January 2016

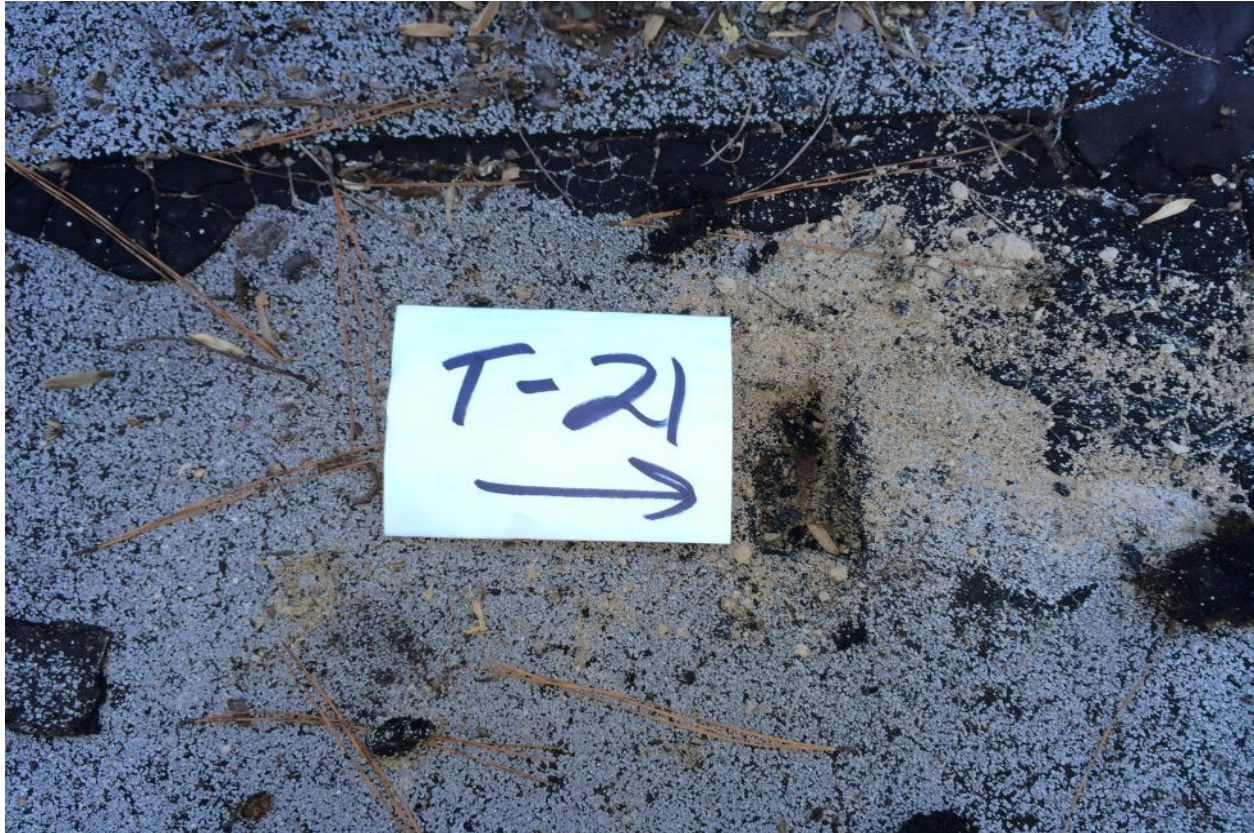
Plate 70: Laboratory analyses did not detect asbestos minerals within asphalt roof sample TS-21 collected from the Theatre Building roof.

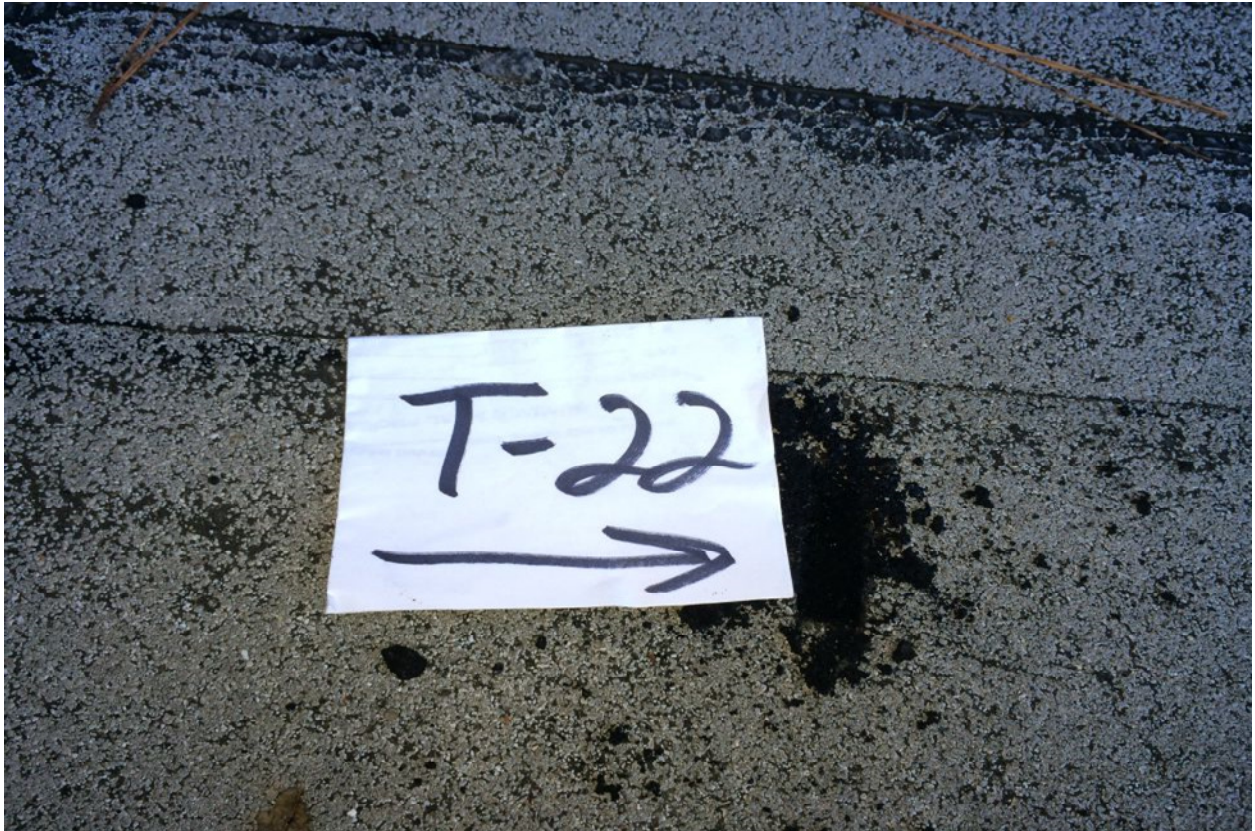
Plate 71: Laboratory analyses did not detect asbestos minerals within asphalt roof sample TS-22 collected from the Theatre Building roof.

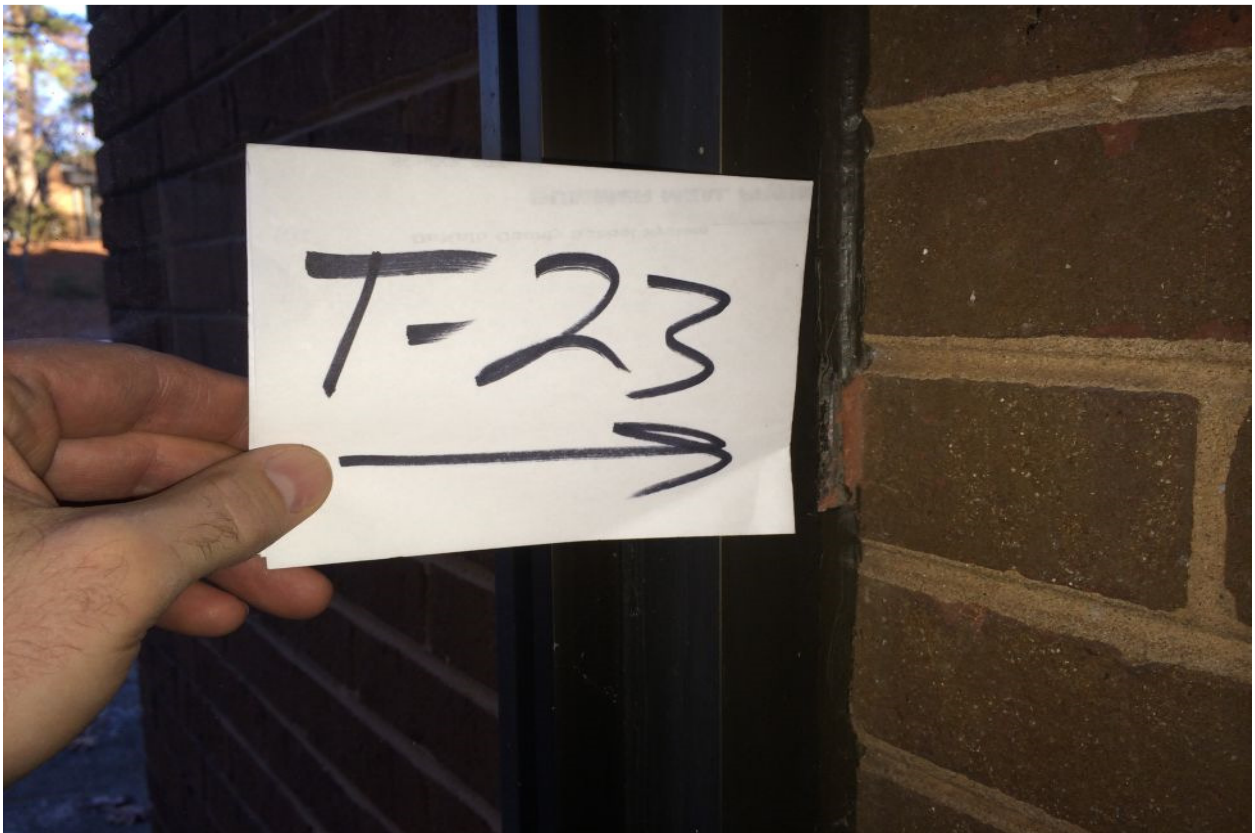
Plate 72: Laboratory analyses did not detect asbestos minerals within the window caulk sample TS-23 collected from the Theatre Building windows.

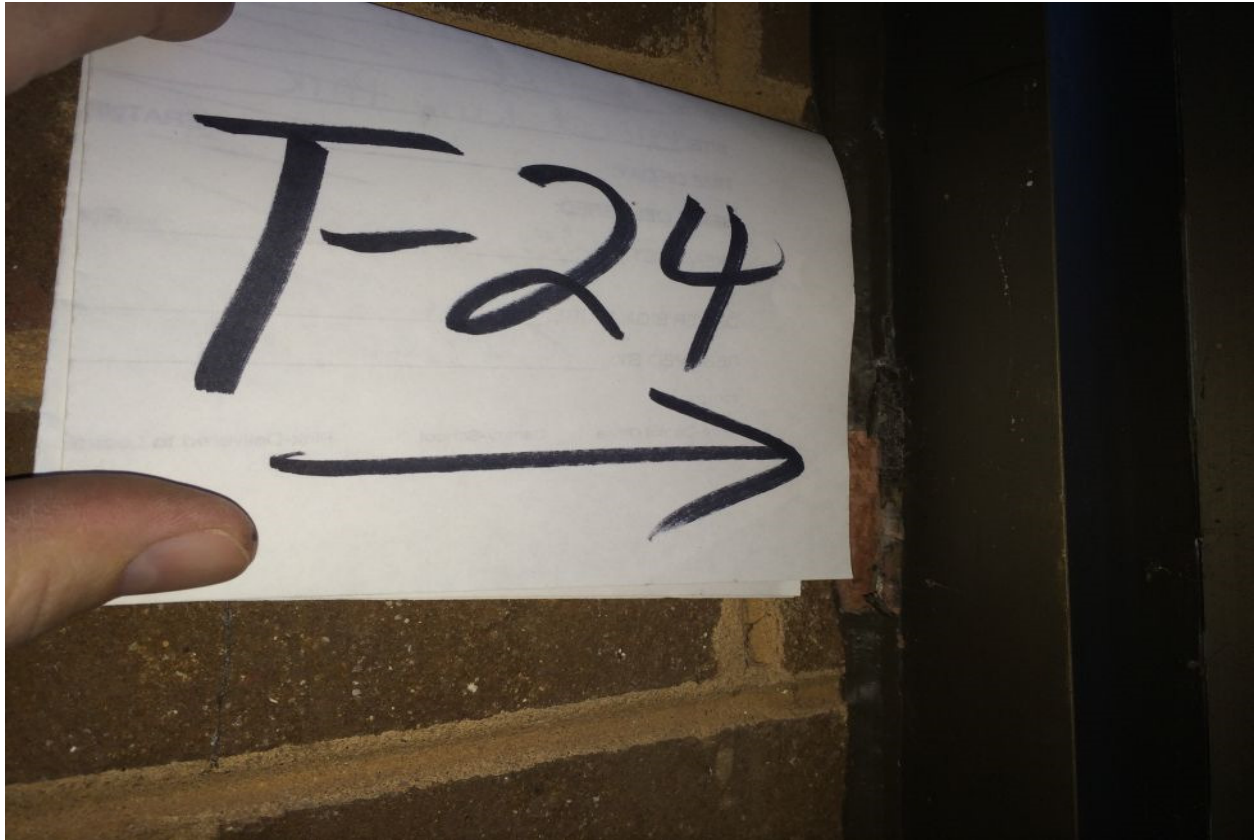
Plate 73: Laboratory analyses did not detect asbestos minerals within the window caulk sample TS-24 collected from the Theatre Building windows.
