MEMORANDUM

Subject: Memorandum - FUNDING AUTHORIZATION FOR 1266 REDFIELD RIDGE STORMWATER REPAIRS

Subject: Memorandum - FUNDING AUTHORIZATION FOR 1811 VERMACK COURT STORMWATER REPAIRS

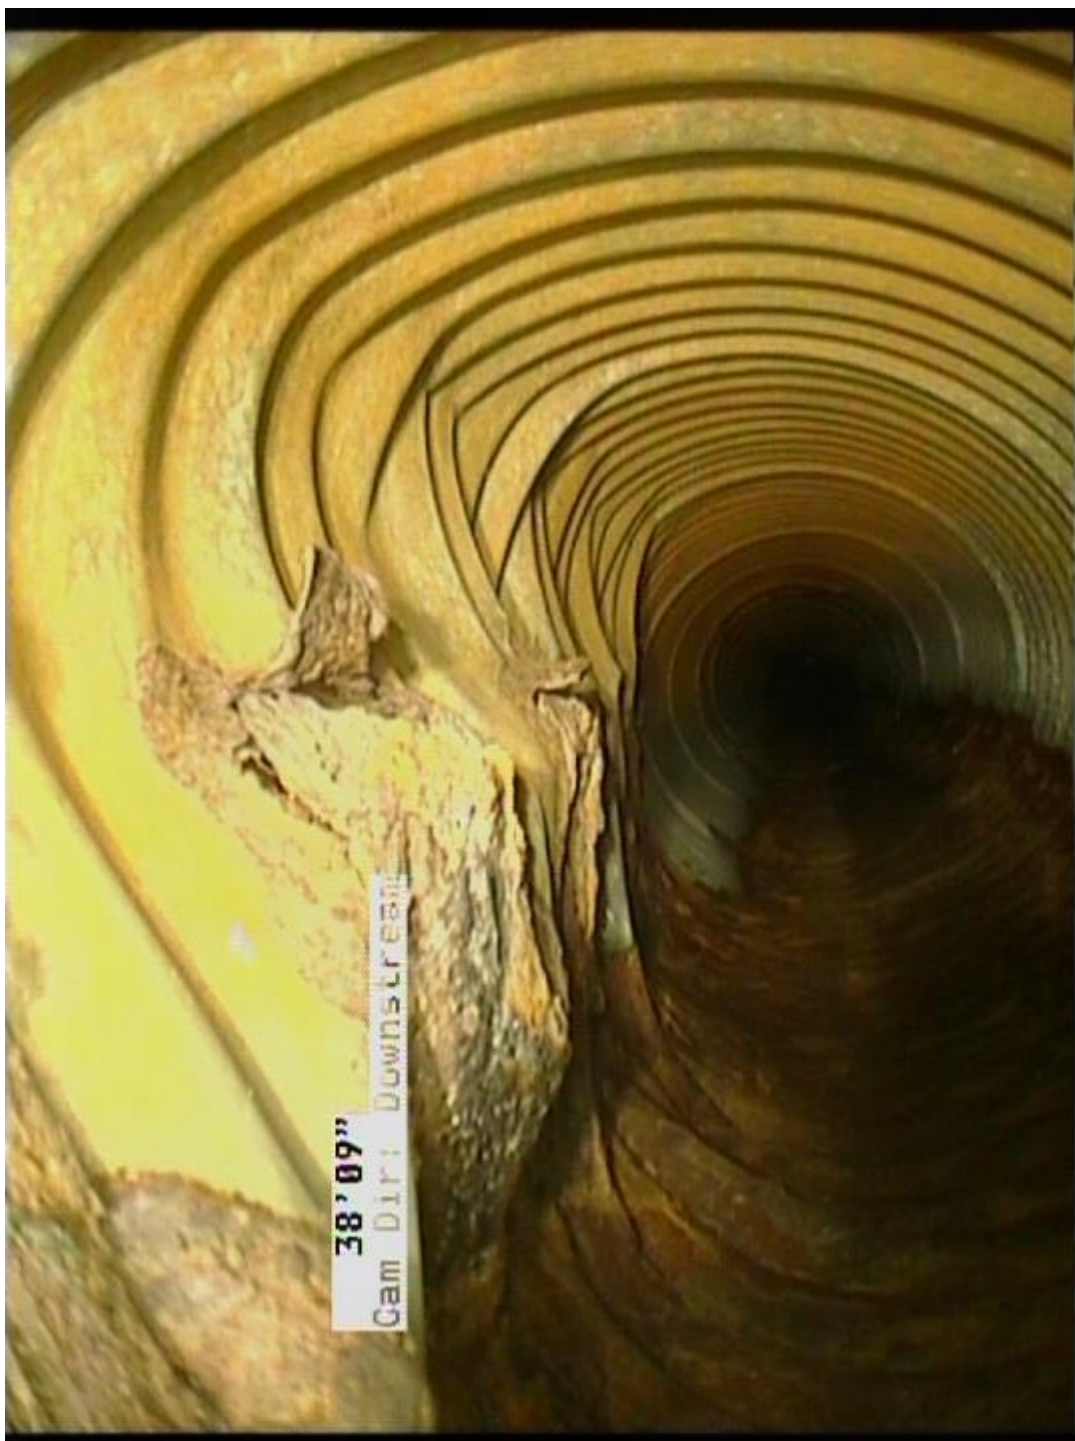
Structural impairments were identified during routine infrastructure inspections on 7/11/2017 using field & CCTV inspections and require:

SEVERE DEFORMITY IN PIPE

- Repair 20-50 feet of deformed pipe
- Traffic Control
- Tree removal
- Lining of 123 linear feet of 18" Corrugated Metal Pipe with cured in place pipe
- Lining of 595 linear feet of 24" Corrugated Metal Pipe with cured in place pipe

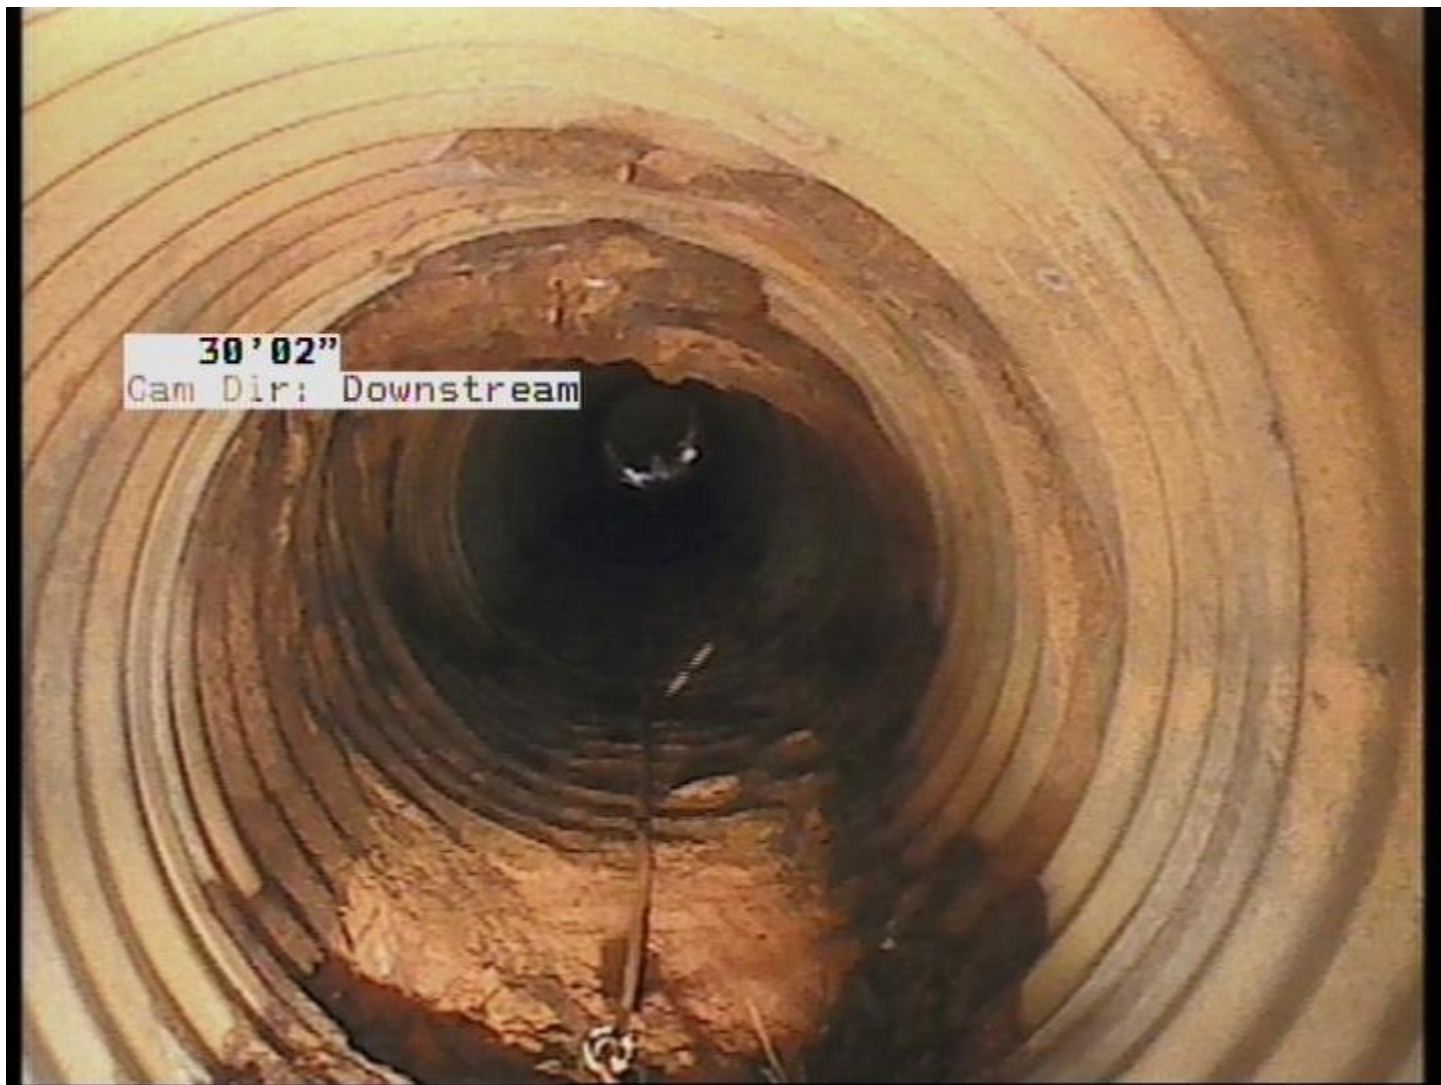
INVERT FAILURE IN PIPE

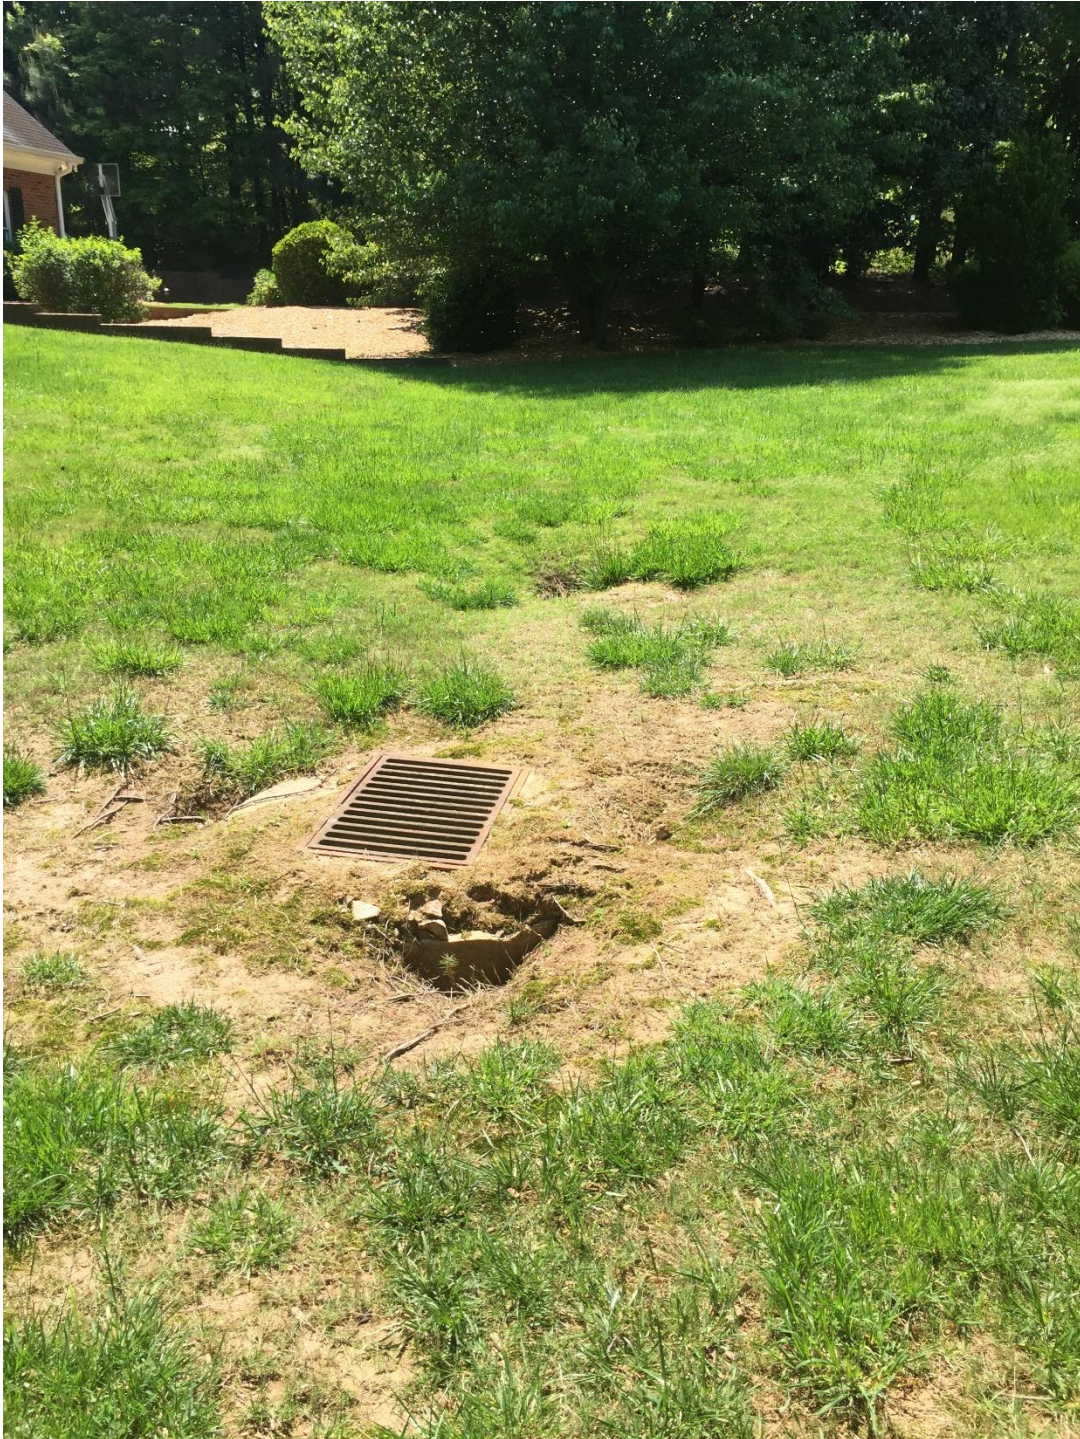
Structural impairments were identified after a citizen called about a sinkhole on April 30, 2018. The last inspection by city staff was on 2/13/2013. Pipes were reported in poor condition but no sinkholes were observed at that time. Repairs were identified using CCTV inspections and require:

MULTIPLE SINKHOLES FORMING AROUND INLET

- Invert repair with flowable fill
- Sinkhole repair
- Repair and grout work on 2 storm manholes
- Lining of 474 linear feet of 30" Corrugated Metal Pipe with cured in place pipe
- Lining of 159 linear feet of 24" Corrugated Metal Pipe with cured in place pipe
- Lining of 49 linear feet of 12" Pipe with cured in place pipe

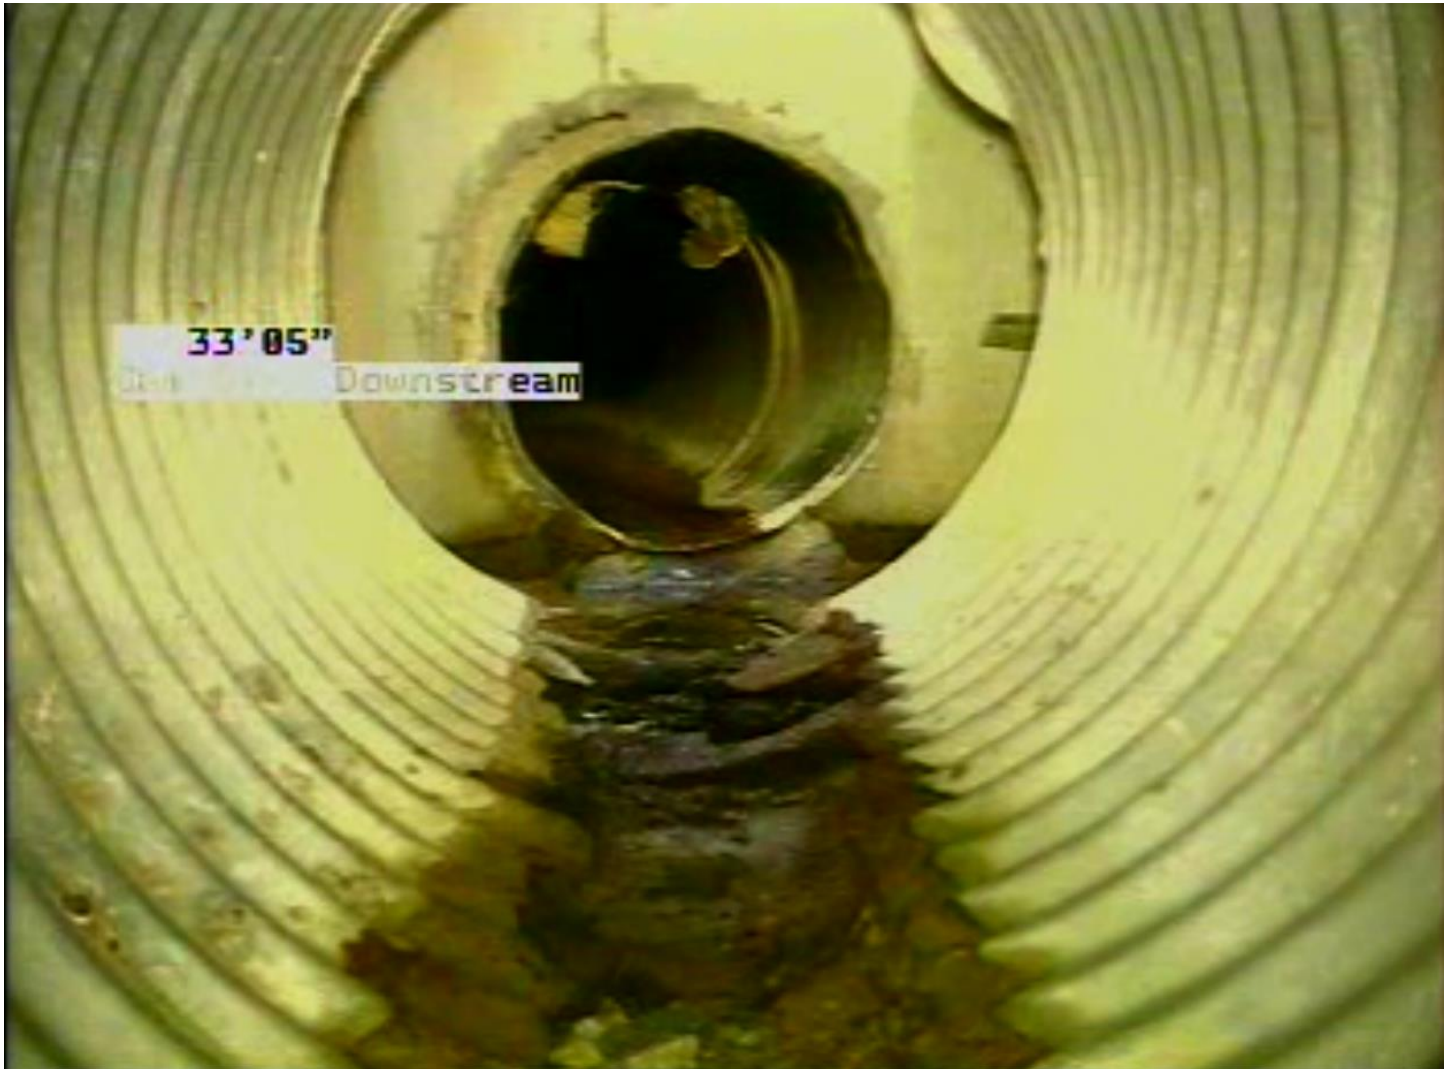
INVERT FAILURE IN PIPE
