## **MEMORANDUM**

**To:** Mayor and City Council  
**From:** Carl Thomas, Stormwater Manager  
**Date:** May 11th, 2020  
**Subject:** **Funding Authorization for 5207 Redfield Court Stormwater Repairs**

Approval of Funding for Stormwater Pipe Repairs at **5207 Redfield Court**. Estimated cost, plus 10% contingency, is **\$107,418.36**.

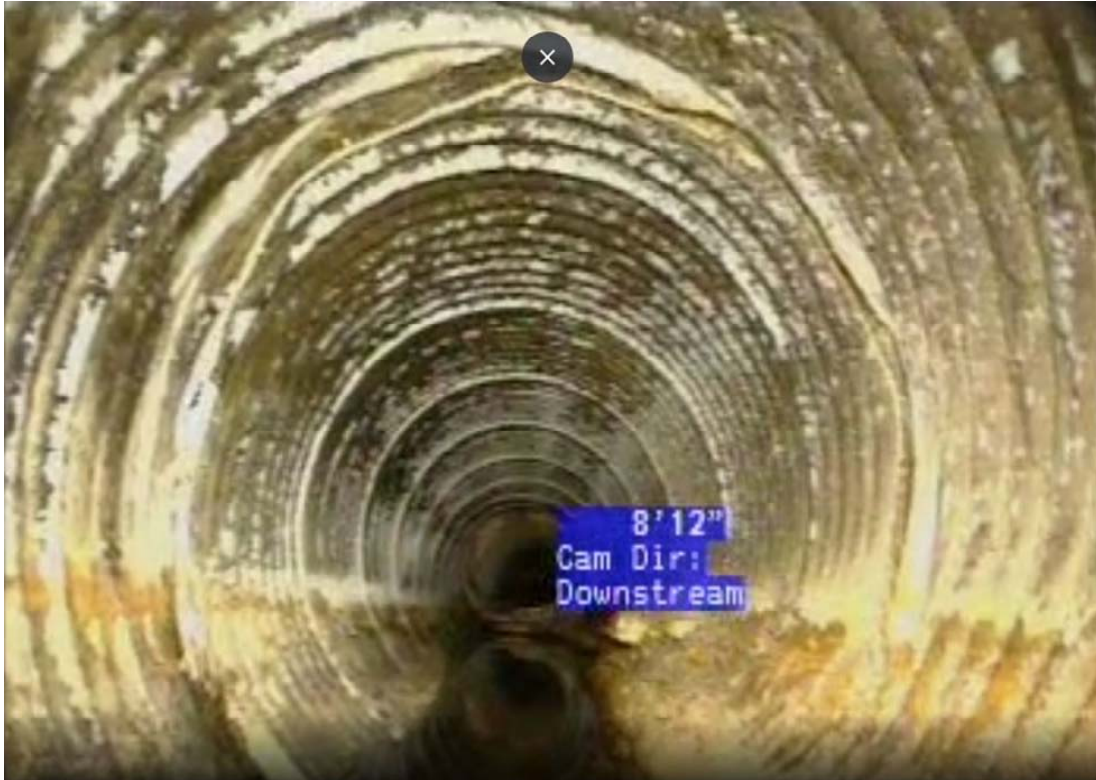
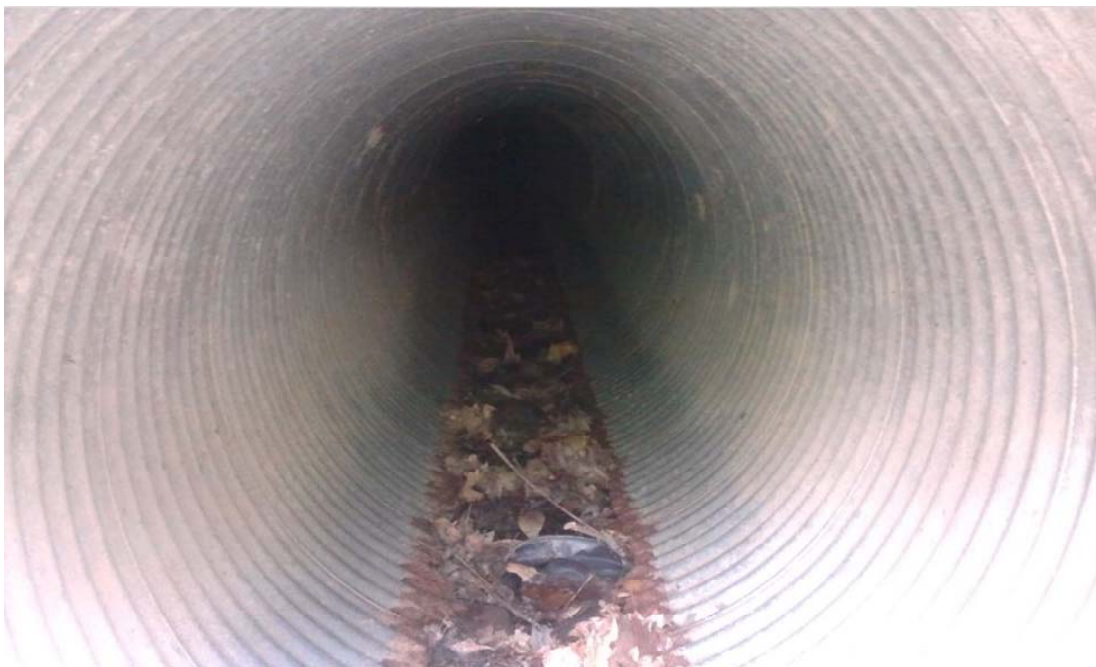
Structural deficiencies to the 42-year old storm system on Redfield Court were discovered performing site inspections in January of 2019. CCTV footage identified corrosion, visible holes in the invert, and deformities. Recommended repairs include:

## CORROSION WITH HOLES IN CORRUGATED METAL PIPE

- Restore 565 linear feet of 18, 24, and 36 inch Corrugated Metal Pipe (CMP) with cured in place pipe
- Dig and Replace 20 LF of deformed CMP
- Locate and Raise two buried junction boxes

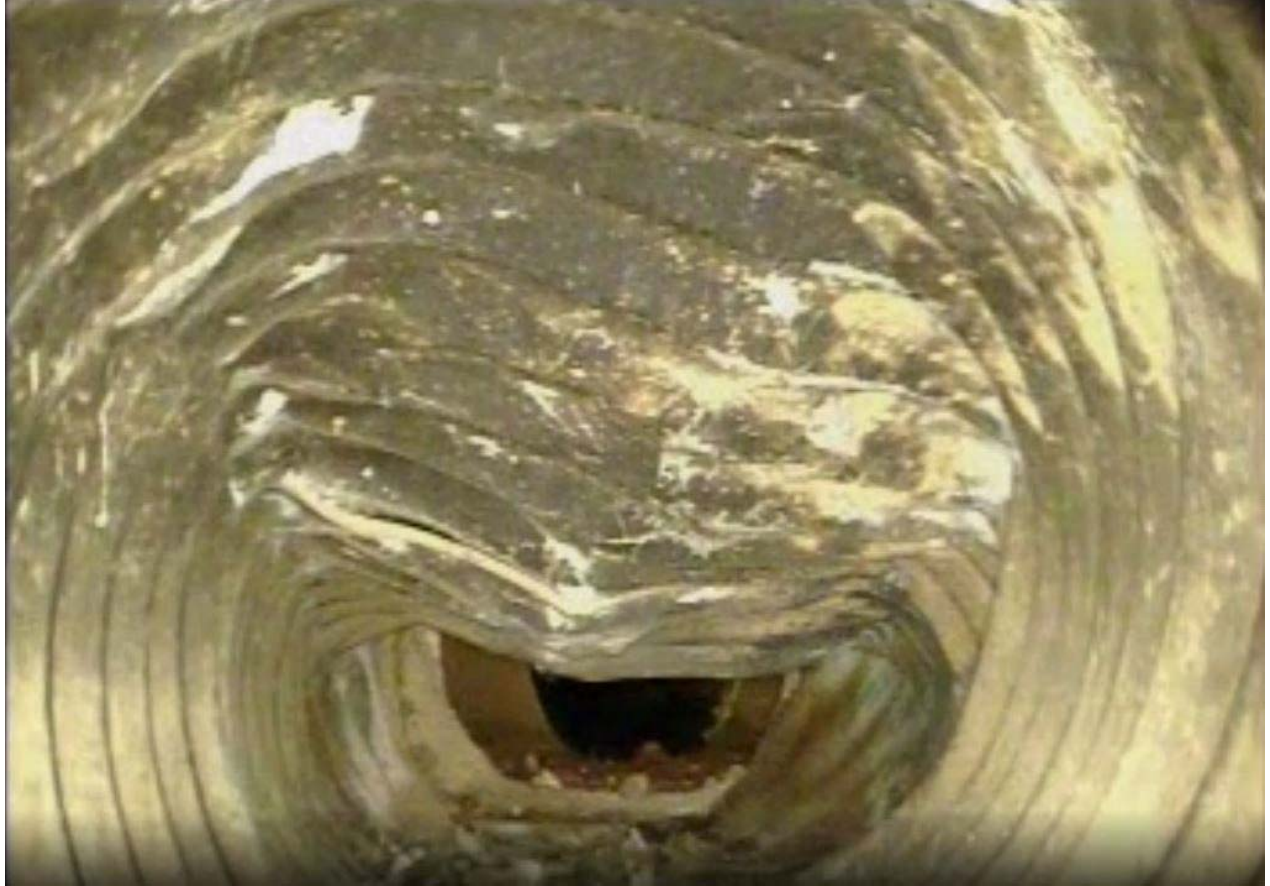
## DEFORMED CORRUGATED METAL PIPE
