MEMORANDUM

To: Mayor and City Council
From: Carl Thomas, Stormwater Manager
Date: April 26th, 2021
Subject: Funding Authorization for 4833 Dunwoody Station Drive Stormwater Repairs

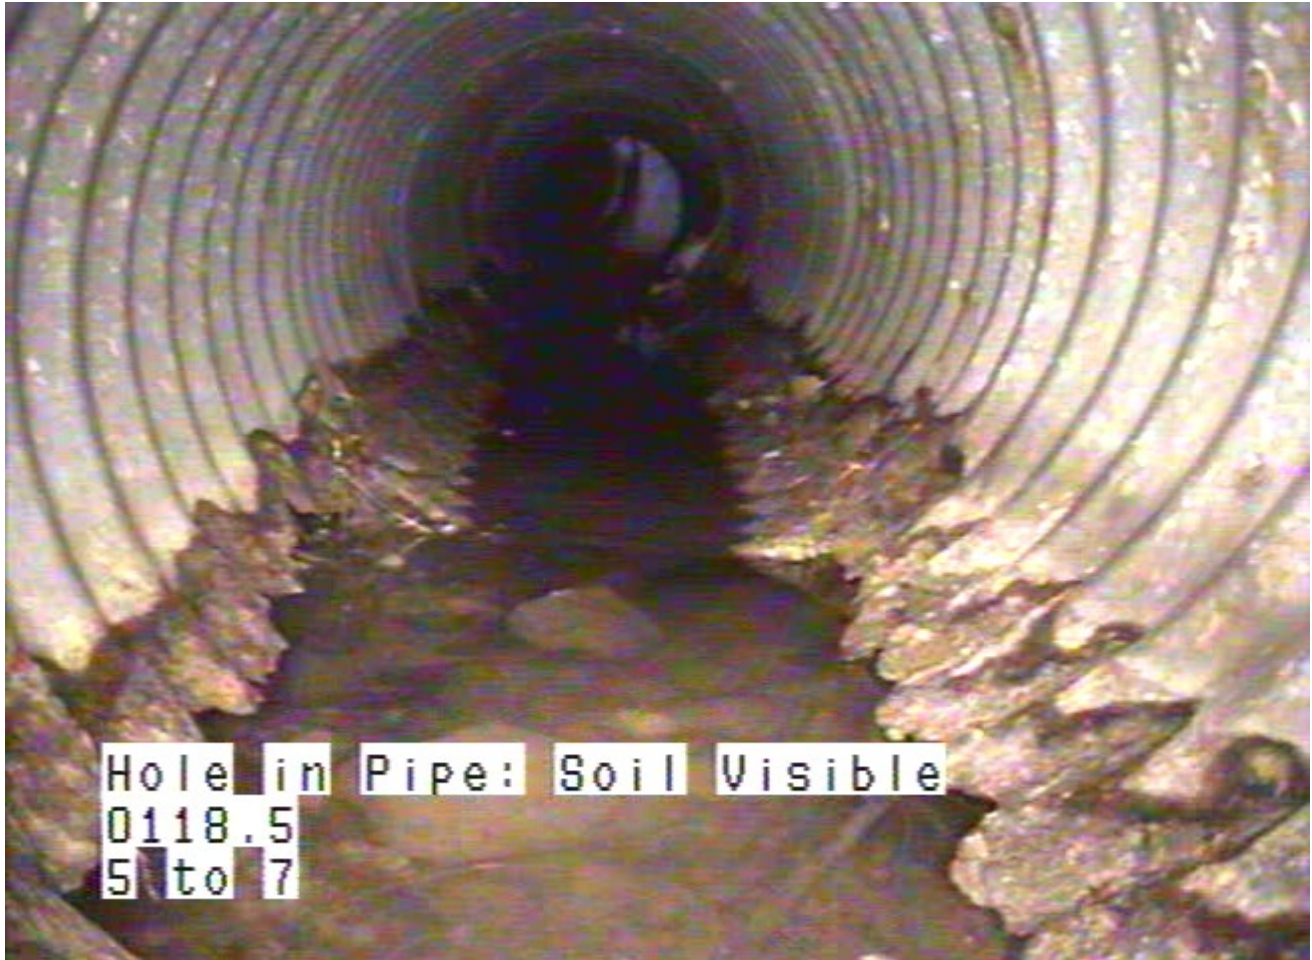
INVERT CORROSION WITH VISIBLE HOLES

- Repair 382 LF of 18" Corrugated Metal Pipe (CMP) with cured in place pipe
- Dig and Replace 10 LF of 18" CMP
- Replace one solid top junction box with ring and cover
- Reset and stabilize headwall

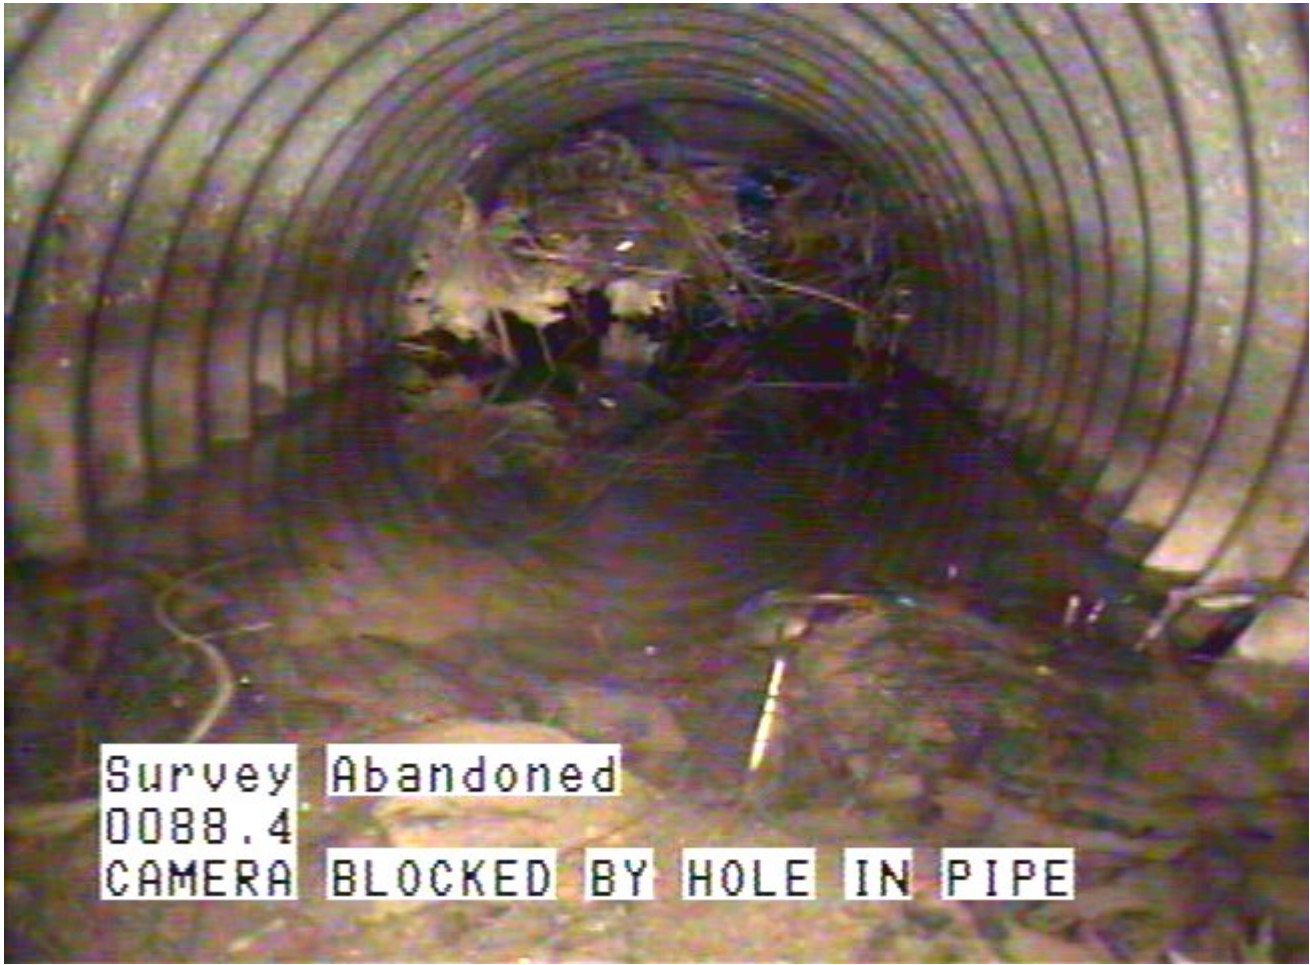
PARTIAL COLLAPSE OF OUTLET PIPE

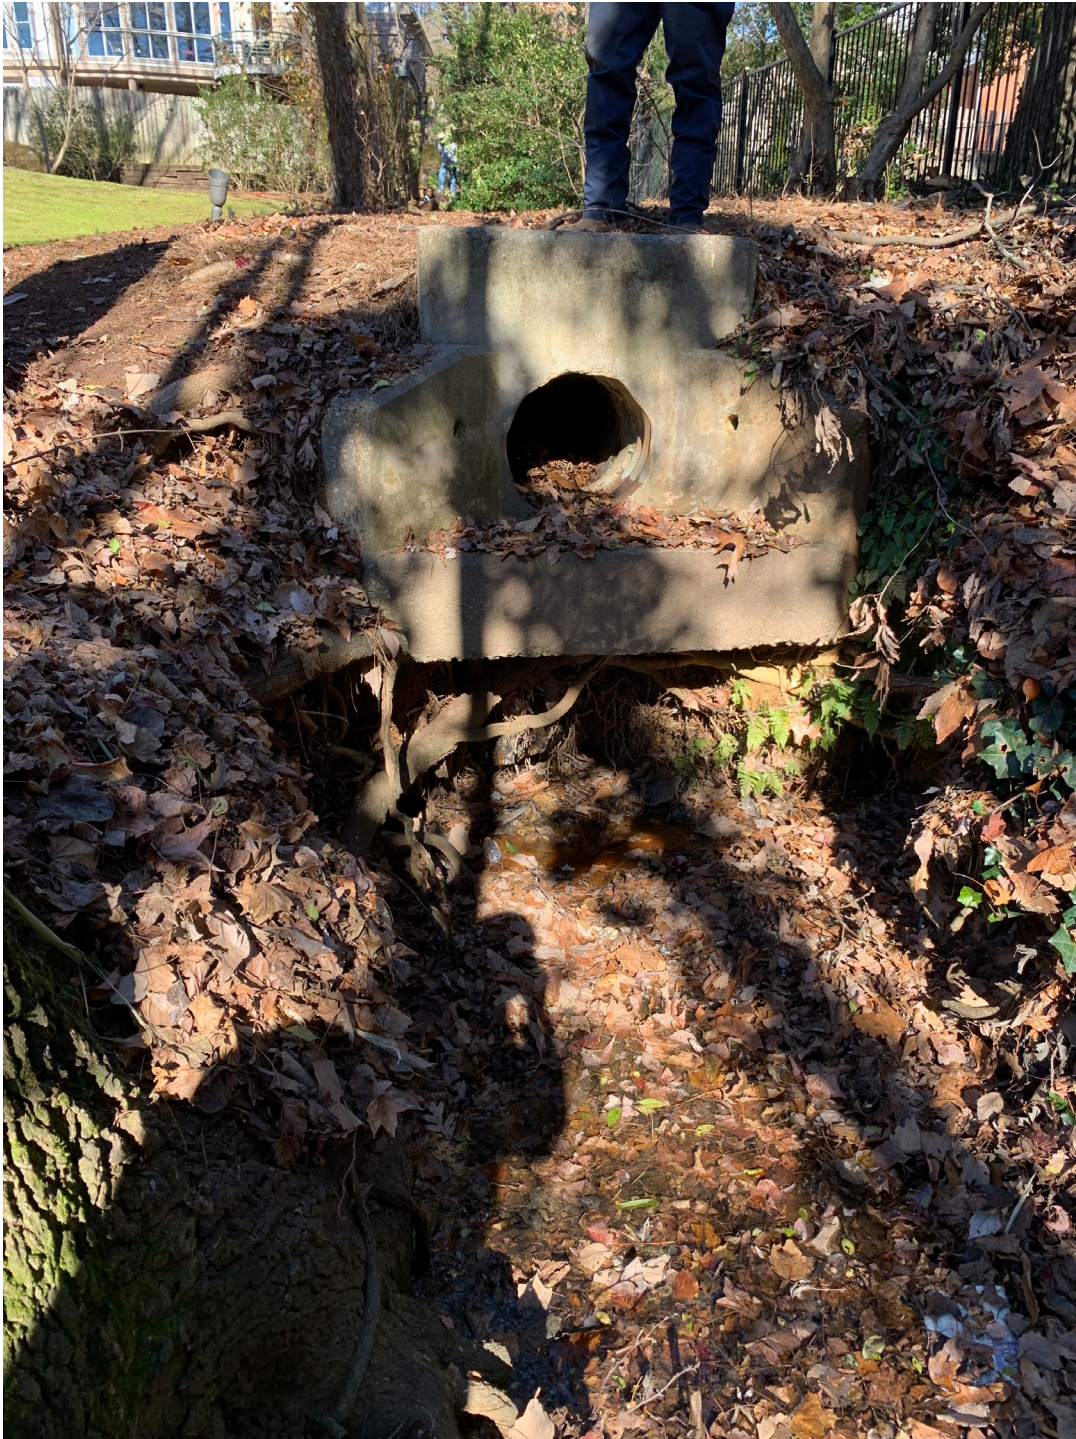
UNSTABLE OUTLET STRUCTURE
