MEMORANDUM

Subject: Funding Authorization for 4833 Dunwoody Station Drive Stormwater Repairs

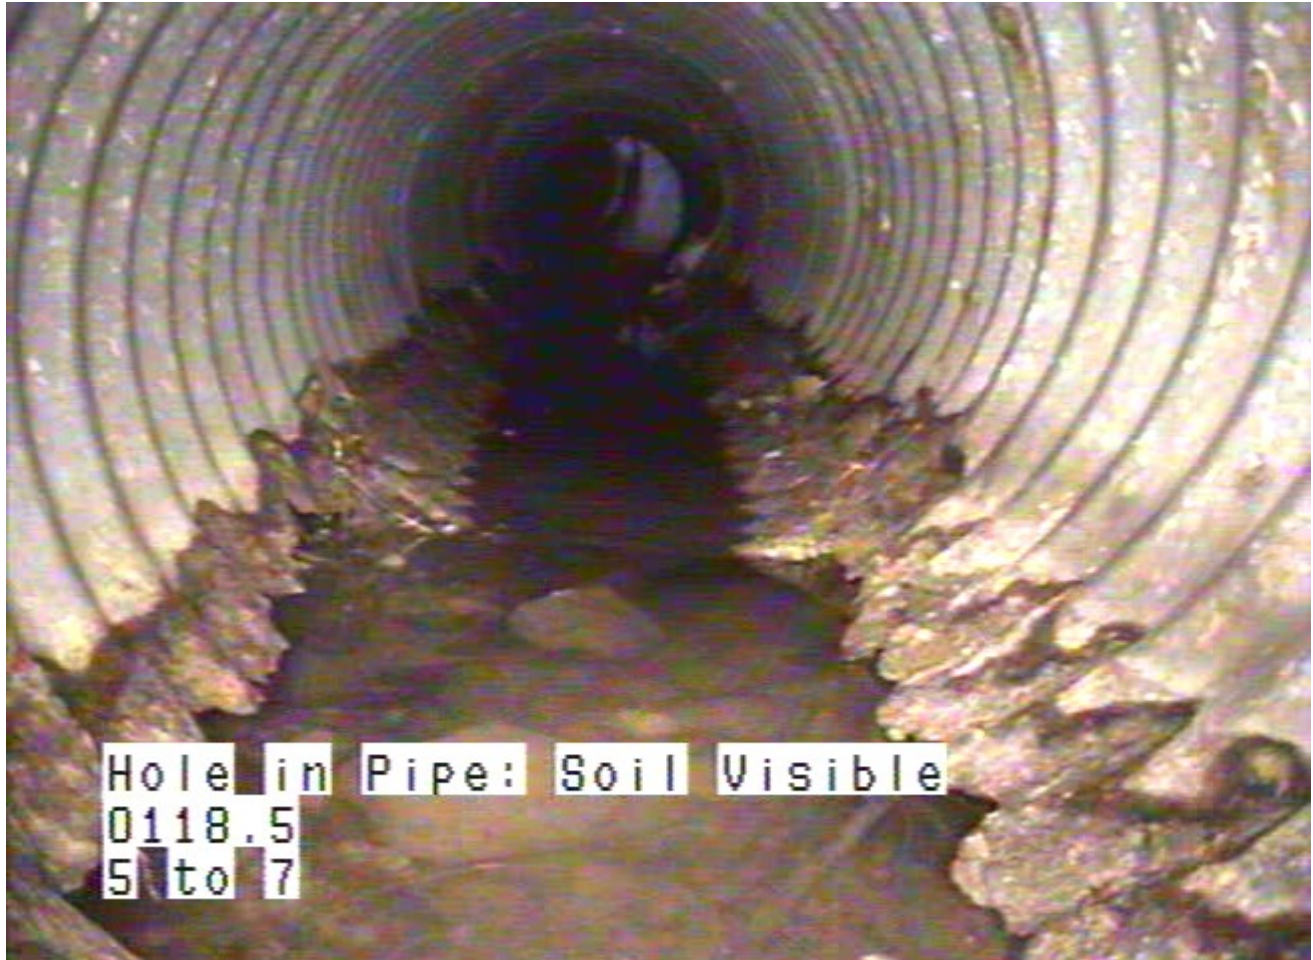
INVERT CORROSION WITH VISIBLE HOLES

- Repair 382 LF of 18" Corrugated Metal Pipe (CMP) with cured in place pipe
- Dig and Replace 10 LF of 18" CMP
- Replace one solid top junction box with ring and cover
- Reset and stabilize headwall

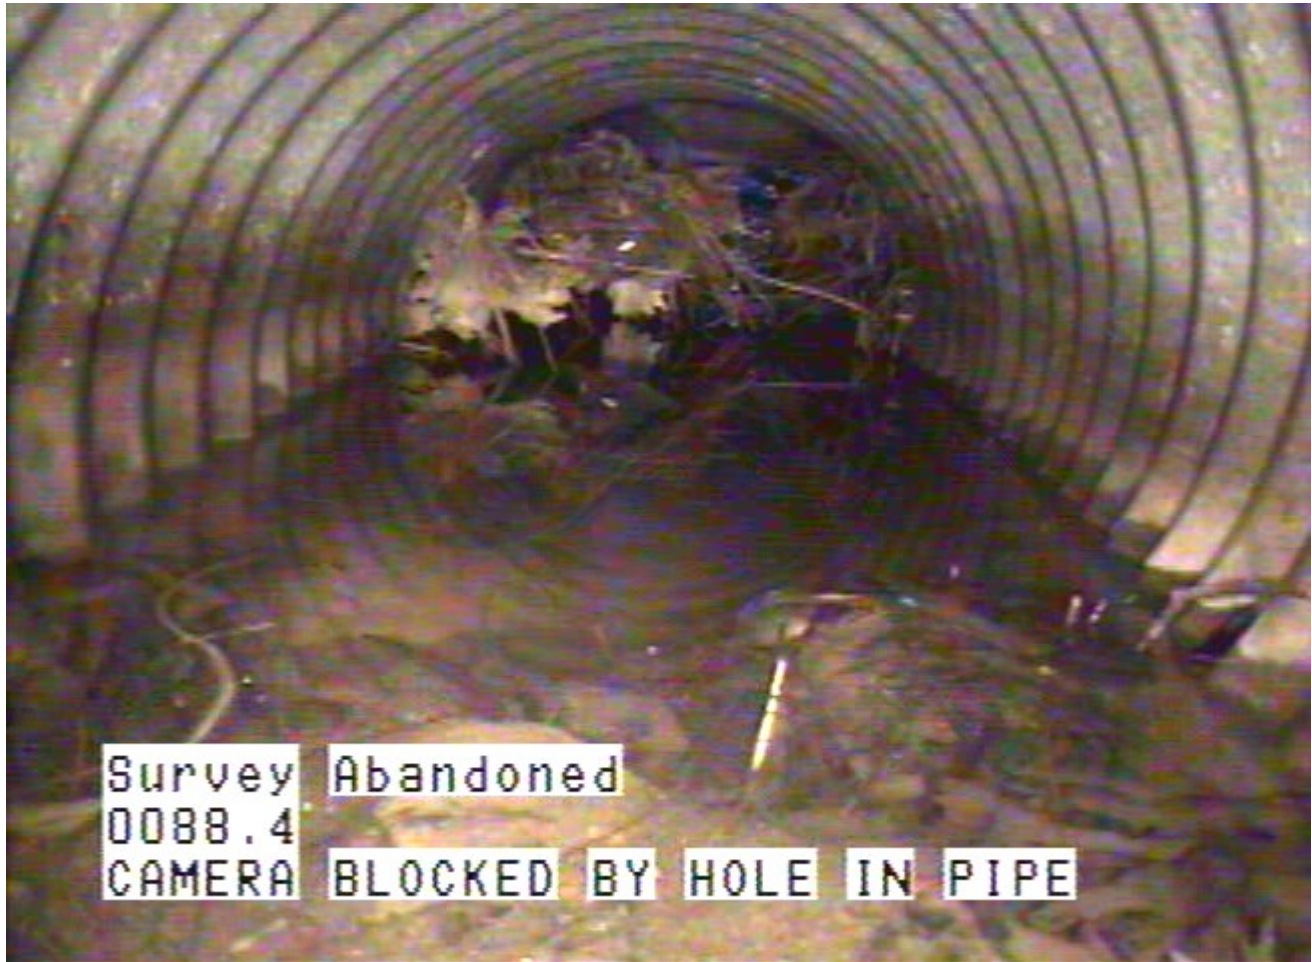
PARTIAL COLLAPSE OF OUTLET PIPE
