- From: Rachel Waldron Parks and Recreation Director
- Re: **Donaldson-Bannister Farm Blacksmith Shop Renovations**

# Donaldson-Bannister Farm Blacksmith Shop Renovation May 27, 2025

Subject: Structural Assessment & Repair Recommendations Donaldson-Bannister Shop Renovation Project No. 25027

Report – Limited Structural Assessment & Repair Recommendations City of Dunwoody Donaldson-Bannister Shop March 14, 2025 Project No. 25027

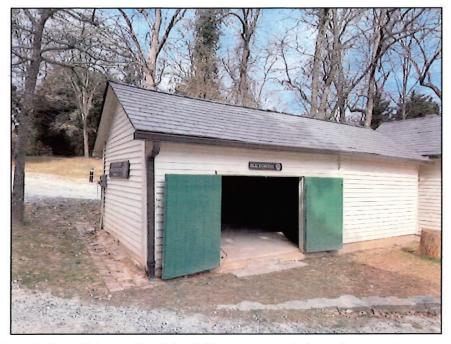
Figure 1 – Overall view of blacksmiths "Shop". Ensure proper drainage is present.

- 6. Drainage:
  - 6.1. We recommend ensuring that no sitting or ponding water be allowed to rest at the base of the wall. All water runoff should be directed away from the building to prevent deterioration of the wood components at the base of the structure.

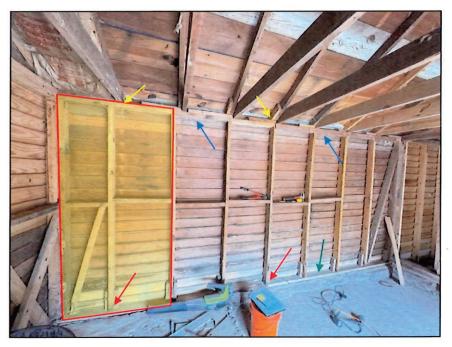
**Figure 2** – Typical view of west face (rear face) of the "Shop". Wood rot at the base of studs shall be replaced or repaired (red arrow); installation of new "blocking" second top plate (blue arrow); repair of damaged roof rafters at top plate (yellow arrow). The highlighted section shows shear wall sheathing; add bottom plate anchors to foundation (green arrow). The arrows show the general location, not each location that requires repair.

- 1.2. We recommend installing a "Sister" rafter to the side of all rafters that exhibit deterioration (likely due to water intrusion and crushing) at the end supports. The length of the new rafter shall match the existing and shall be fastened to the rafter with 16d nails at 8" OC, with (4) nails at each end. The new rafter shall bear directly on the top wall plate and be fastened with H1A ties.

- 2. Wall Framing:
  - 2.1. Approximately (8) wall studs show signs of deterioration in the form of wood rot or cracking. These studs can either be removed and replaced in like kind (2x4 SYP No. 2 min.), or a "sister" stud can be installed flush with one side of the existing stud.

- 2.2. Several locations show signs of wood rot/deterioration of the bottom wall plate. This 2x4 bottom plate should be removed and replaced (this will likely be done in conjunction with stud repairs).

- 2.3. There is only one 2x4 top wall plate for all walls. Contractor shall install new top plate, which can be a full length 2x4 section (this will require shoring the existing rafters, cutting the top of the wall studs to accommodate the new top plate), OR; the contractor can install a new 2x4 flush to the underside of the existing top plate and connect with (4) evenly spaced 2½" lag screws (from bottom of new 2x4 into existing top plate) and toe nailed to existing studs (section will likely need to be 22½" wide to fit between studs, contactor field verify all cuts).

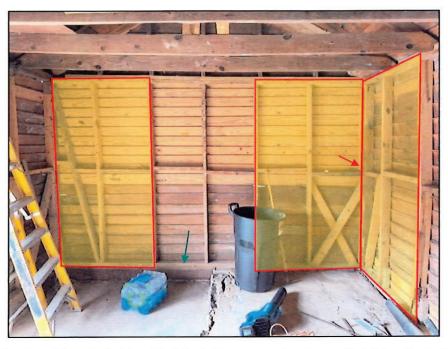
*Figure 3* – South wall face (left side of building). Remove and replace with full length stud (red arrow), install wall sheathing (highlighted section); green arrow shows location of anchorage for bottom plate.

- 2.4. Installation of shear wall sheathing, 4'-0" long, each corner of the building, each direction (meaning on the 8'-0" total length at each short wall length, and 8'-0" total for each long wall length, a total of 32'-0" of sheathing):

- 2.6. Installation of a new 2x4 stud at locations where the top plate is not supported (see figure 3 or 4).
- 2.7. Remove and replace 2x4 studs that are not continuous from bottom to top plates (see figure 3).

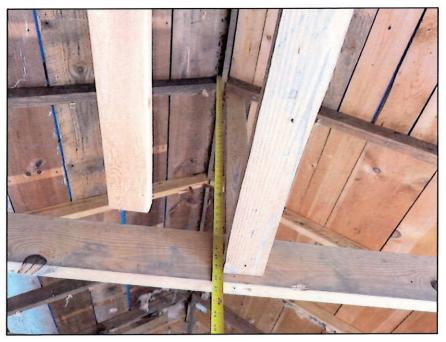
Figure 4 – Typical view of roof framing.

- 1. Roof Framing:
  - 1.1. We recommend installing hurricane ties, Simpson Strong-tie H1A (or equal), at the ends of all rafters connected to the end walls.

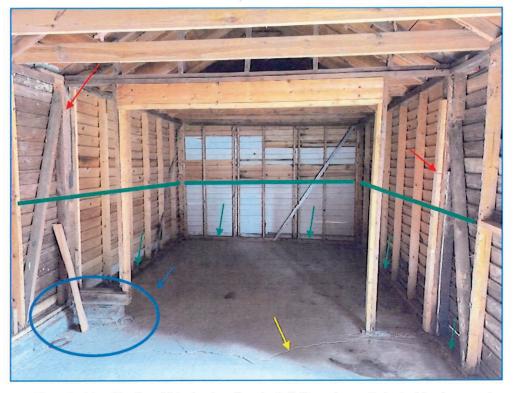
*Figure 5* – View, looking North, of interior framing. Installation of new 2x4 stud (red arrows); repair of concrete "curb" foundation (blue arrow); and repair of cracks in slab-on-ground (yellow arrow); green lines show location of new 2x4 blocking; anchorage for bottom plate (green arrow).

- 4. Foundation:
  - 4.1. There are two 2'-0" long walls, centered along the long dimension of the building. The walls are supported on a concrete "curb" foundation which needs to be repaired using a high strength cementitious mortar, such as Quikrete 5,000 or Rapid Set Concrete Mix. Repair to original dimensions.

- 5. Slab on Ground
  - 5.1. There are multiple cracks and elevation changes in the existing slab on ground. Where elevation change occurs (I.E. one side of the crack is higher than the other), the surface(s) shall be ground flush using a diamond plate wheel. The crack can be repaired by flushing the crack, saw cutting with a v-grove diamond blade, and injected the crack with a joint filler material.

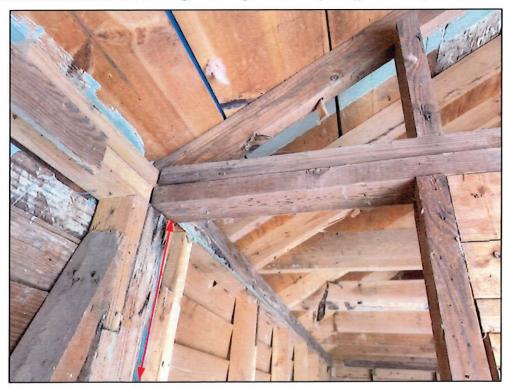
Figure 6 – Close up of needed stud from Figure 5 (red arrow).
