Re: Donaldson-Bannister Farm Blacksmith Shop Renovations

Subject: Structural Assessment & Repair Recommendations
Donaldson-Bannister Shop Renovation
Project No. 25027

Issued By: Joshua R. Lloyd, PE
GA Registration No. PE045503
March 14, 2025

Report – Limited Structural Assessment & Repair Recommendations
City of Dunwoody
Donaldson-Bannister Shop

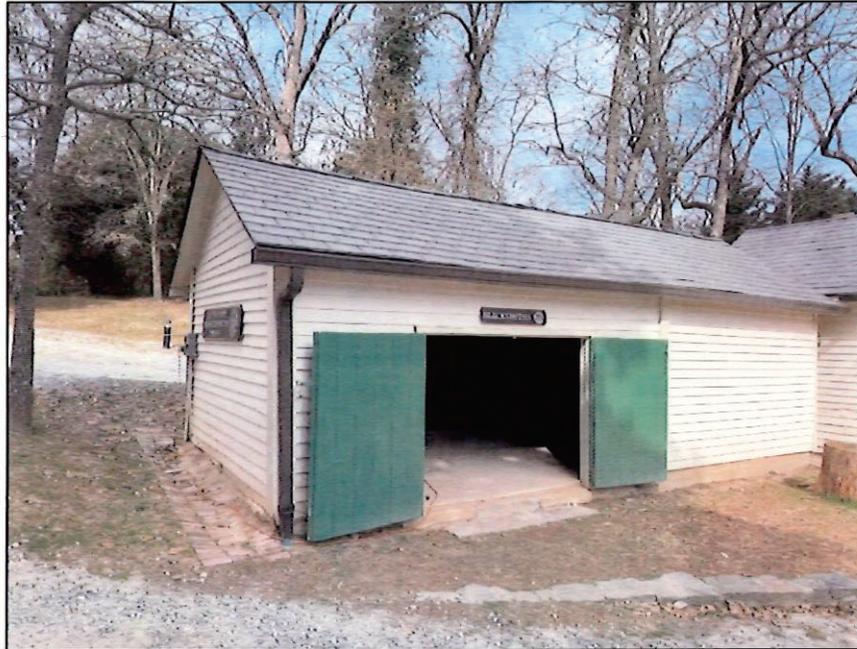
Figure 1 – Overall view of blacksmiths “Shop”. Ensure proper drainage is present.

6. Drainage:
- 6.1. We recommend ensuring that no sitting or ponding water be allowed to rest at the base of the wall. All water runoff should be directed away from the building to prevent deterioration of the wood components at the base of the structure.

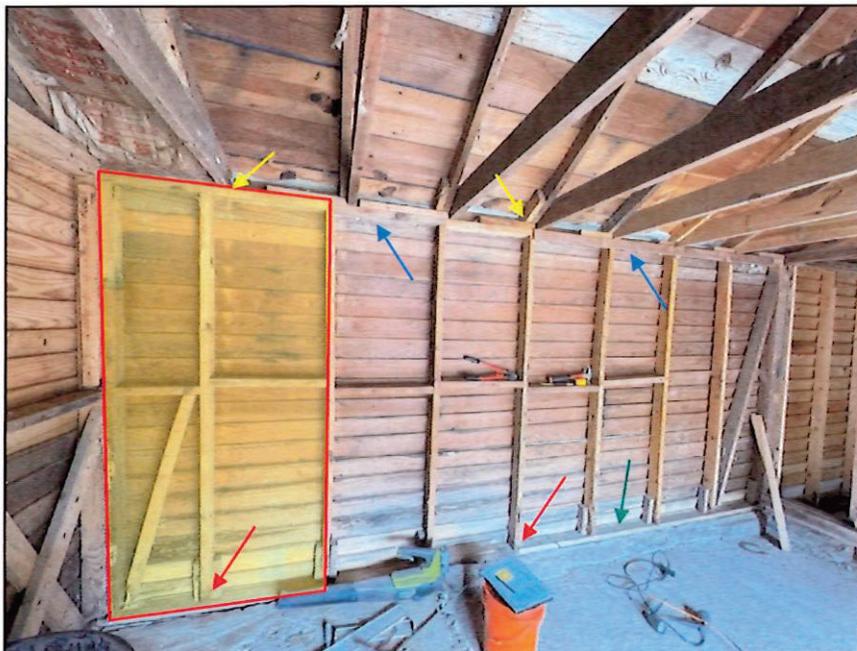
- 2.1. Approximately (8) wall studs show signs of deterioration in the form of wood rot or cracking. These studs can either be removed and replaced in like kind (2x4 SYP No. 2 min.), or a "sister" stud can be installed flush with one side of the existing stud.

- 2.2. Several locations show signs of wood rot/deterioration of the bottom wall plate. This 2x4 bottom plate should be removed and replaced (this will likely be done in conjunction with stud repairs).

Figure 2 – Typical view of west face (rear face) of the “Shop”. Wood rot at the base of studs shall be replaced or repaired (red arrow); installation of new “blocking” second top plate (blue arrow); repair of damaged roof rafters at top plate (yellow arrow). The highlighted section shows shear wall sheathing; add bottom plate anchors to foundation (green arrow). The arrows show the general location, not each location that requires repair.

- 1.1. We recommend installing hurricane ties, Simpson Strong-tie H1A (or equal), at the ends of all rafters connected to the end walls.
- 1.2. We recommend installing a "Sister" rafter to the side of all rafters that exhibit deterioration (likely due to water intrusion and crushing) at the end supports. The length of the new rafter shall match the existing and shall be fastened to the rafter with 16d nails at 8" OC, with (4) nails at each end. The new rafter shall bear directly on the top wall plate and be fastened with H1A ties.

- 2.3. There is only one 2x4 top wall plate for all walls. Contractor shall install new top plate, which can be a full length 2x4 section (this will require shoring the existing rafters, cutting the top of the wall studs to accommodate the new top plate), OR; the contractor can install a new 2x4 flush to the underside of the existing top plate and connect with (4) evenly spaced 2½" lag screws (from bottom of new 2x4 into existing top plate) and toe nailed to existing studs (section will likely need to be 22½" wide to fit between studs, contractor field verify all cuts).

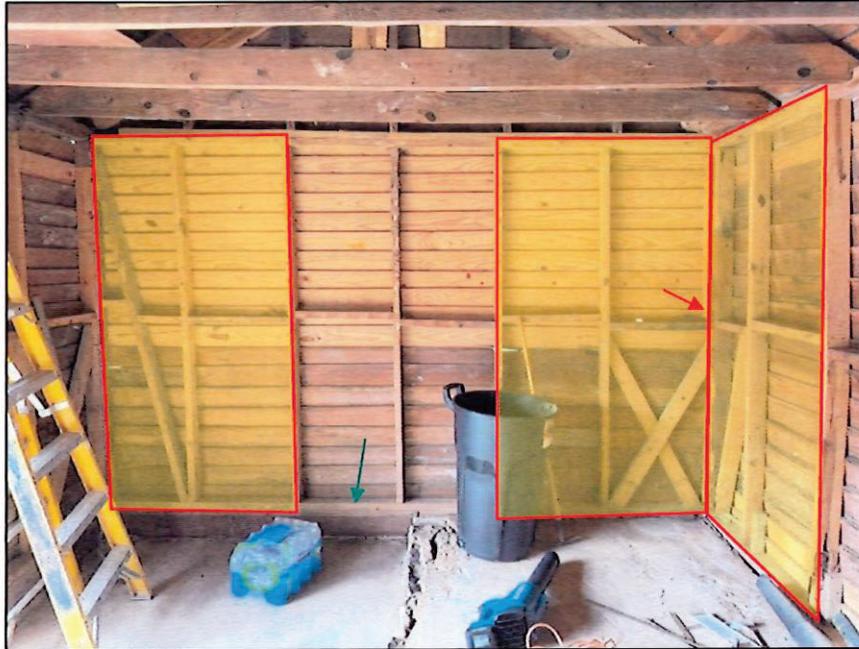
Figure 3 – South wall face (left side of building). Remove and replace with full length stud (red arrow), install wall sheathing (highlighted section); green arrow shows location of anchorage for bottom plate.

- 2.4. Installation of shear wall sheathing, 4'-0" long, each corner of the building, each direction (meaning on the 8'-0" total length at each short wall length, and 8'-0" total for each long wall length, a total of 32'-0" of sheathing):

- 2.6. Installation of a new 2x4 stud at locations where the top plate is not supported (see figure 3 or 4).
 - 2.7. Remove and replace 2x4 studs that are not continuous from bottom to top plates (see figure 3).

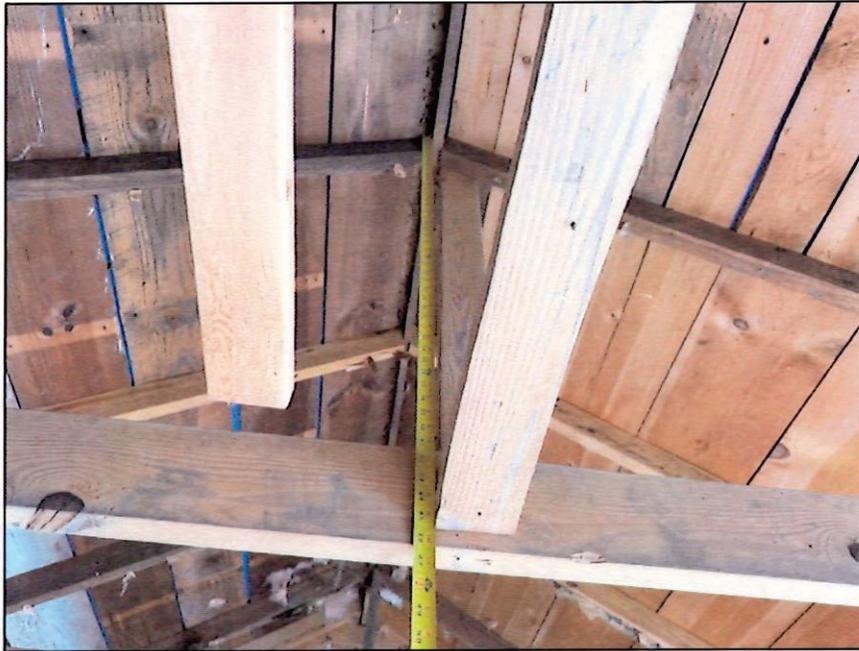
Figure 4 – Typical view of roof framing.

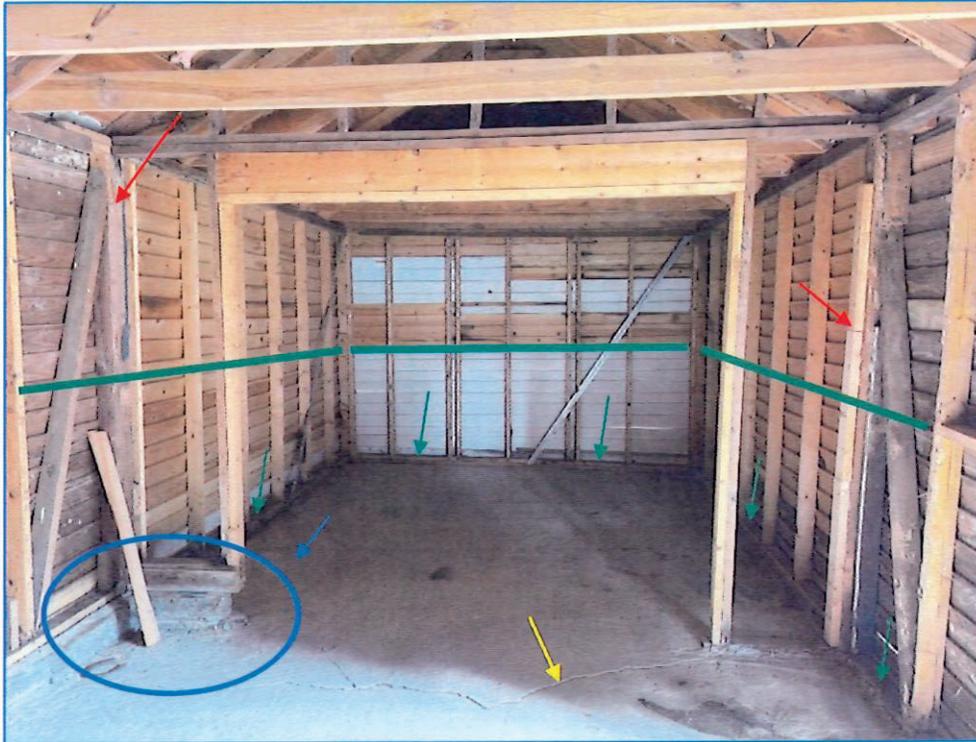
- 5.1. There are multiple cracks and elevation changes in the existing slab on ground. Where elevation change occurs (I.E. one side of the crack is higher than the other), the surface(s) shall be ground flush using a diamond plate wheel. The crack can be repaired by flushing the crack, saw cutting with a v-groove diamond blade, and injected the crack with a joint filler material.

Figure 5 – View, looking North, of interior framing. Installation of new 2x4 stud (red arrows); repair of concrete “curb” foundation (blue arrow); and repair of cracks in slab-on-ground (yellow arrow); green lines show location of new 2x4 blocking; anchorage for bottom plate (green arrow).

4. Foundation:
- 4.1. There are two 2'-0" long walls, centered along the long dimension of the building. The walls are supported on a concrete "curb" foundation which needs to be repaired using a high strength cementitious mortar, such as Quikrete 5,000 or Rapid Set Concrete Mix. Repair to original dimensions.

- 4.2. The perimeter foundation shall be repaired to provide uniform bearing for the bottom wall plate using a cementitious repair mortar (see note 4.1. for material reference).

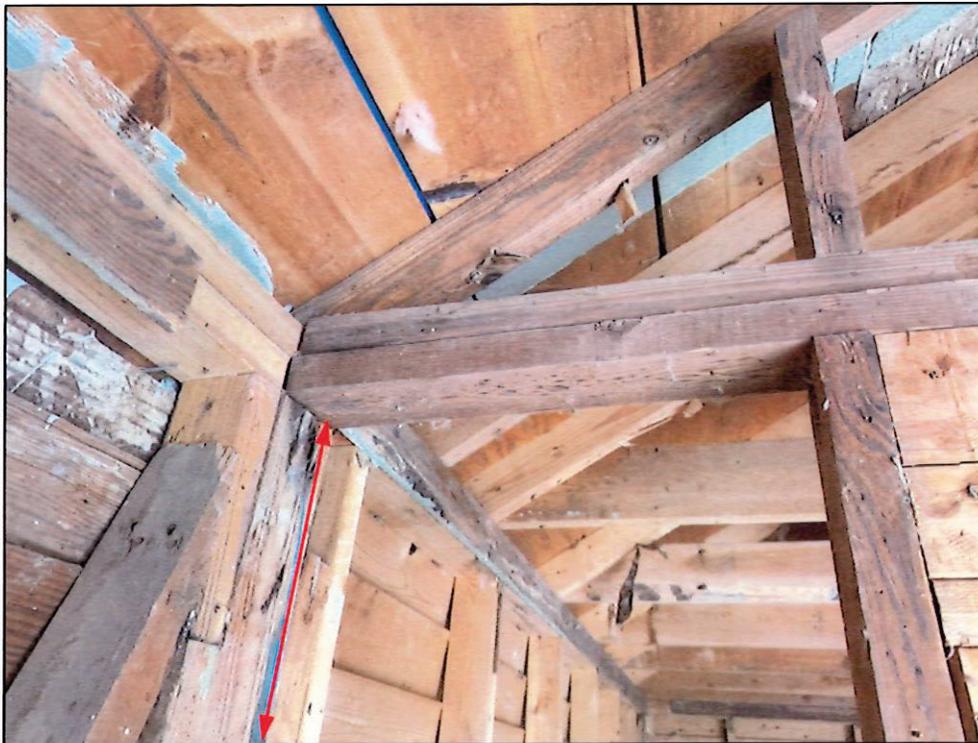
Figure 6 – Close up of needed stud from Figure 5 (red arrow).
