To: Mayor and City Council
From: Carl Thomas, Stormwater Utility Manager
Re: Funding Authorization for 5617 Woodsong Trail Storm Repairs
Date: November 28th, 2022

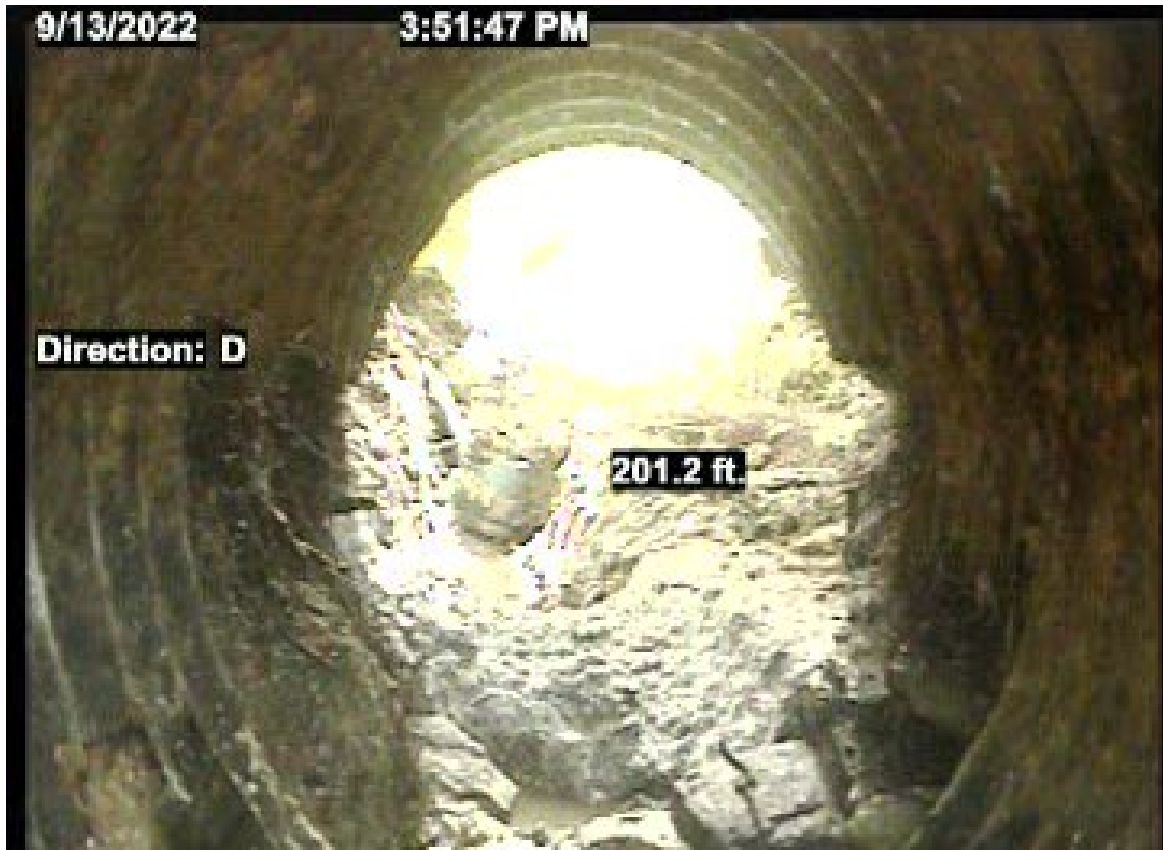
Structural deficiencies to the storm system on Woodsong Trail were identified responding to a sinkhole reported by the property owner. The pipe system is composed of +/- 240 linear feet of 18 and 21-inch corrugated metal pipe (CMP) that is approximately 31 years old and in poor condition. Closed-Caption Television (CCTV) footage discovered root infiltration, corrosion, and visible holes in the pipe system. Recommended repairs include:

Severe Corrosion with Large Voids

- Point repairs to 10 LF of 21-inch severely corroded CMP
- Repair 240 LF of CMP with Cured In Place Pipe (CIPP) liner
- 2 cubic yards (CY) flowable fill

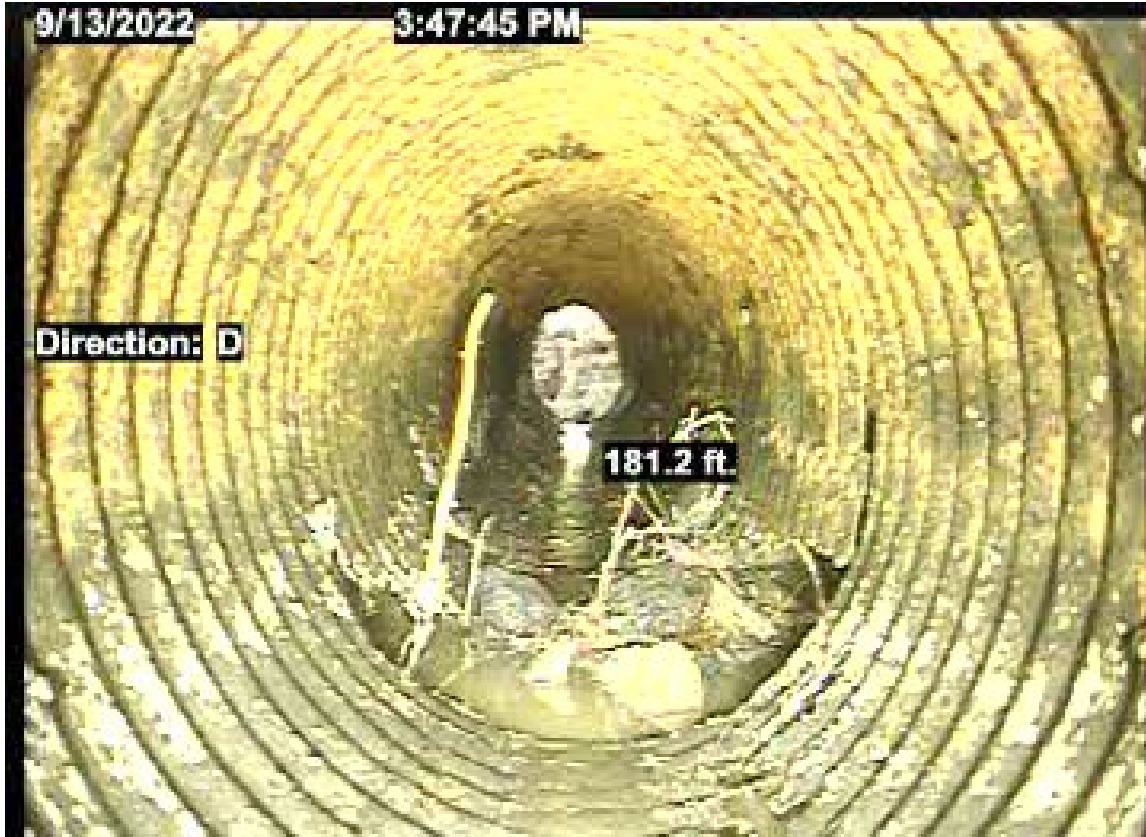
Root Intrusion, Severe Corrosion with Large Voids #2
