**To:** Mayor and City Council  
**From:** Carl Thomas, Stormwater Utility Manager  
**Re:** Funding Authorization for 4706 Equestrian Way Storm Repairs  
**Date:** September 26<sup>th</sup>, 2023

**To:** Mayor and City Council  
**From:** Carl Thomas, Stormwater Utility Manager  
**Re:** Funding Authorization for 4964 Buckline Crossing Storm Repairs  
**Date:** September 26<sup>th</sup>, 2023

**To:** Mayor and City Council  
**From:** Carl Thomas, Stormwater Utility Manager  
**Re:** Funding Authorization for 5233 Fontainebleau Ct Storm Repairs  
**Date:** September 26<sup>th</sup>, 2023

**To:** Mayor and City Council  
**From:** Carl Thomas, Stormwater Utility Manager  
**Re:** Funding Authorization for 5548 Glenrich Drive Storm Repairs  
**Date:** September 26<sup>th</sup>, 2023

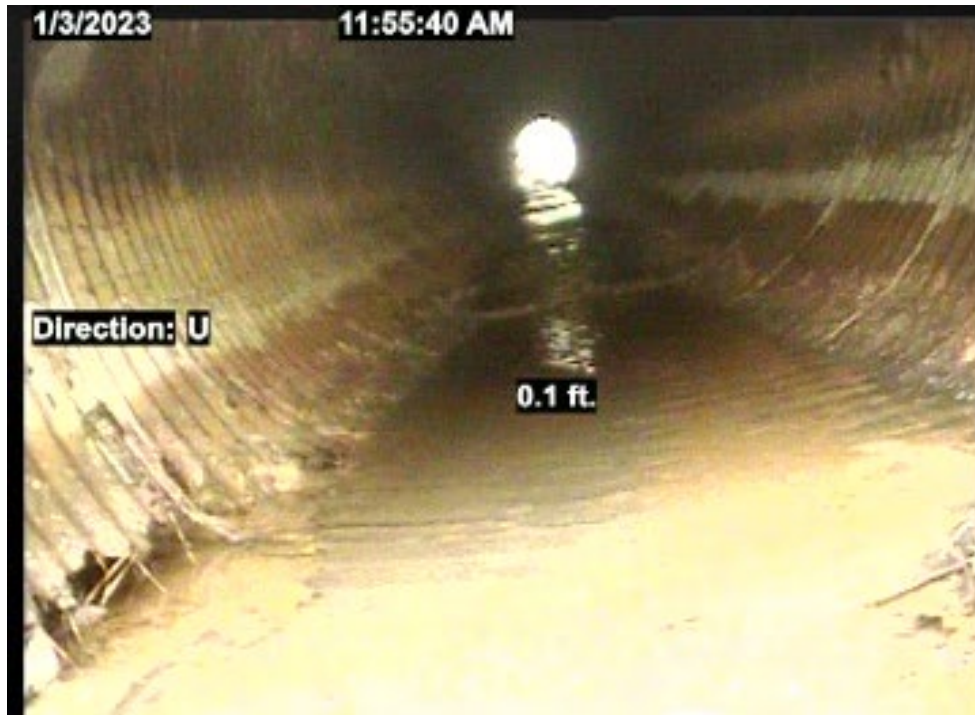
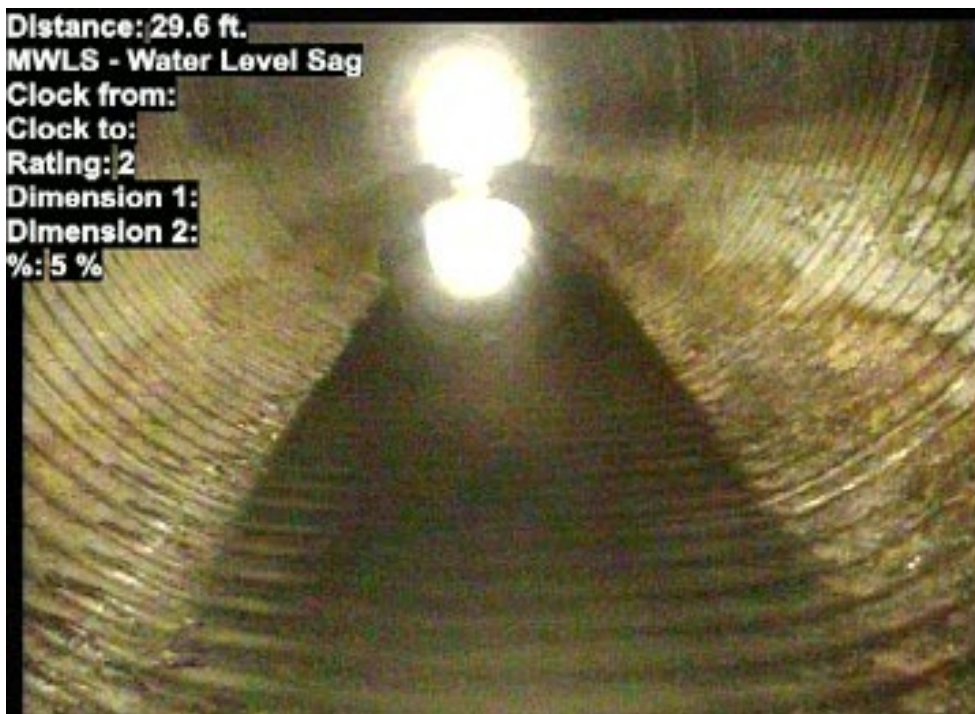
Structural deficiencies to the storm system on Equestrian Way were identified by staff performing routine inspections. The pipe system is composed of +/- 200 linear feet (LF) of 18 and 48-inch corrugated metal pipe (CMP) that is approximately 40 years old and in poor condition. Closed-Caption Television (CCTV) footage discovered corrosion, visible holes, and water sag. Recommended repairs include:

## Severe Corrosion with visible holes Water Sagging

- Repair +/- 40 LF of 18-inch CMP with Cured-In-Place Pipe (CIPP) liner
- Repair +/- 160 LF of 48-inch CMP with Spray-On Spincast Liner
- 60 hours bypass pumping
- 10 days Minor traffic control

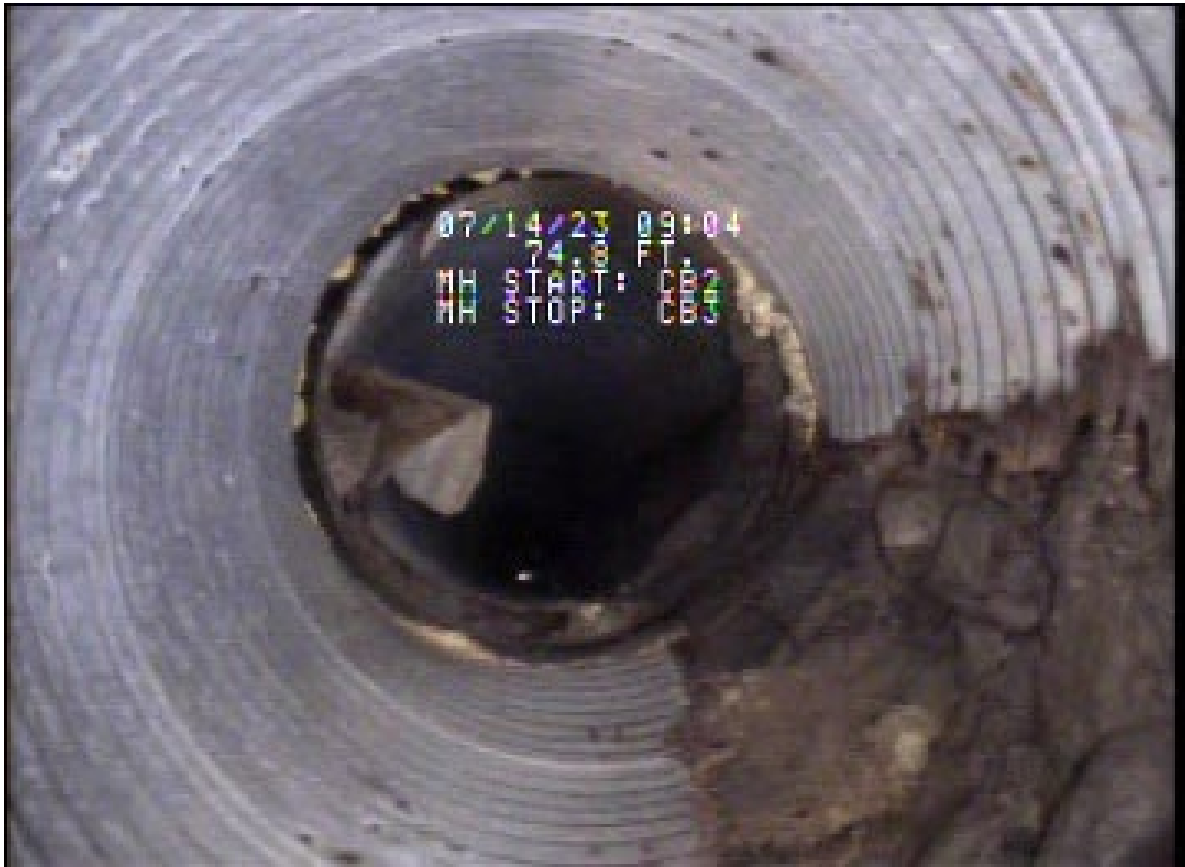
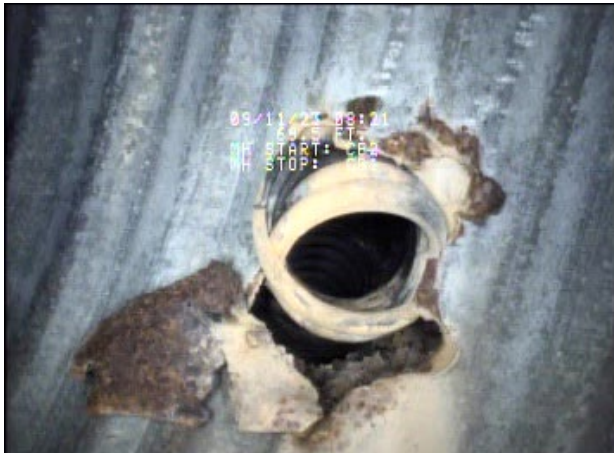
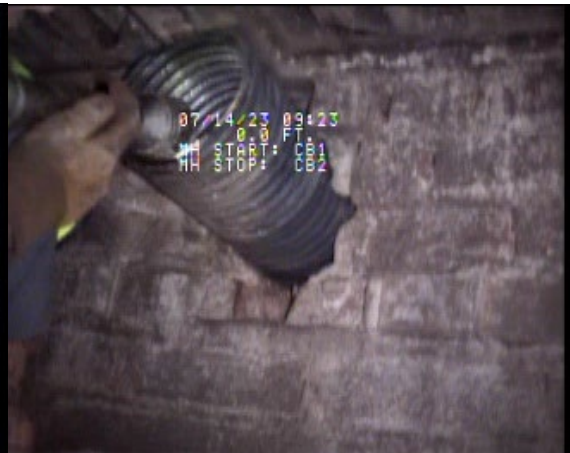
Structural deficiencies to the storm system on Buckline Crossing were identified responding to a sinkhole reported by the homeowner. The pipe system is composed of +/- 350 linear feet (LF) of 30-inch corrugated metal pipe (CMP) that is approximately 45 years old and in poor condition. Closed-Caption Television (CCTV) footage discovered corrosion, multiple private tie-ins, visible holes, and minor joint separation. Recommended repairs include:

## Corrosion with visible holes Multiple private drain tie-ins

- Repair +/- 350 LF of 30-inch CMP with Cured-In-Place Pipe (CIPP) liner
- Install three (3) 4-foot brick manholes with pedestal tops/grates
- Seven (7) days of Minor Traffic Control

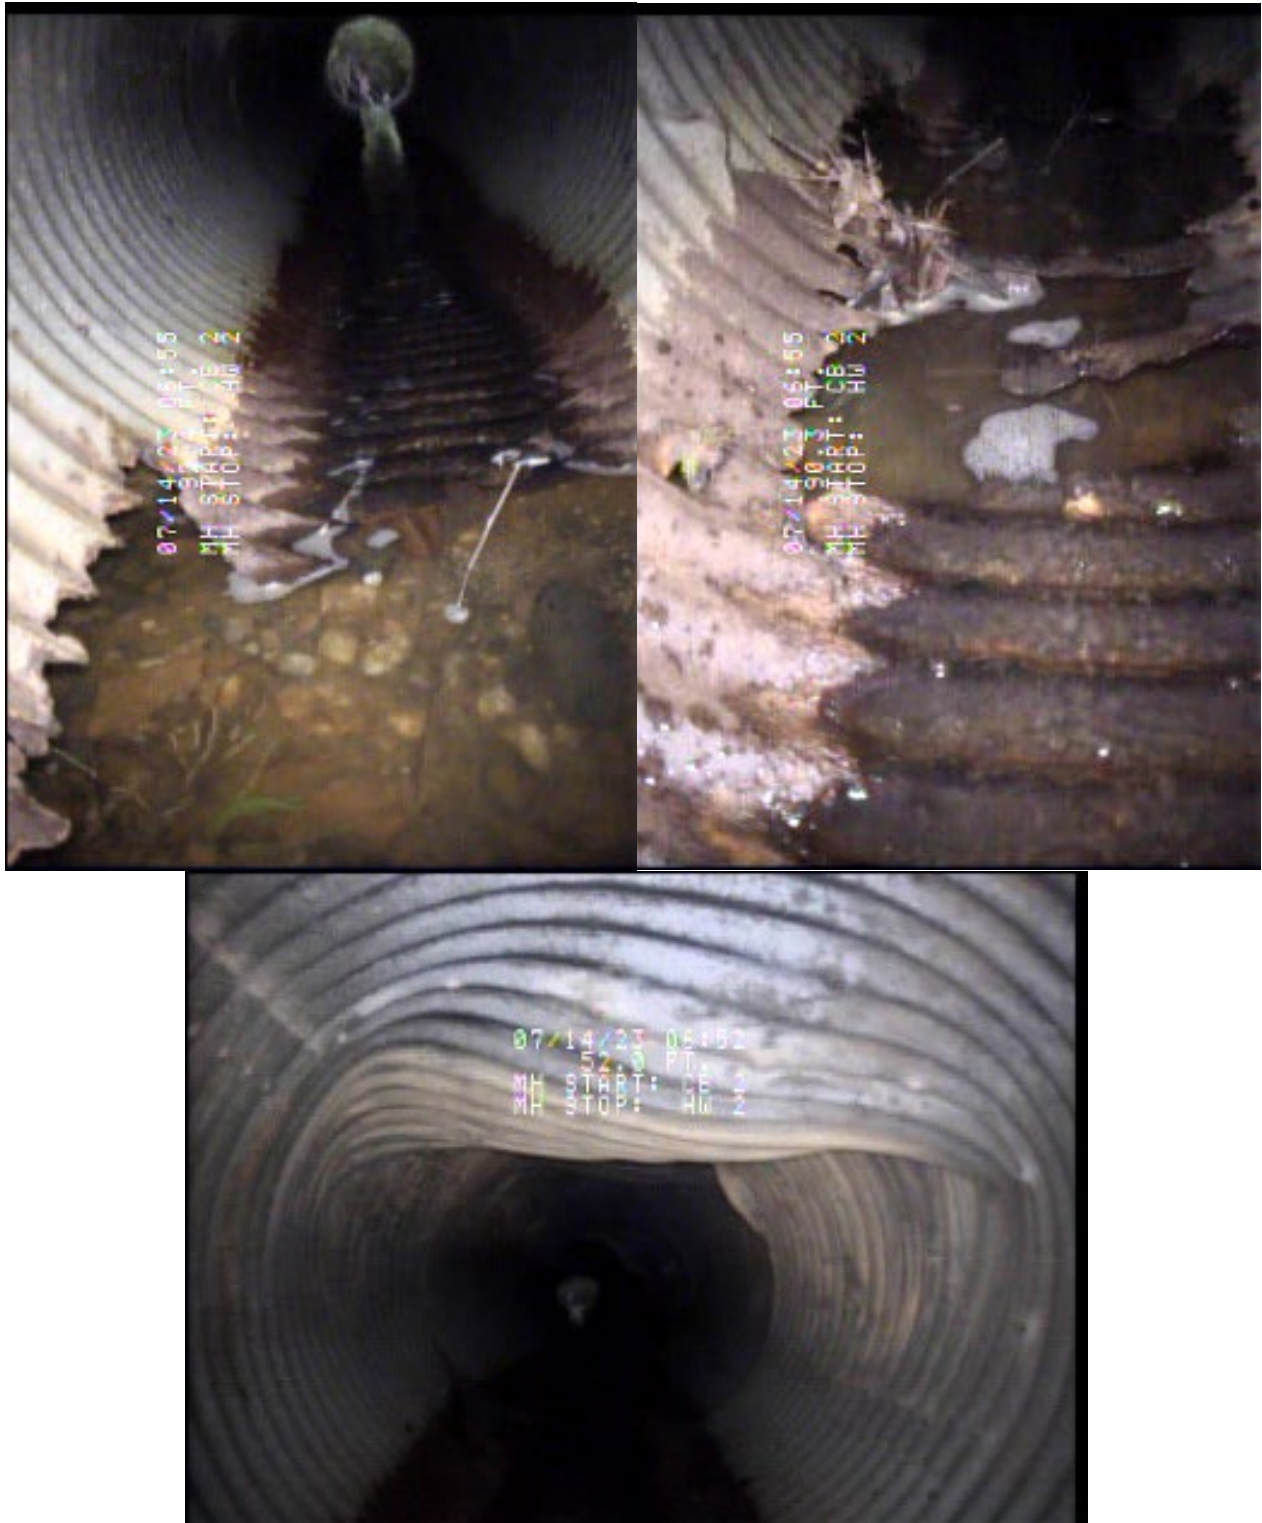
Structural deficiencies to the storm system on Fontainebleau Ct were identified responding to a sinkhole reported by the homeowner. The pipe system is composed of +/- 360 linear feet (LF) of 30-inch corrugated metal pipe (CMP) that is approximately 60 years old and in poor condition. Closed-Caption Television (CCTV) footage discovered corrosion, visible holes, deformities, and minor joint separation. Recommended repairs include:

## Corrosion With Visible Holes Minor Deformities To Pipe Crown

- Repair +/- 360 LF of 30-inch CMP with Cured-In-Place Pipe (CIPP) liner
- Dig and Replace 20 LF of Corrugated Metal Pipe (CMP)
- 133 SY Zoysia Sod replacement

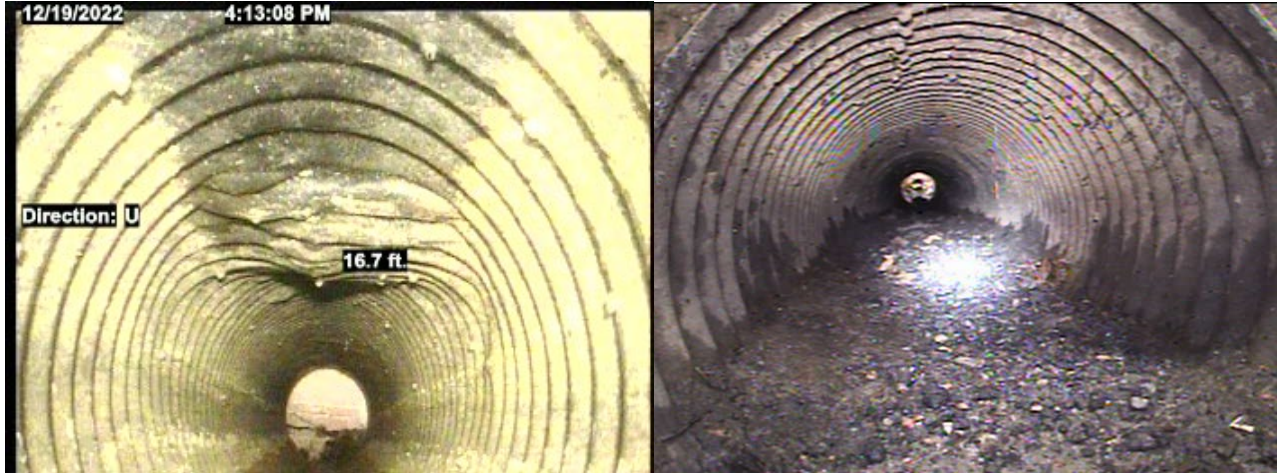
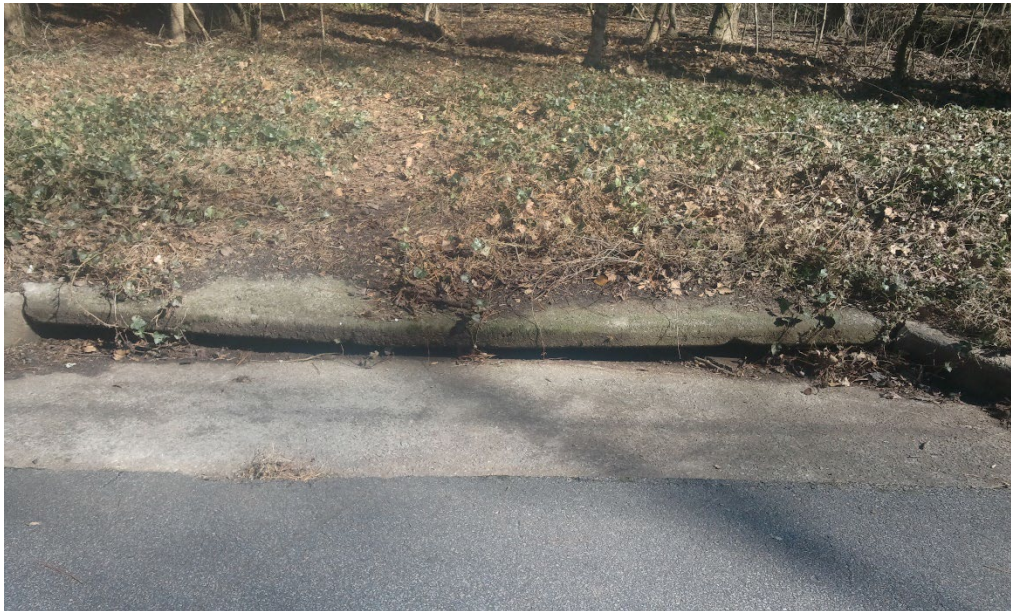
Structural deficiencies to the storm system on Glenrich Drive were identified by staff performing routine inspections. The pipe system is composed of +/- 70 linear feet (LF) of 18-inch corrugated metal pipe (CMP) that is approximately 53 years old and in poor condition. Closed-Caption Television (CCTV) footage discovered moderate corrosion, sedimentation obstructing the pipe catch/basin, and minor deformities. Recommended repairs include:

## Invert corrosion, Deformed Crown, Moderate/Heavy Debris Accumulation

- Repair +/- 70 LF of 18-inch CMP with Cured-In-Place Pipe (CIPP) liner
- 8 LF of point repairs
- 4 catch basin top slabs and throats (cast in place)

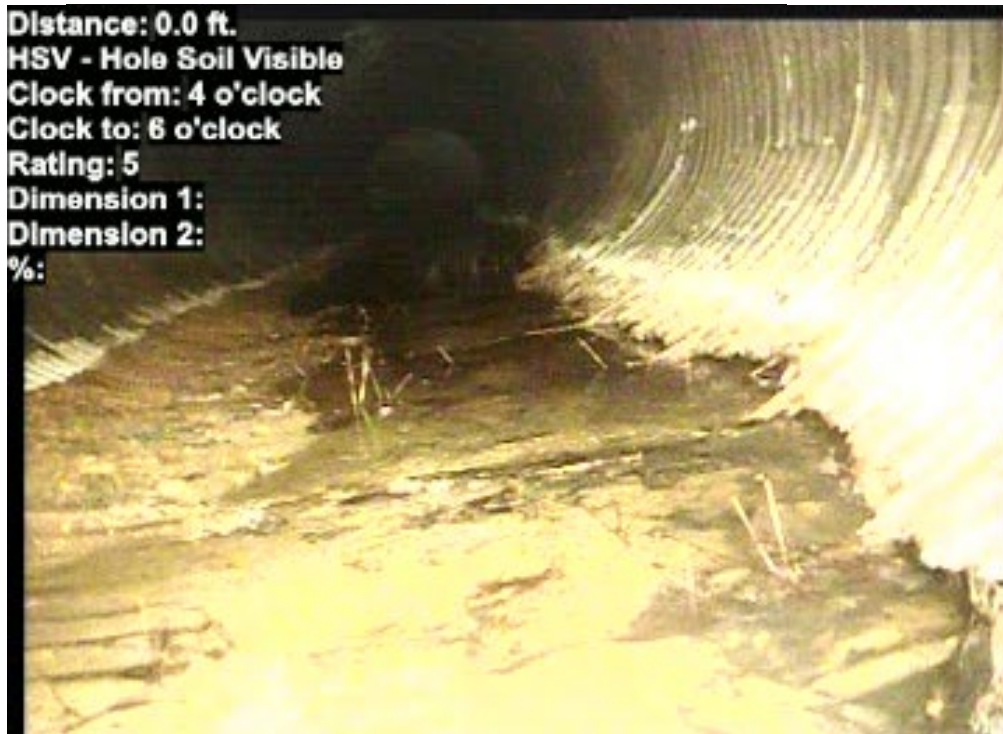
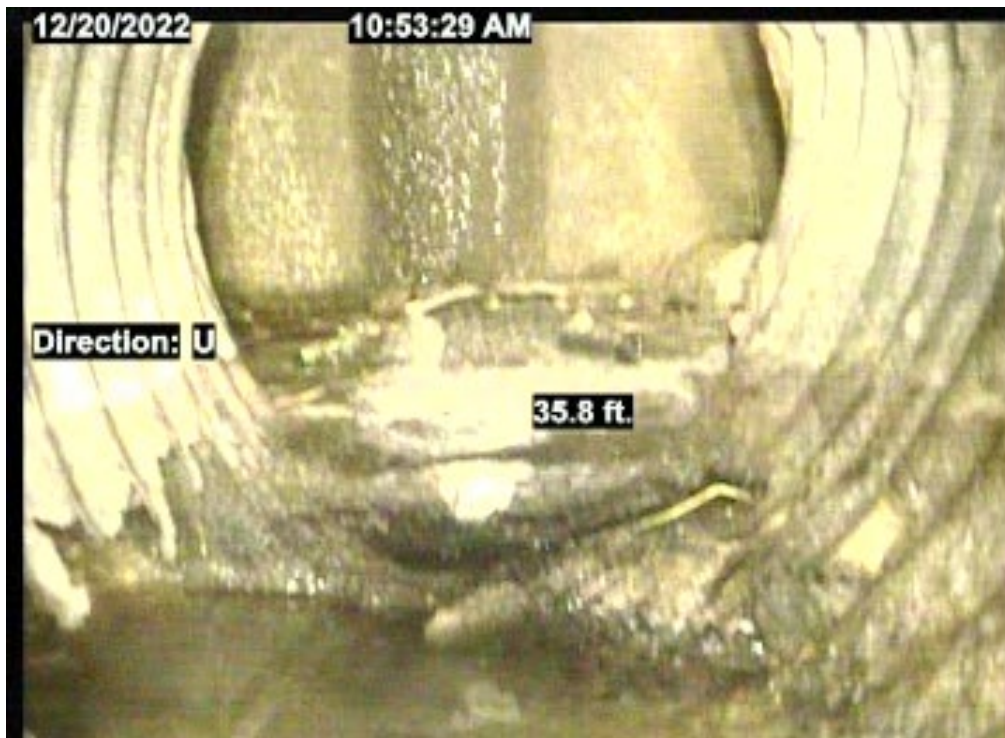
Structural deficiencies to the storm system on Mill Gate Court were identified by staff conducting routine storm inspections. The pipe system is composed of +/- 100 linear feet (LF) of 18 and 60-inch corrugated metal pipe (CMP) that is approximately 46 years old and in poor condition. Closed-Caption Television (CCTV) footage discovered corrosion with visible holes. Recommended repairs include:

## Corrosion with visible holes

- Repair +/- 40 LF of 18-inch CMP with Cured-In-Place Pipe (CIPP) liner
- Repair +/- 60 LF of 60-inch CMP with spray on Spincast liner
- 20 CY pressure grout (fill voids in the subgrade)
- 75 hours of bypass pumping
