**RE: Pre-Demolition Property Conditions & Hazardous Materials Assessment
Brook Run Property— C.E.R.M. Project No. 11-0862-034
4770 North Peachtree Road
Dunwoody, Georgia**

DEMOLITION & FACILITY ASSESSMENT PLANS

for BROOK RUN PARK

DEKALB COUNTY PARKS AND RECREATIONS 4770 N PEACHTREE RD. & BROOK RUN AVE. DeKalb County, Georgia 30338 Commissioner District: 4

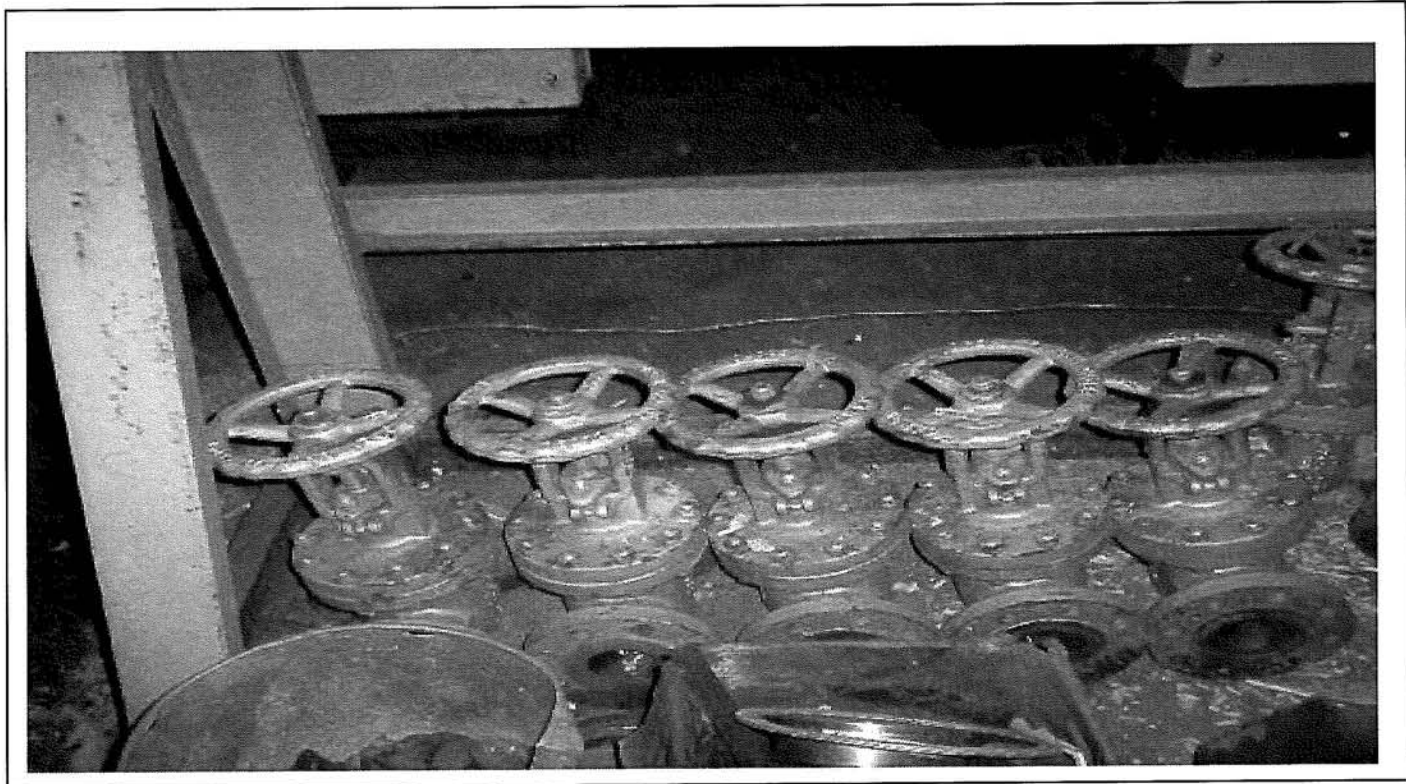
Photo 4: View of miscellaneous valves stored in the power plant building.

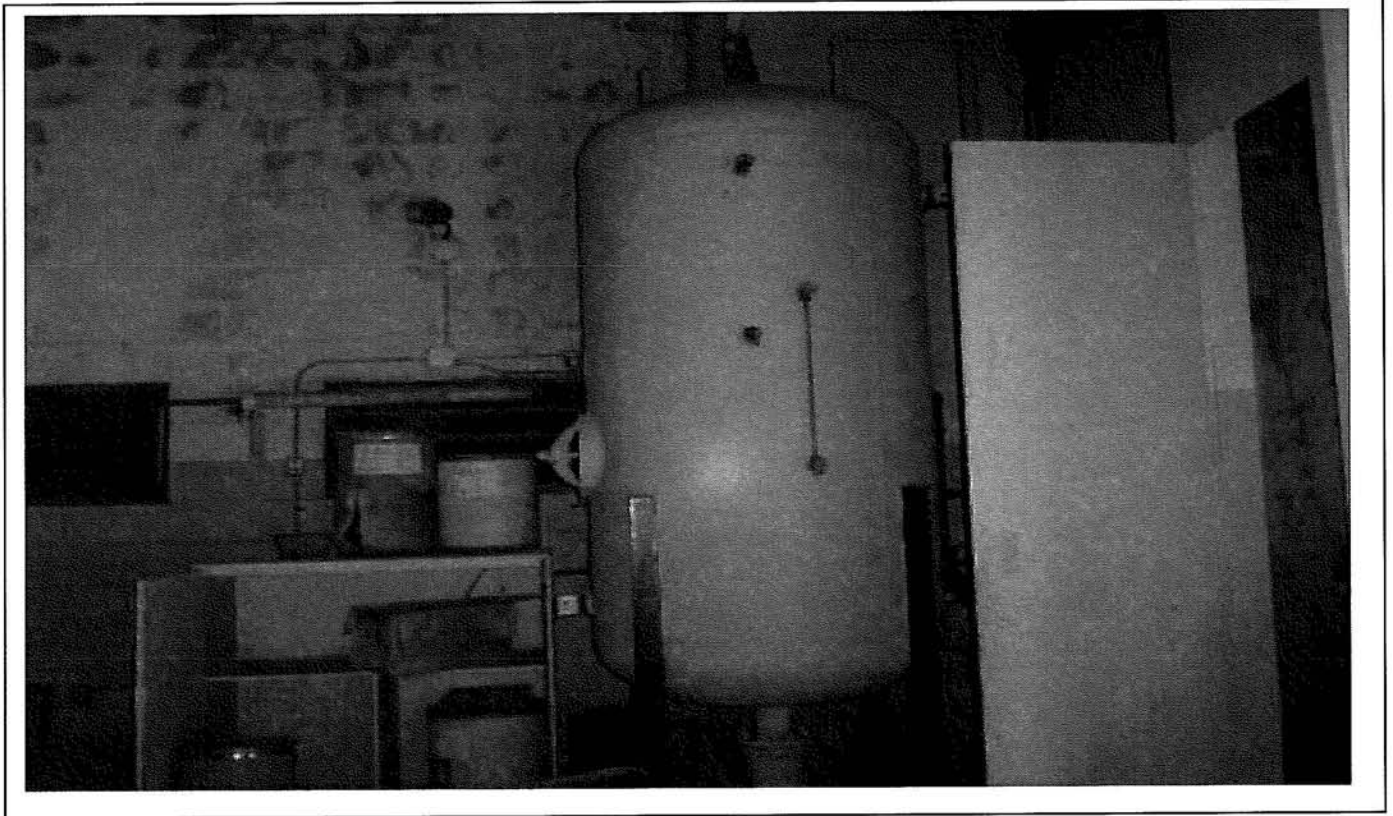
Photo 5: View of a chilled water storage tank in the power plant building.

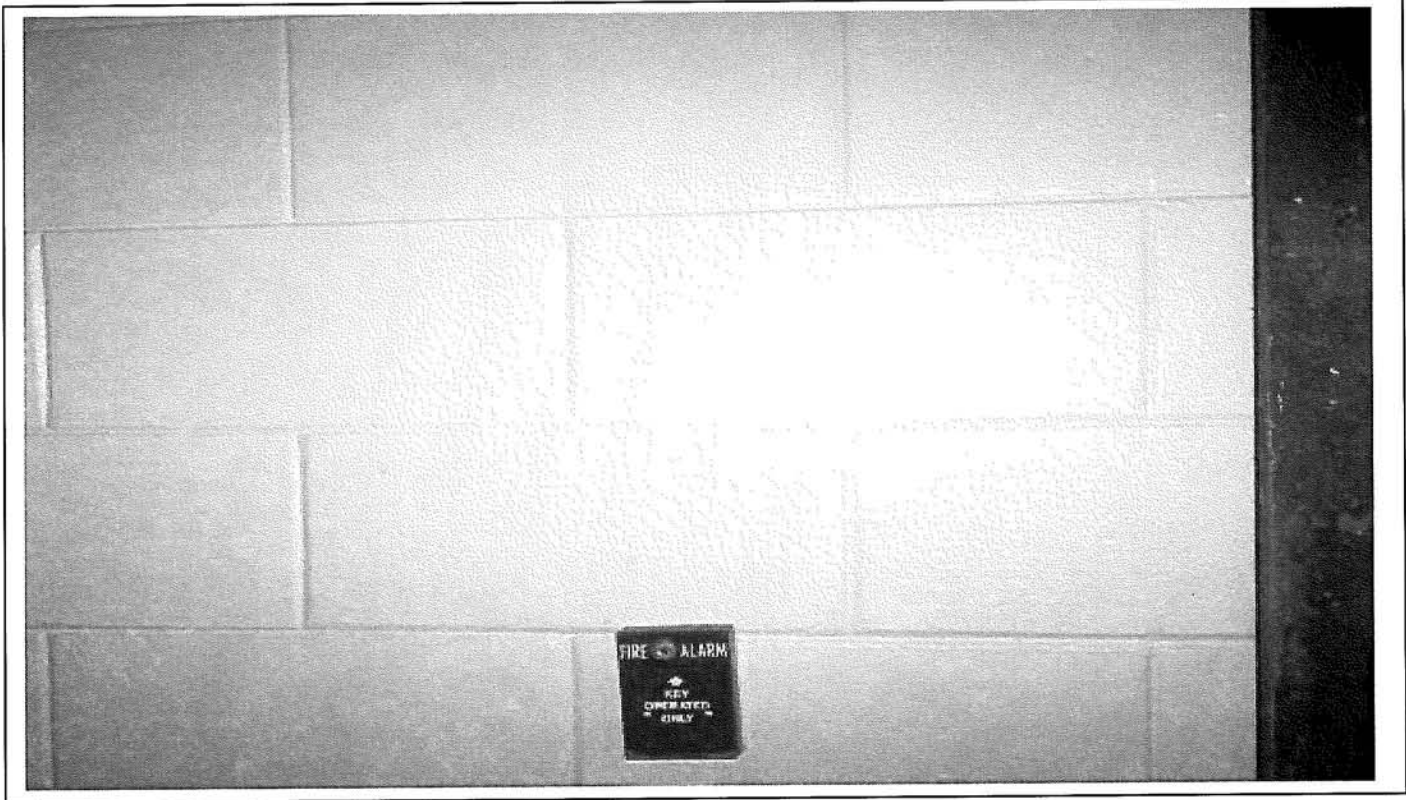
Photo 9: View of typical concrete masonry unit (CMU) system in lower level of cottage No. 3.

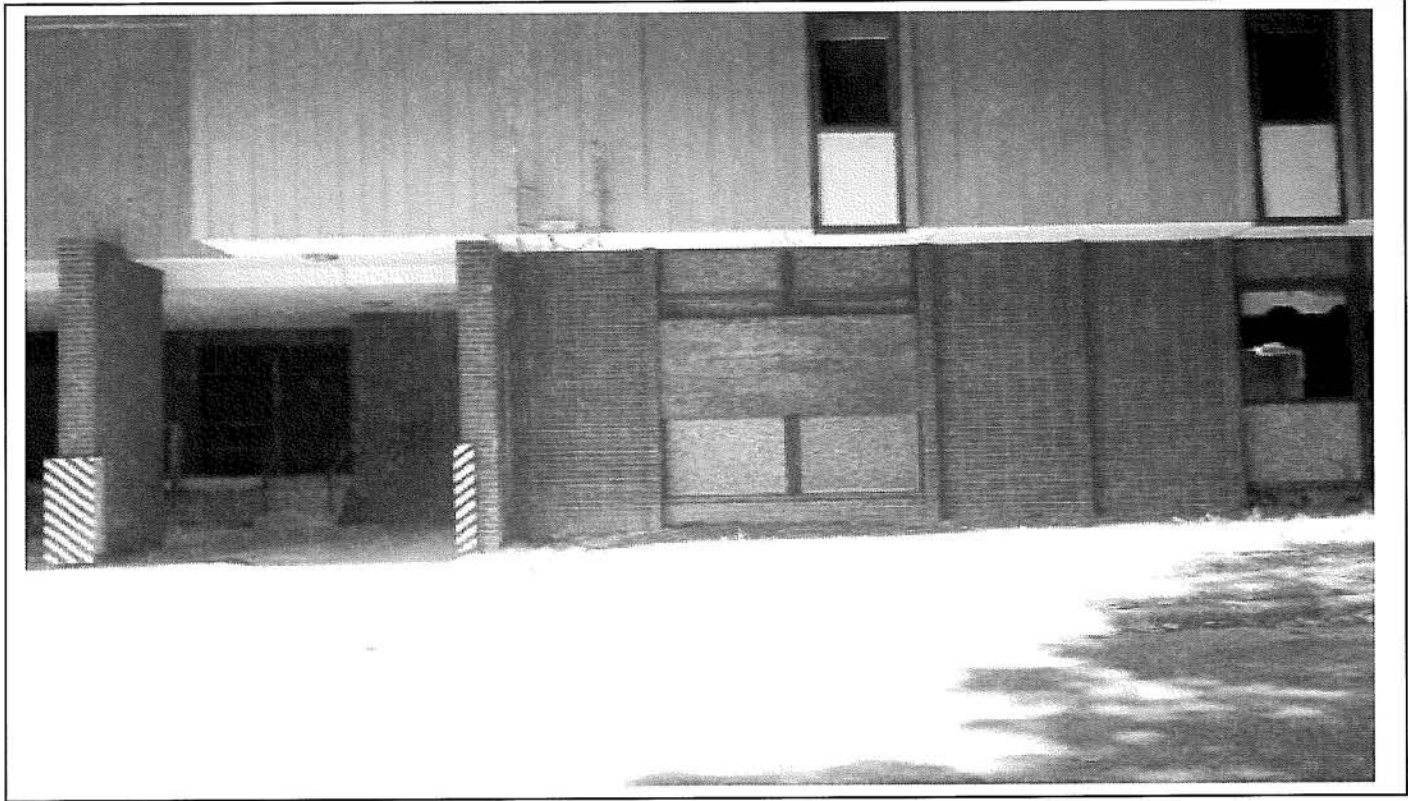
Photo 11: View of side elevation of cottage No. 3 depicting the brick/wood exterior façade.

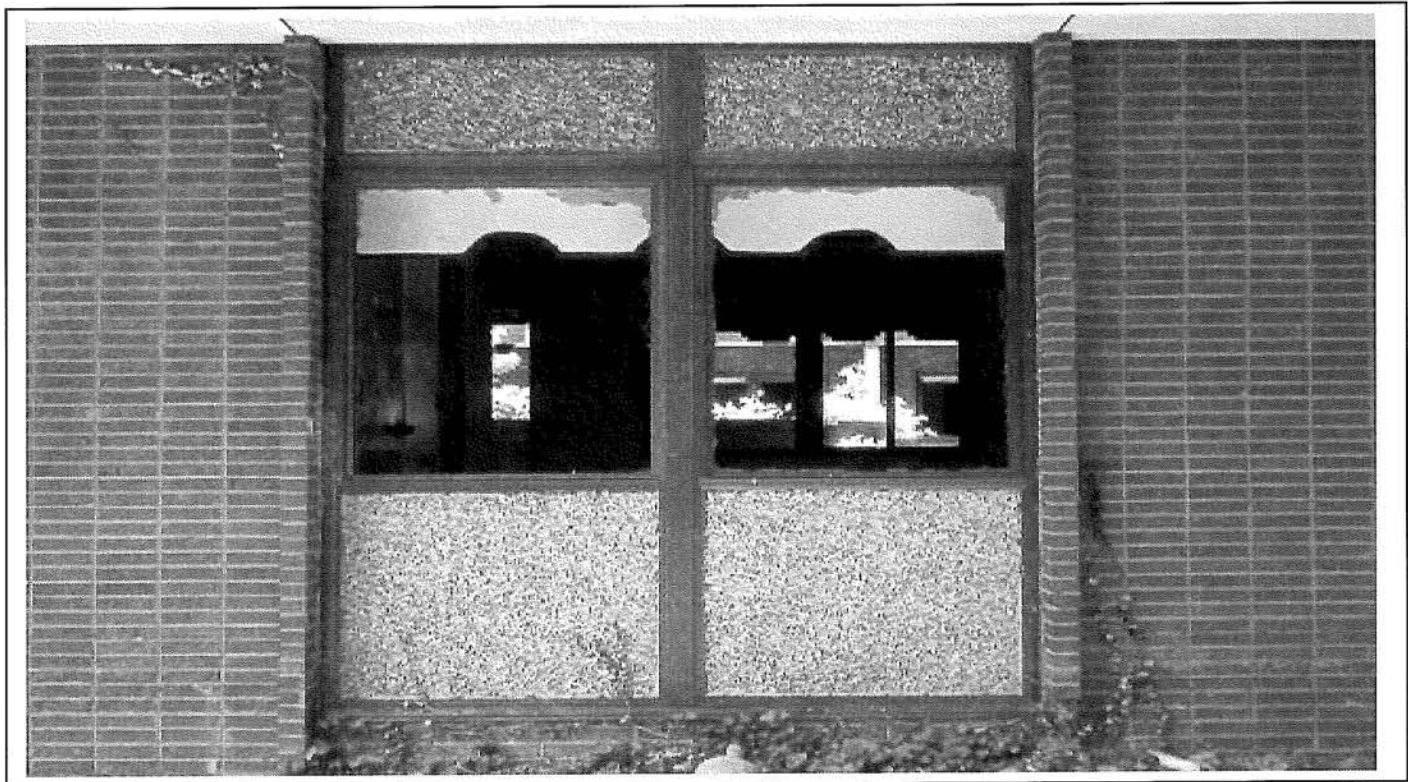
Photo 12: View of the side elevation if cottage No. 3 depicting the metal window framing and aggregate panels.

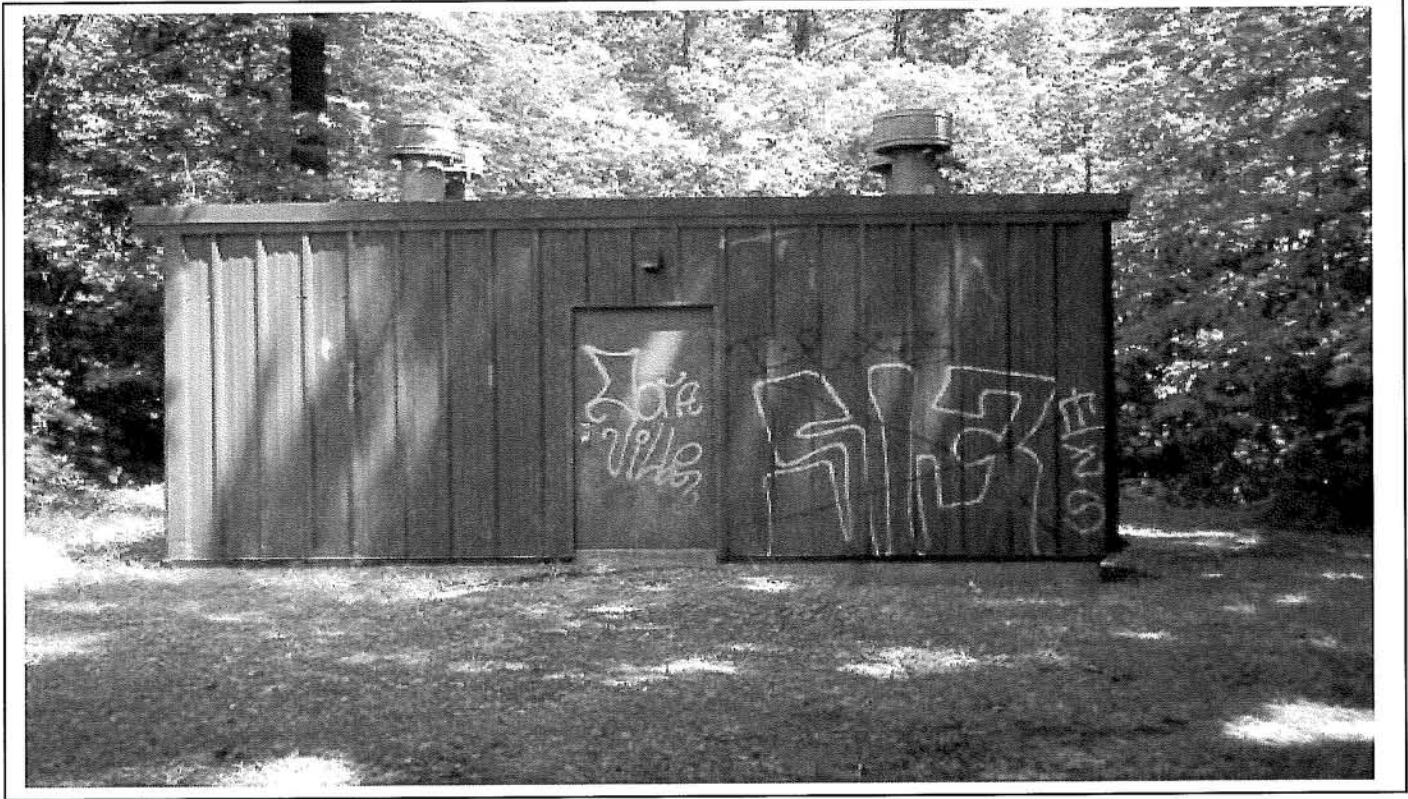
Photo 13: View of an electrical switch building adjacent cottage No 3.

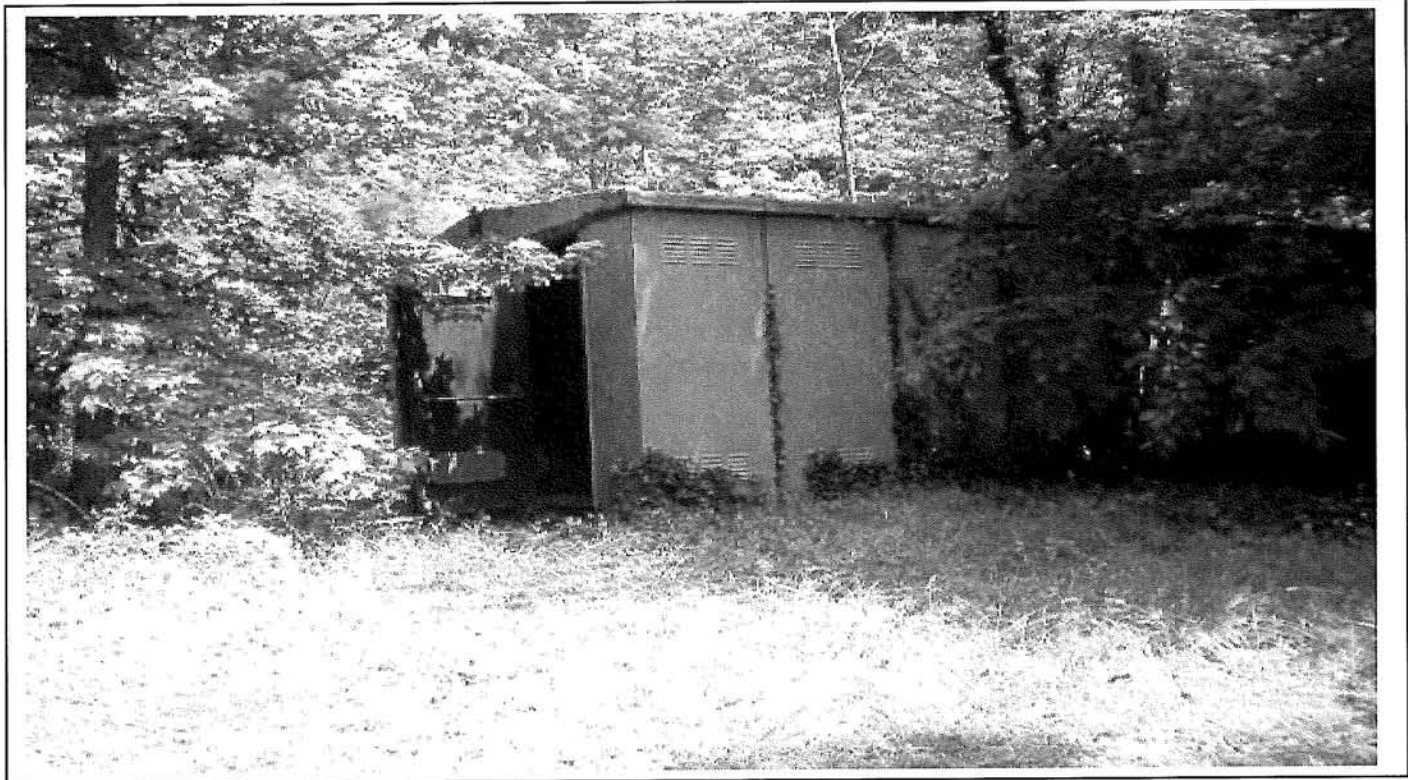
Photo 14: Miscellaneous metal storage building located behind cottage No 3.

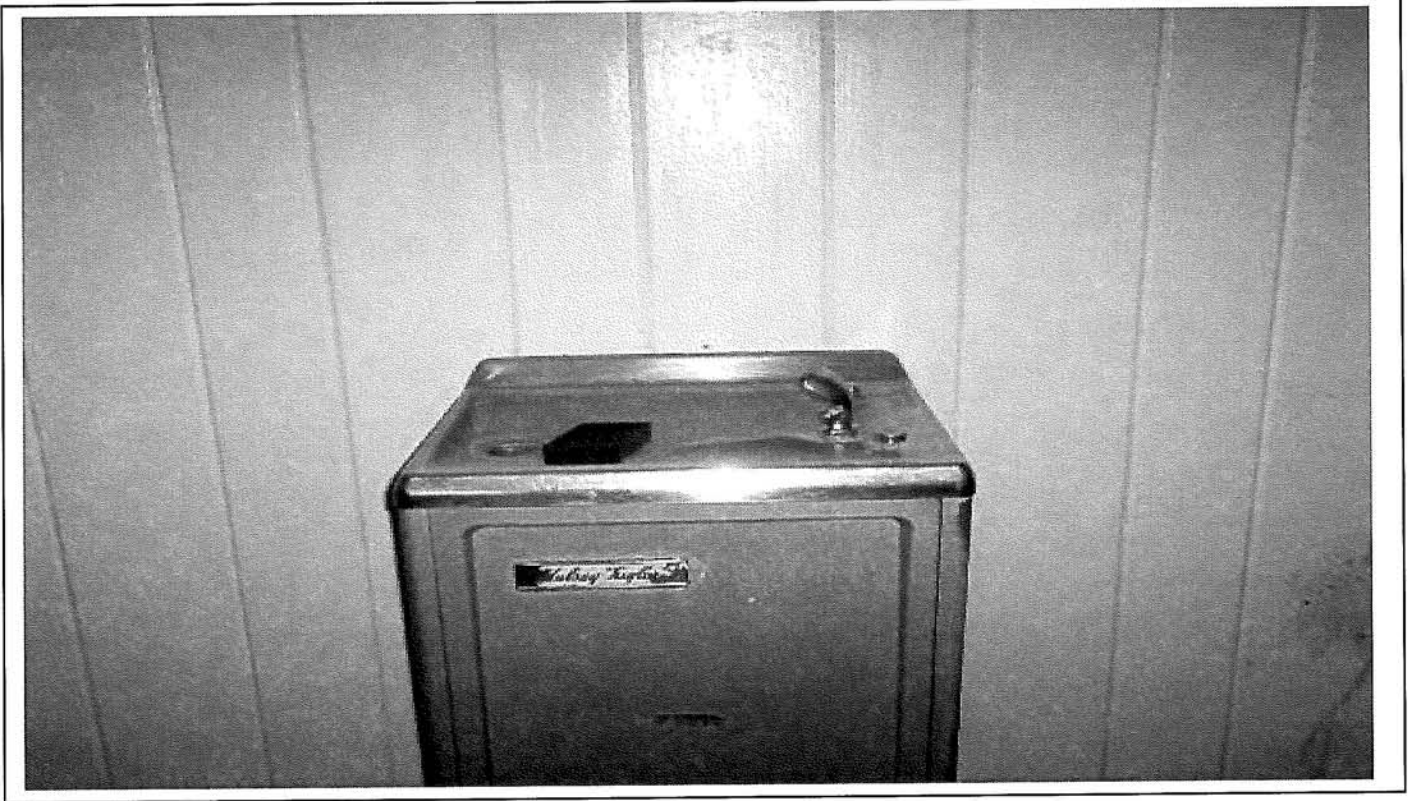
Photo 15: Typical metal, wall-mounted water fountain located in cottages.

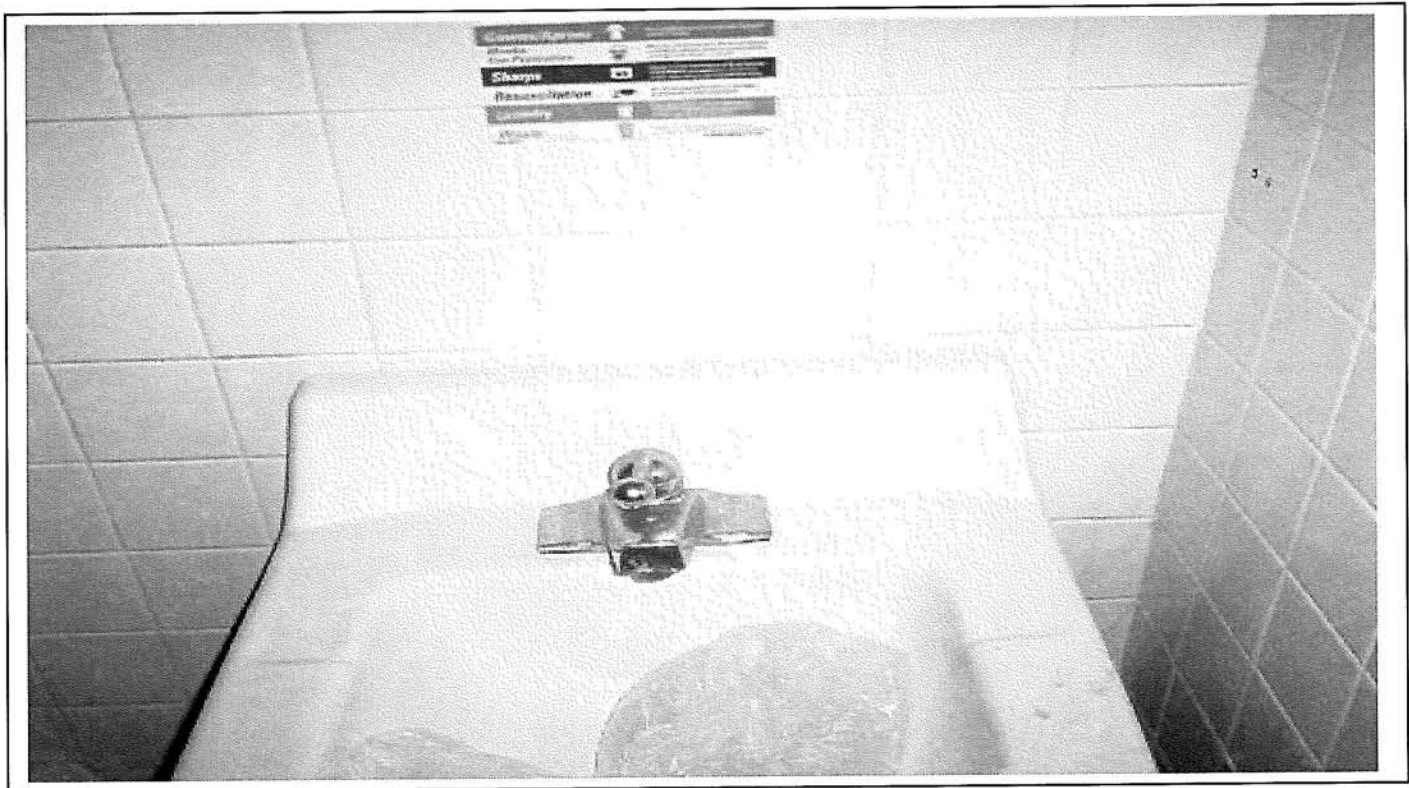
Photo 16: Typical fixtures located in cottages 3, 4, & 5.

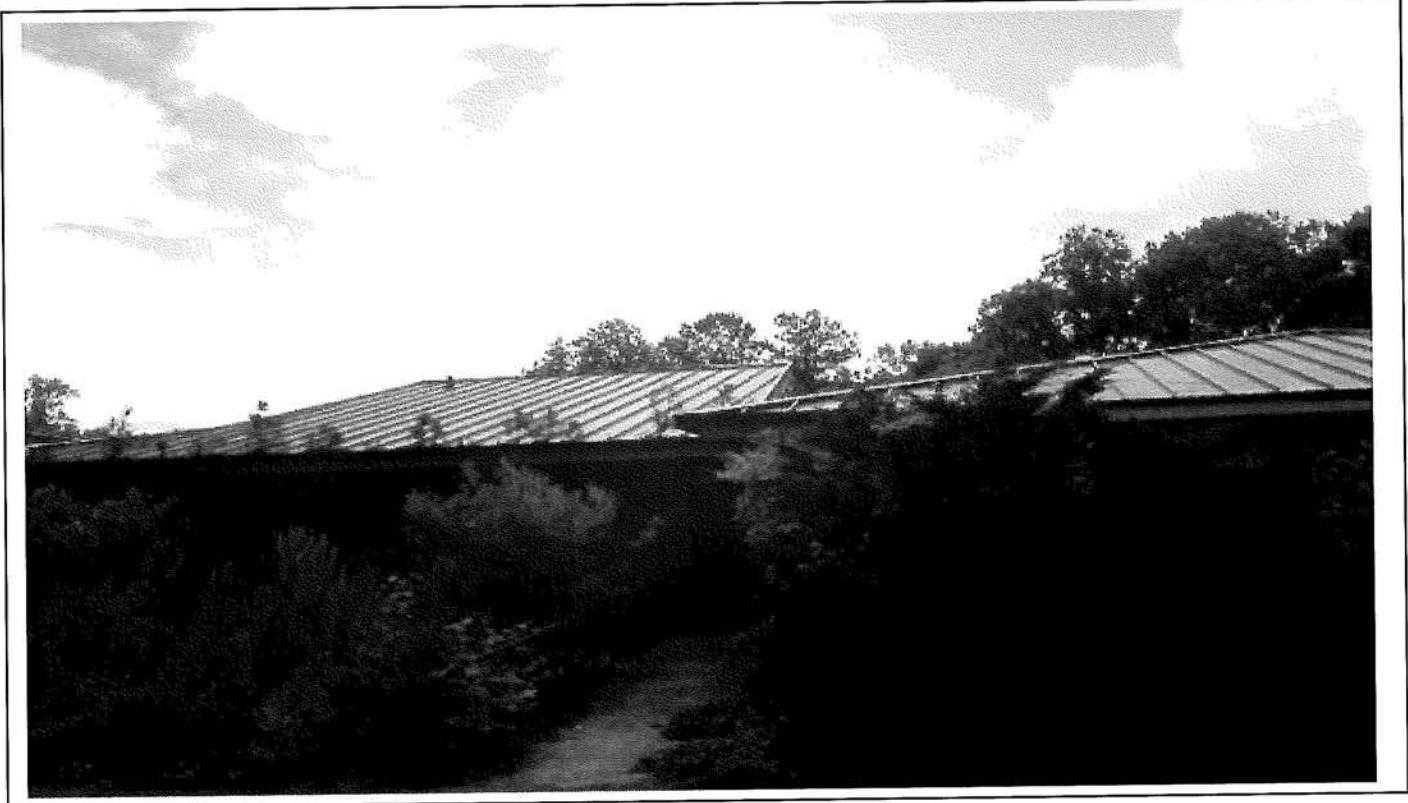
Photo 17: Typical metal standing seam roof located in cottages 3, 4 & 5.

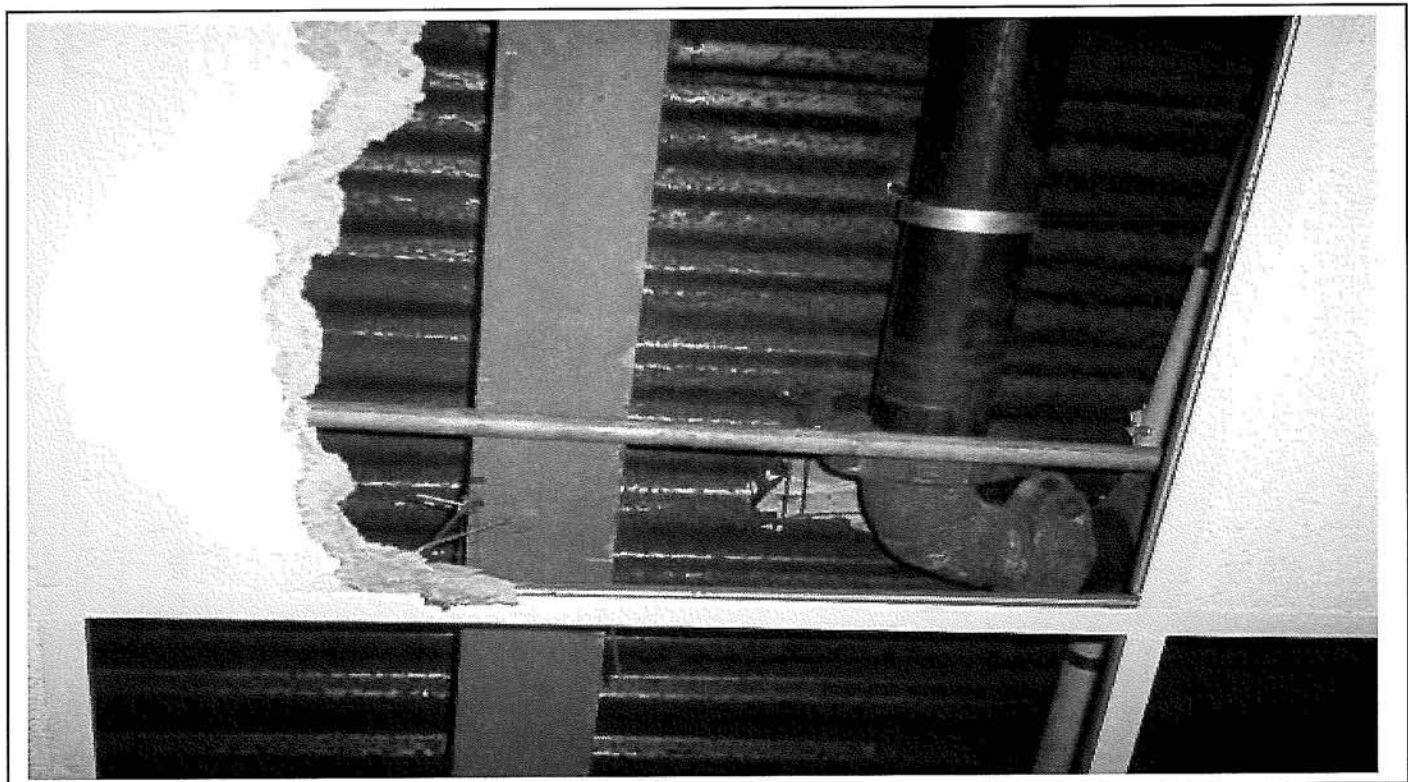
Photo 20: Typical view of section above ceiling in cottage No. 4 depicting structural steel and metal pipes.

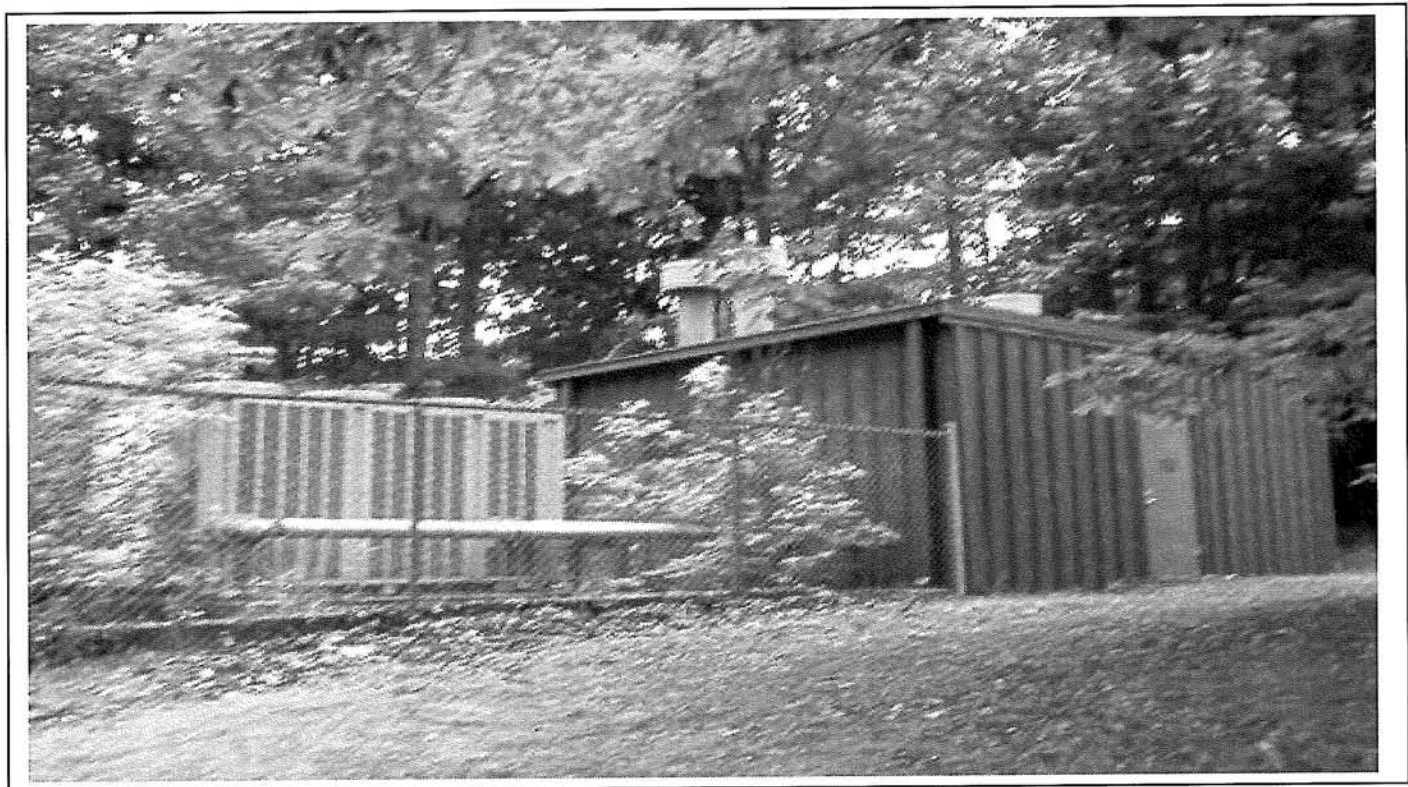
Photo 22: View of electrical equipment building associated with cottage No 4.

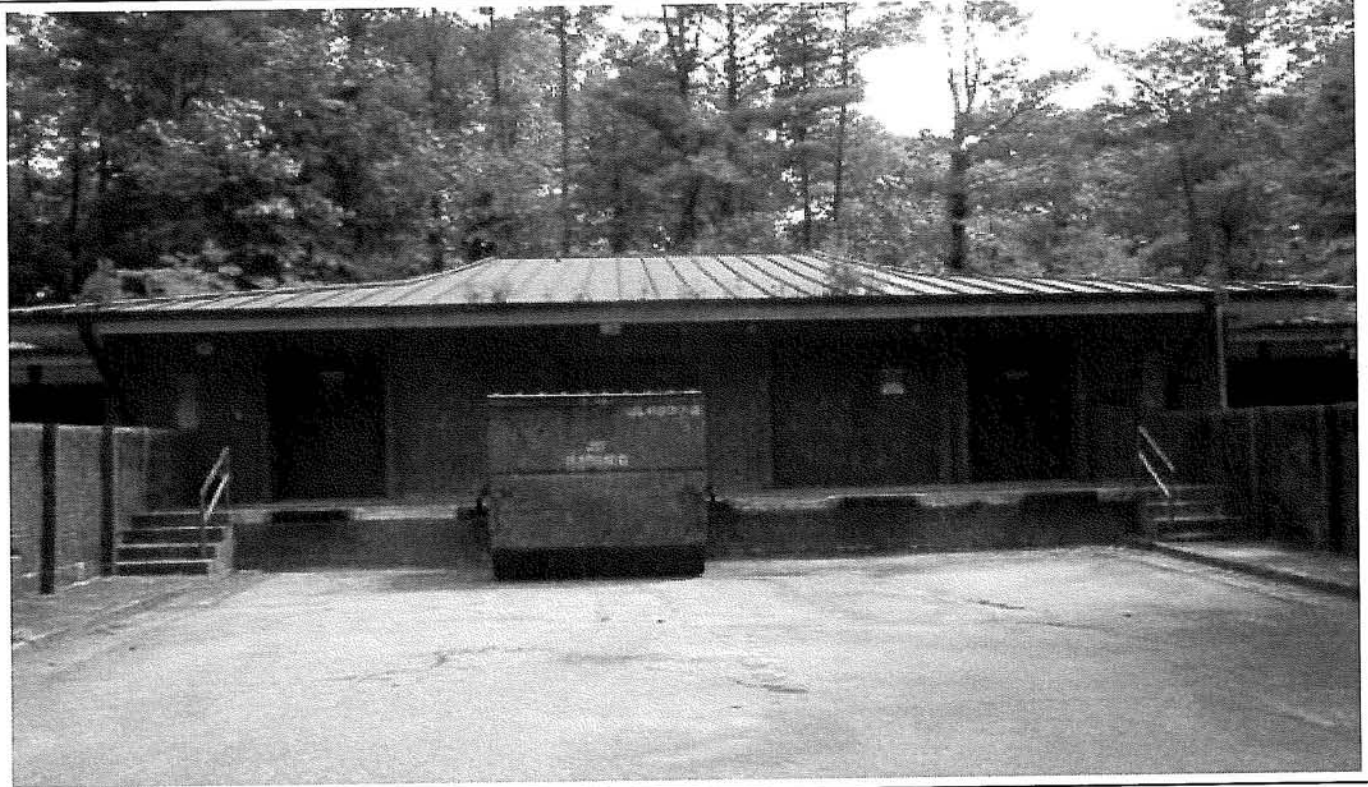
Photo 23: Typical view of cottage No. 5, loading dock area.

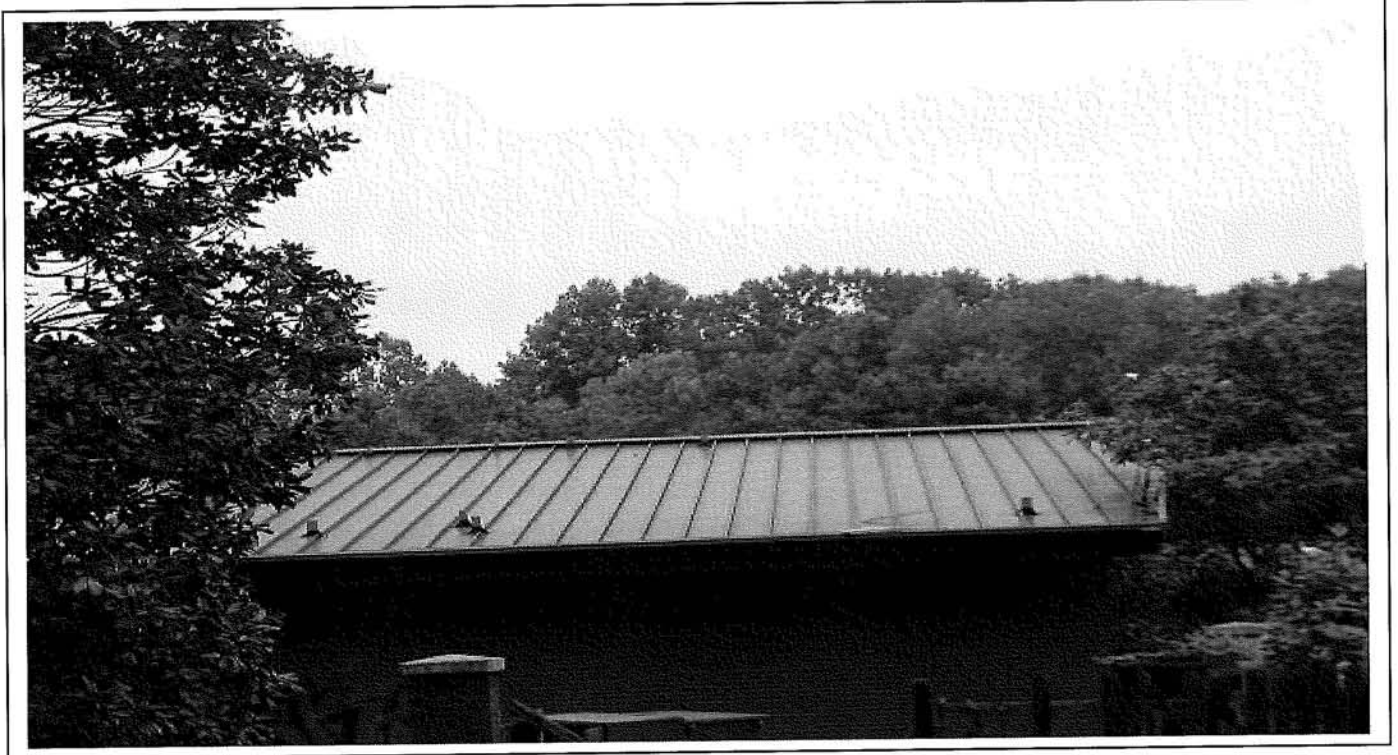
Photo 42: Typical metal raised rib roof system (all buildings)

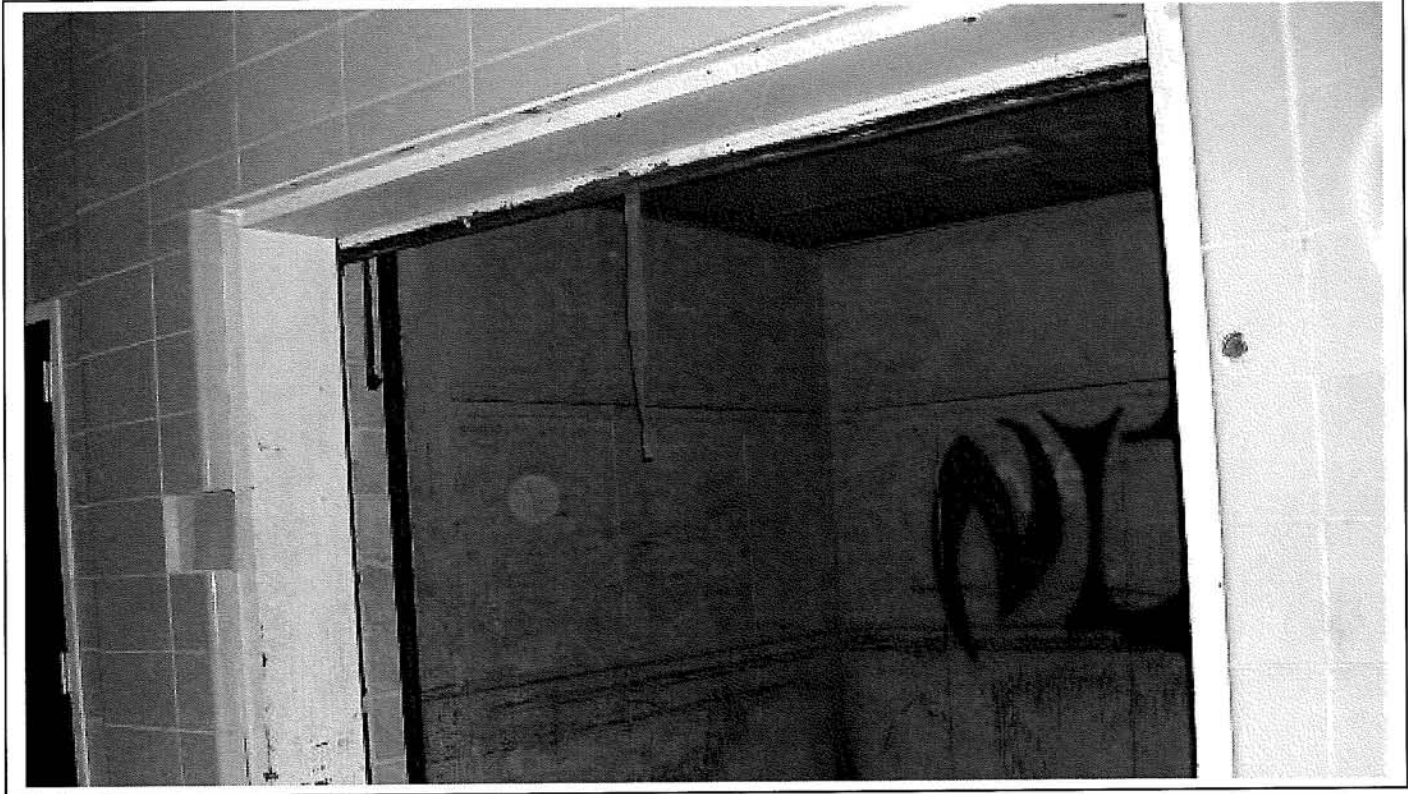
Photo 43: Typical service elevator interior (Therapy Building-Kitchen Area)

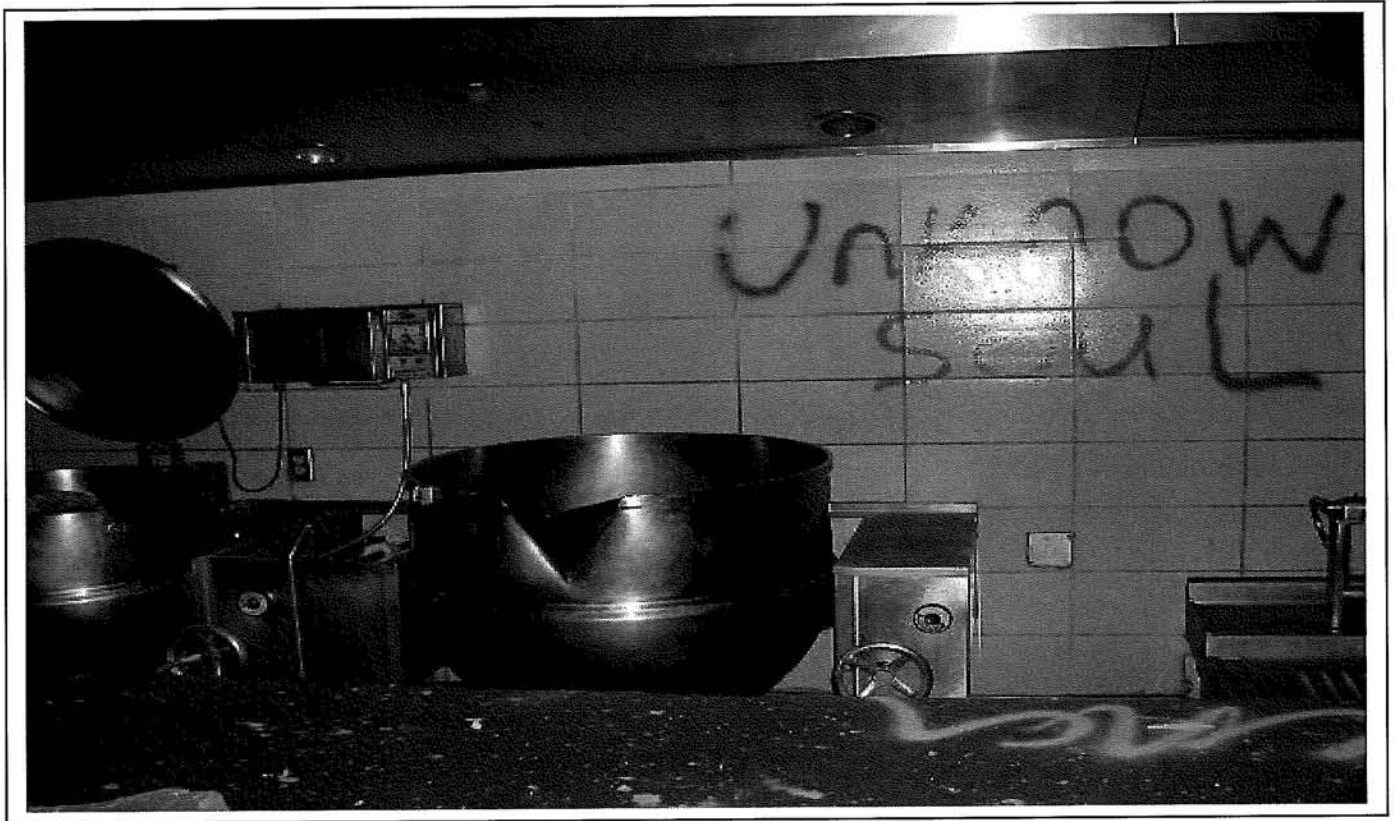
Photo 47: Typical wall-mounted deep fryers in kitchen area Therapy Building.

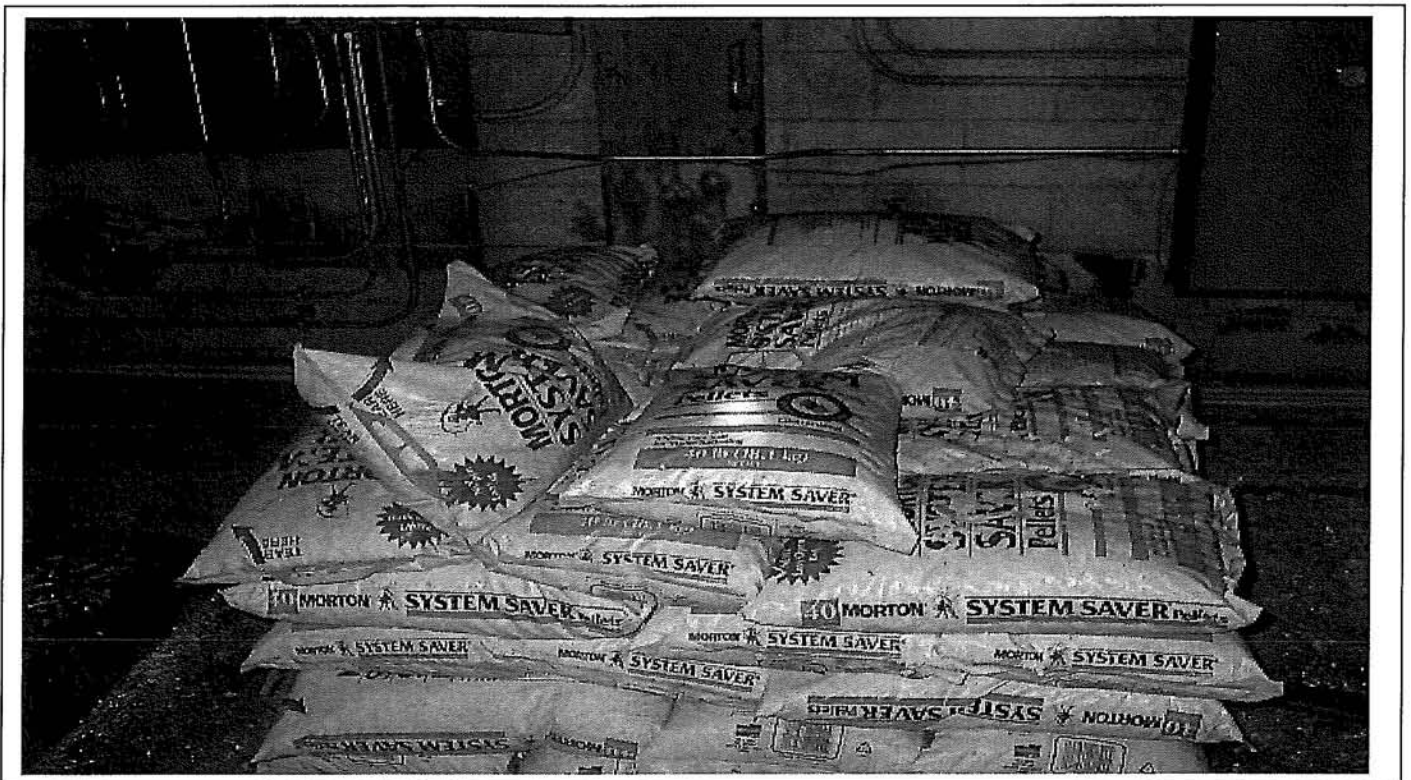
Photo 10: Non-regulated ice-melt observed in Power Plant.

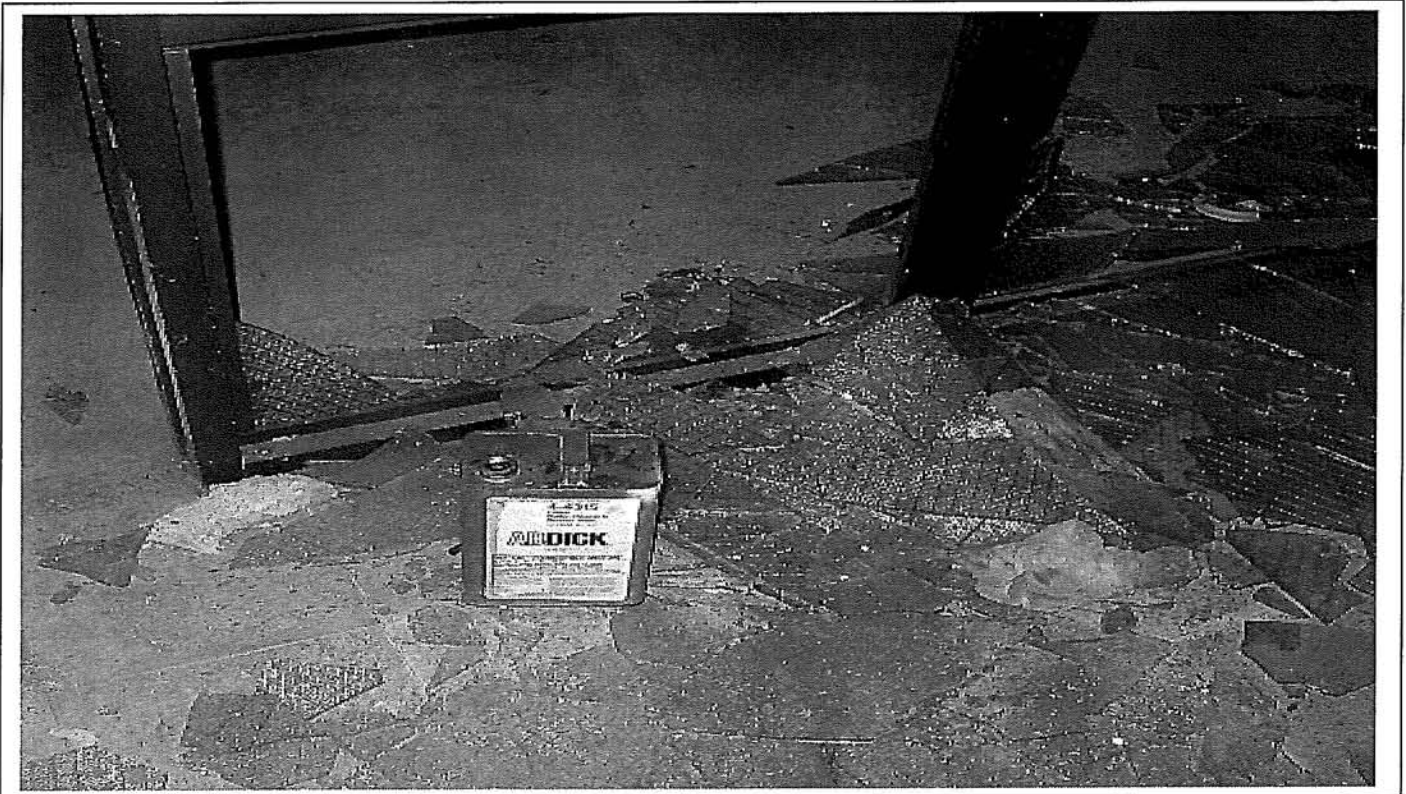
Photo 18: 1 gallon container of chemical located in Therapy Building.

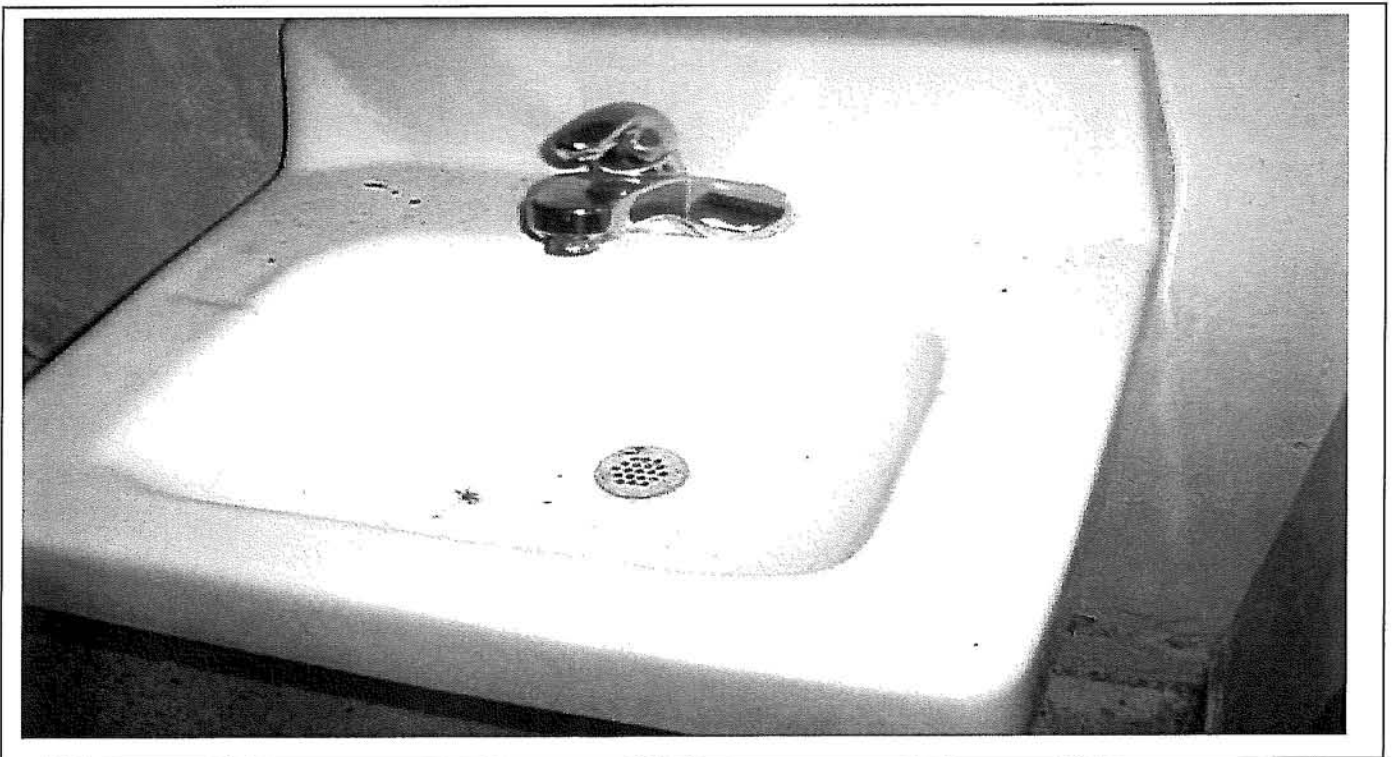
Photo 6: Typical sink with undercoating containing ACM.

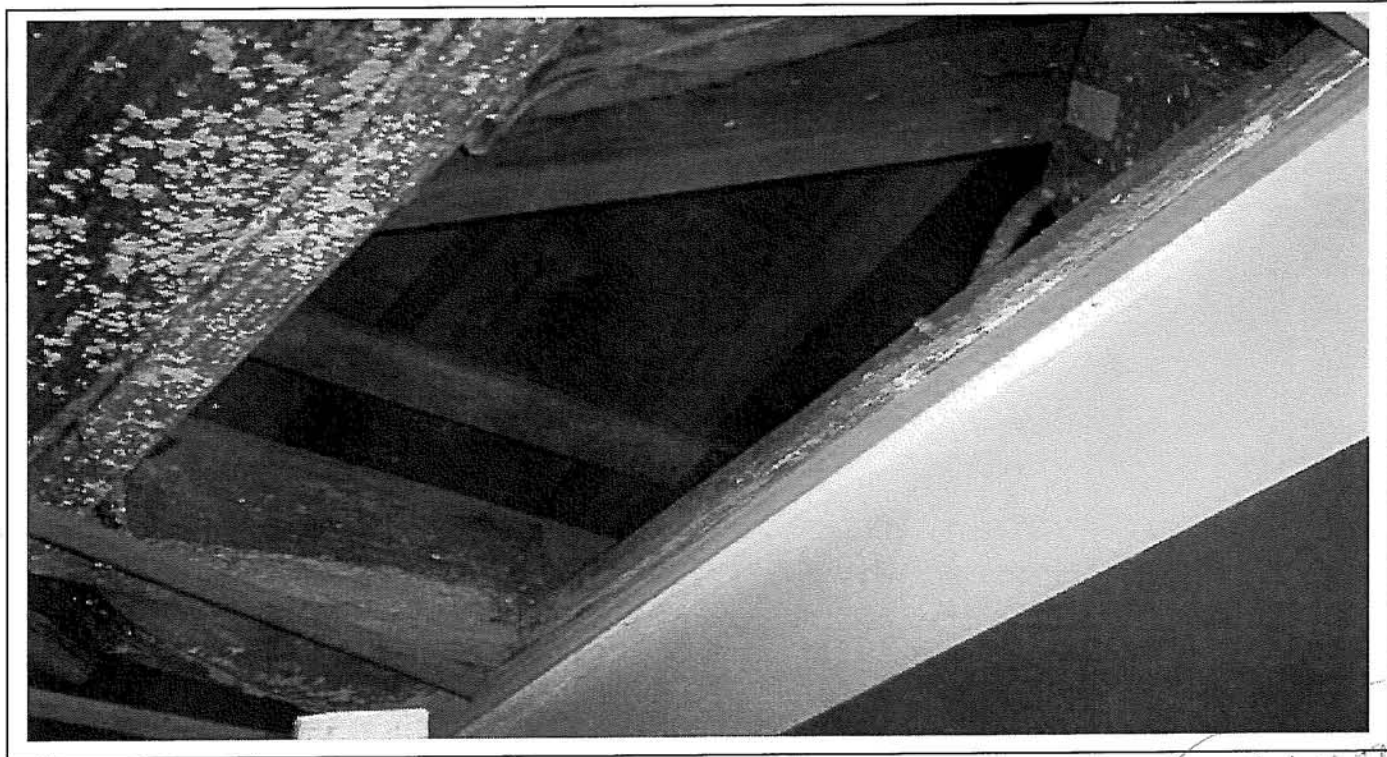
Photo 8: Structural steel I-beam with Spray-applied Fireproofing containing ACM.

*I don't think
this is correct
DS*
