**RE: Pre-Demolition Property Conditions & Hazardous Materials Assessment
Brook Run Property— C.E.R.M. Project No. 11-0862-034
4770 North Peachtree Road
Dunwoody, Georgia**

DEMOLITION & FACILITY ASSESSMENT PLANS

for BROOK RUN PARK

DEKALB COUNTY PARKS AND RECREATIONS 4770 N PEACHTREE RD. & BROOK RUN AVE. DeKalb County, Georgia 30338 Commissioner District: 4

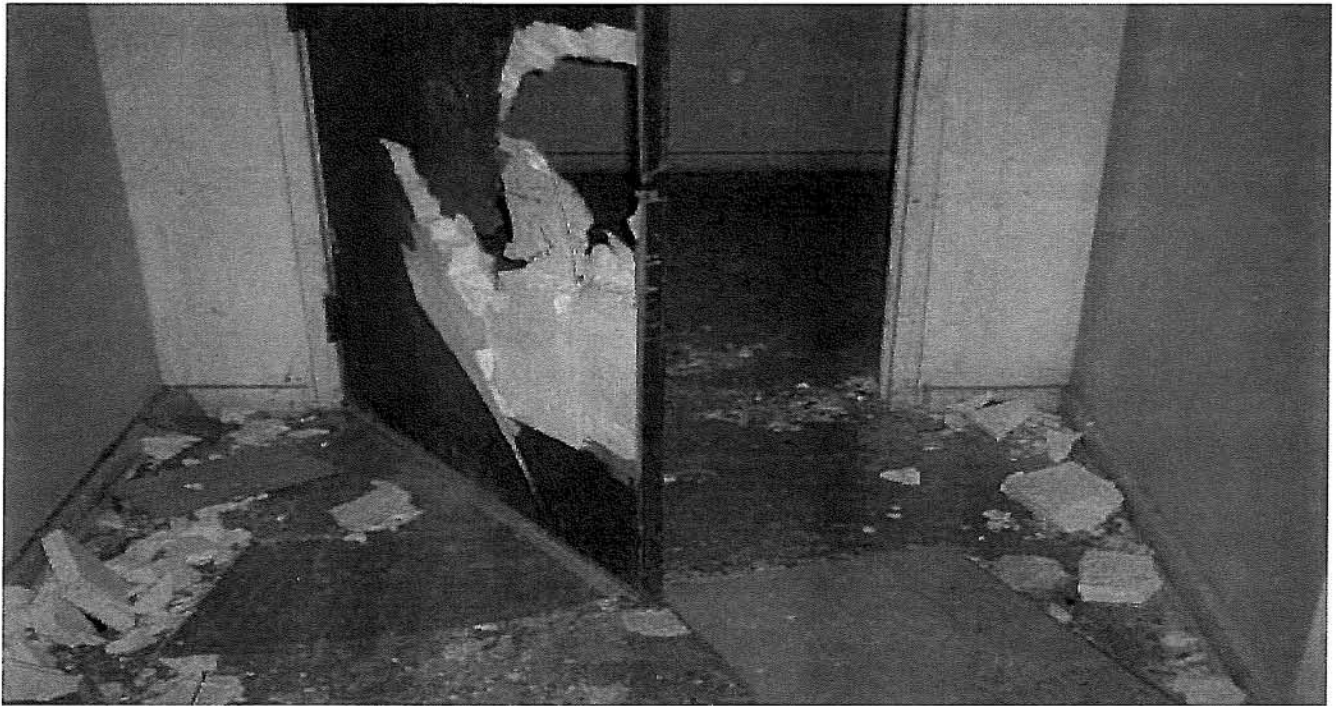
Due to the excessive vandalism, it is recommended that the site is immediately secured and that asbestos warning signs be posted throughout the facility until an asbestos abatement contractor is engaged. Vandals have scattered excessive amounts of friable asbestos debris throughout the facility and have caused the facilities to be considered contaminated.

Photo 12: Typical Fire Door with Insulation containing ACM scattered on the floor.
