FACILITY REPORT

City of Dunwoody
Brook Run Park Theater

June 16, 2011

City of Dunwoody: Brook Run Park Theater

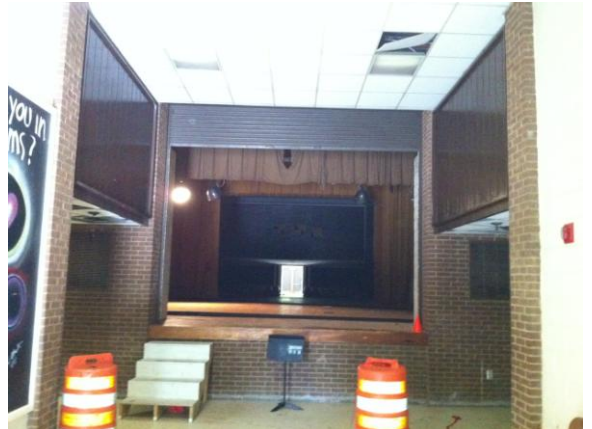
Back Stage Area

Stage Flooring: Existing stage flooring is in fair condition showing wear from heavy use and lack of floor maintenance. The existing flooring could be stripped, sanded, and re-finished, a typical treatment for stage flooring.
