**The Brook Run Theater
Feasibility Study**

**Report of Findings and Recommendations
Regarding Rehabilitation, Adaptive Re-Use and Operations**

Tomlinson-Graham Group

January 2016

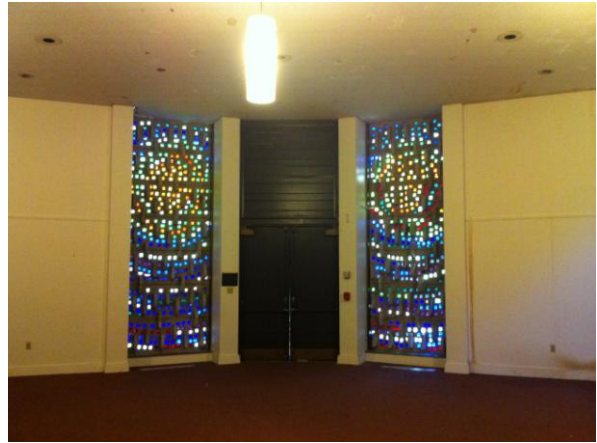
Vandalism at Chapel Windows

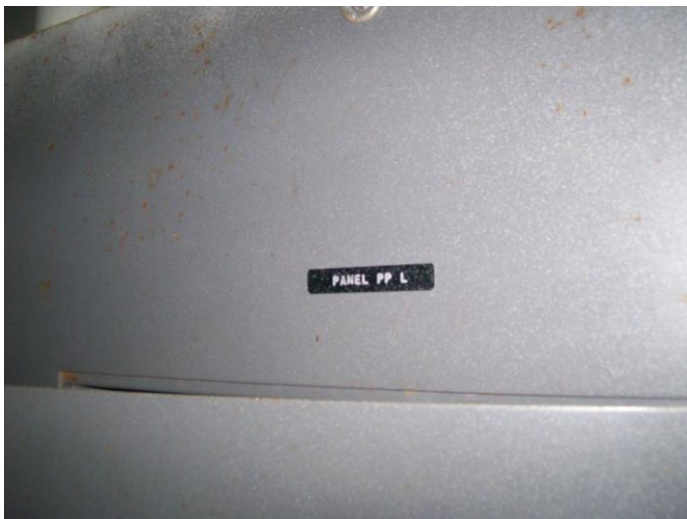
Water Damage at Main Distribution Panel "PP-L"
