- From: Rachel Waldron Parks and Recreation Director
- Re: **Donaldson-Bannister Farm Blacksmith Shop Renovations**

# Donaldson-Bannister Farm Blacksmith Shop Renovation May 27, 2025

Subject: Structural Assessment & Repair Recommendations Donaldson-Bannister Shop Renovation Project No. 25027

Report – Limited Structural Assessment & Repair Recommendations City of Dunwoody Donaldson-Bannister Shop March 14, 2025 Project No. 25027

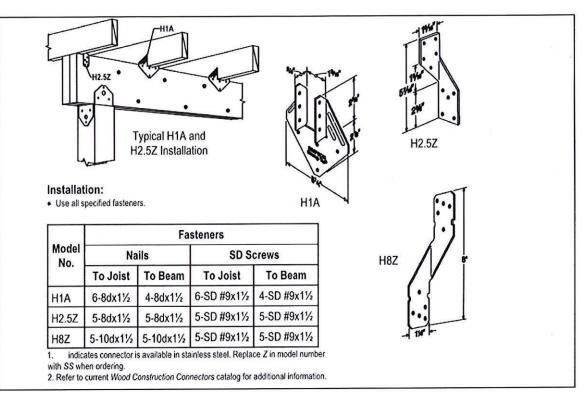
Figure 7 – Simpson Strong-tie Hurricane Tie connection detail.

- 1. Roof Framing:
  - 1.1. We recommend installing hurricane ties, Simpson Strong-tie H1A (or equal), at the ends of all rafters connected to the end walls.
