Re: Donaldson-Bannister Farm Blacksmith Shop Renovations

Subject: Structural Assessment & Repair Recommendations
Donaldson-Bannister Shop Renovation
Project No. 25027

Issued By: Joshua R. Lloyd, PE
GA Registration No. PE045503
March 14, 2025

Report – Limited Structural Assessment & Repair Recommendations
City of Dunwoody
Donaldson-Bannister Shop

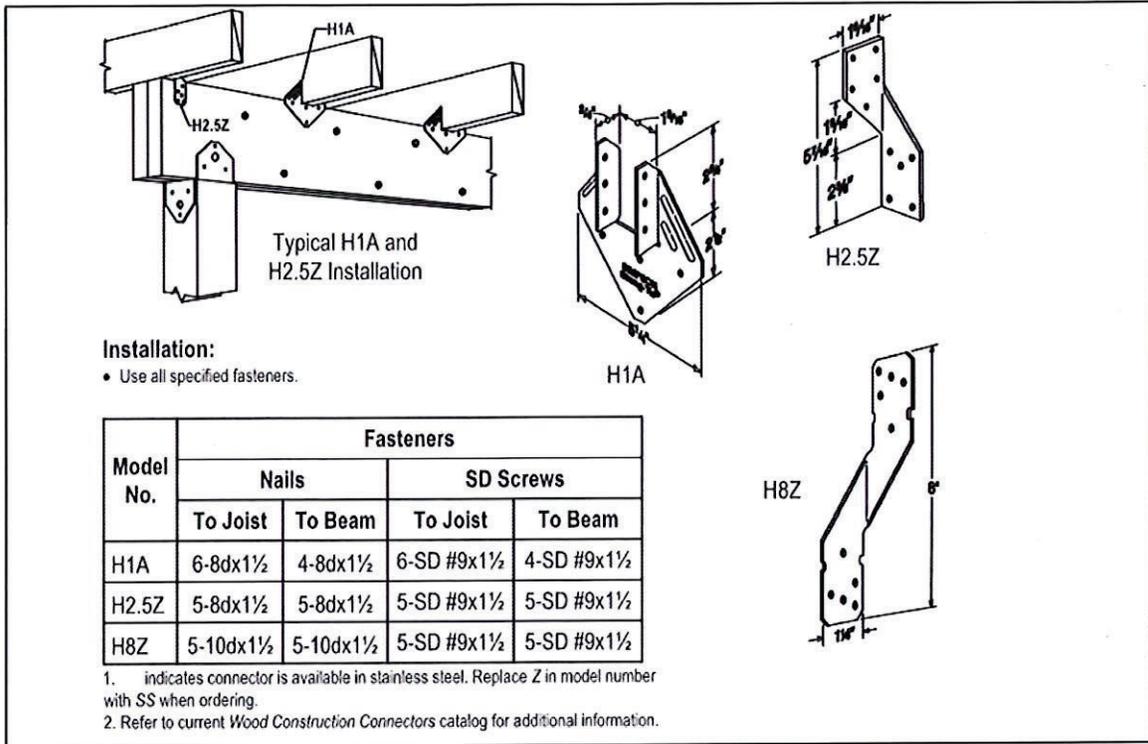
Figure 7 – Simpson Strong-tie Hurricane Tie connection detail.

- 1.1. We recommend installing hurricane ties, Simpson Strong-tie H1A (or equal), at the ends of all rafters connected to the end walls.
- 1.2. We recommend installing a "Sister" rafter to the side of all rafters that exhibit deterioration (likely due to water intrusion and crushing) at the end supports. The length of the new rafter shall match the existing and shall be fastened to the rafter with 16d nails at 8" OC, with (4) nails at each end. The new rafter shall bear directly on the top wall plate and be fastened with H1A ties.
