**To:** Mayor and City Council  
**From:** Carl Thomas, Stormwater Utility Manager  
**Re:** Funding Authorization for 4706 Equestrian Way Storm Repairs  
**Date:** September 26<sup>th</sup>, 2023

**To:** Mayor and City Council  
**From:** Carl Thomas, Stormwater Utility Manager  
**Re:** Funding Authorization for 4964 Buckline Crossing Storm Repairs  
**Date:** September 26<sup>th</sup>, 2023

**To:** Mayor and City Council  
**From:** Carl Thomas, Stormwater Utility Manager  
**Re:** Funding Authorization for 5233 Fontainebleau Ct Storm Repairs  
**Date:** September 26<sup>th</sup>, 2023

**To:** Mayor and City Council  
**From:** Carl Thomas, Stormwater Utility Manager  
**Re:** Funding Authorization for 5548 Glenrich Drive Storm Repairs  
**Date:** September 26<sup>th</sup>, 2023

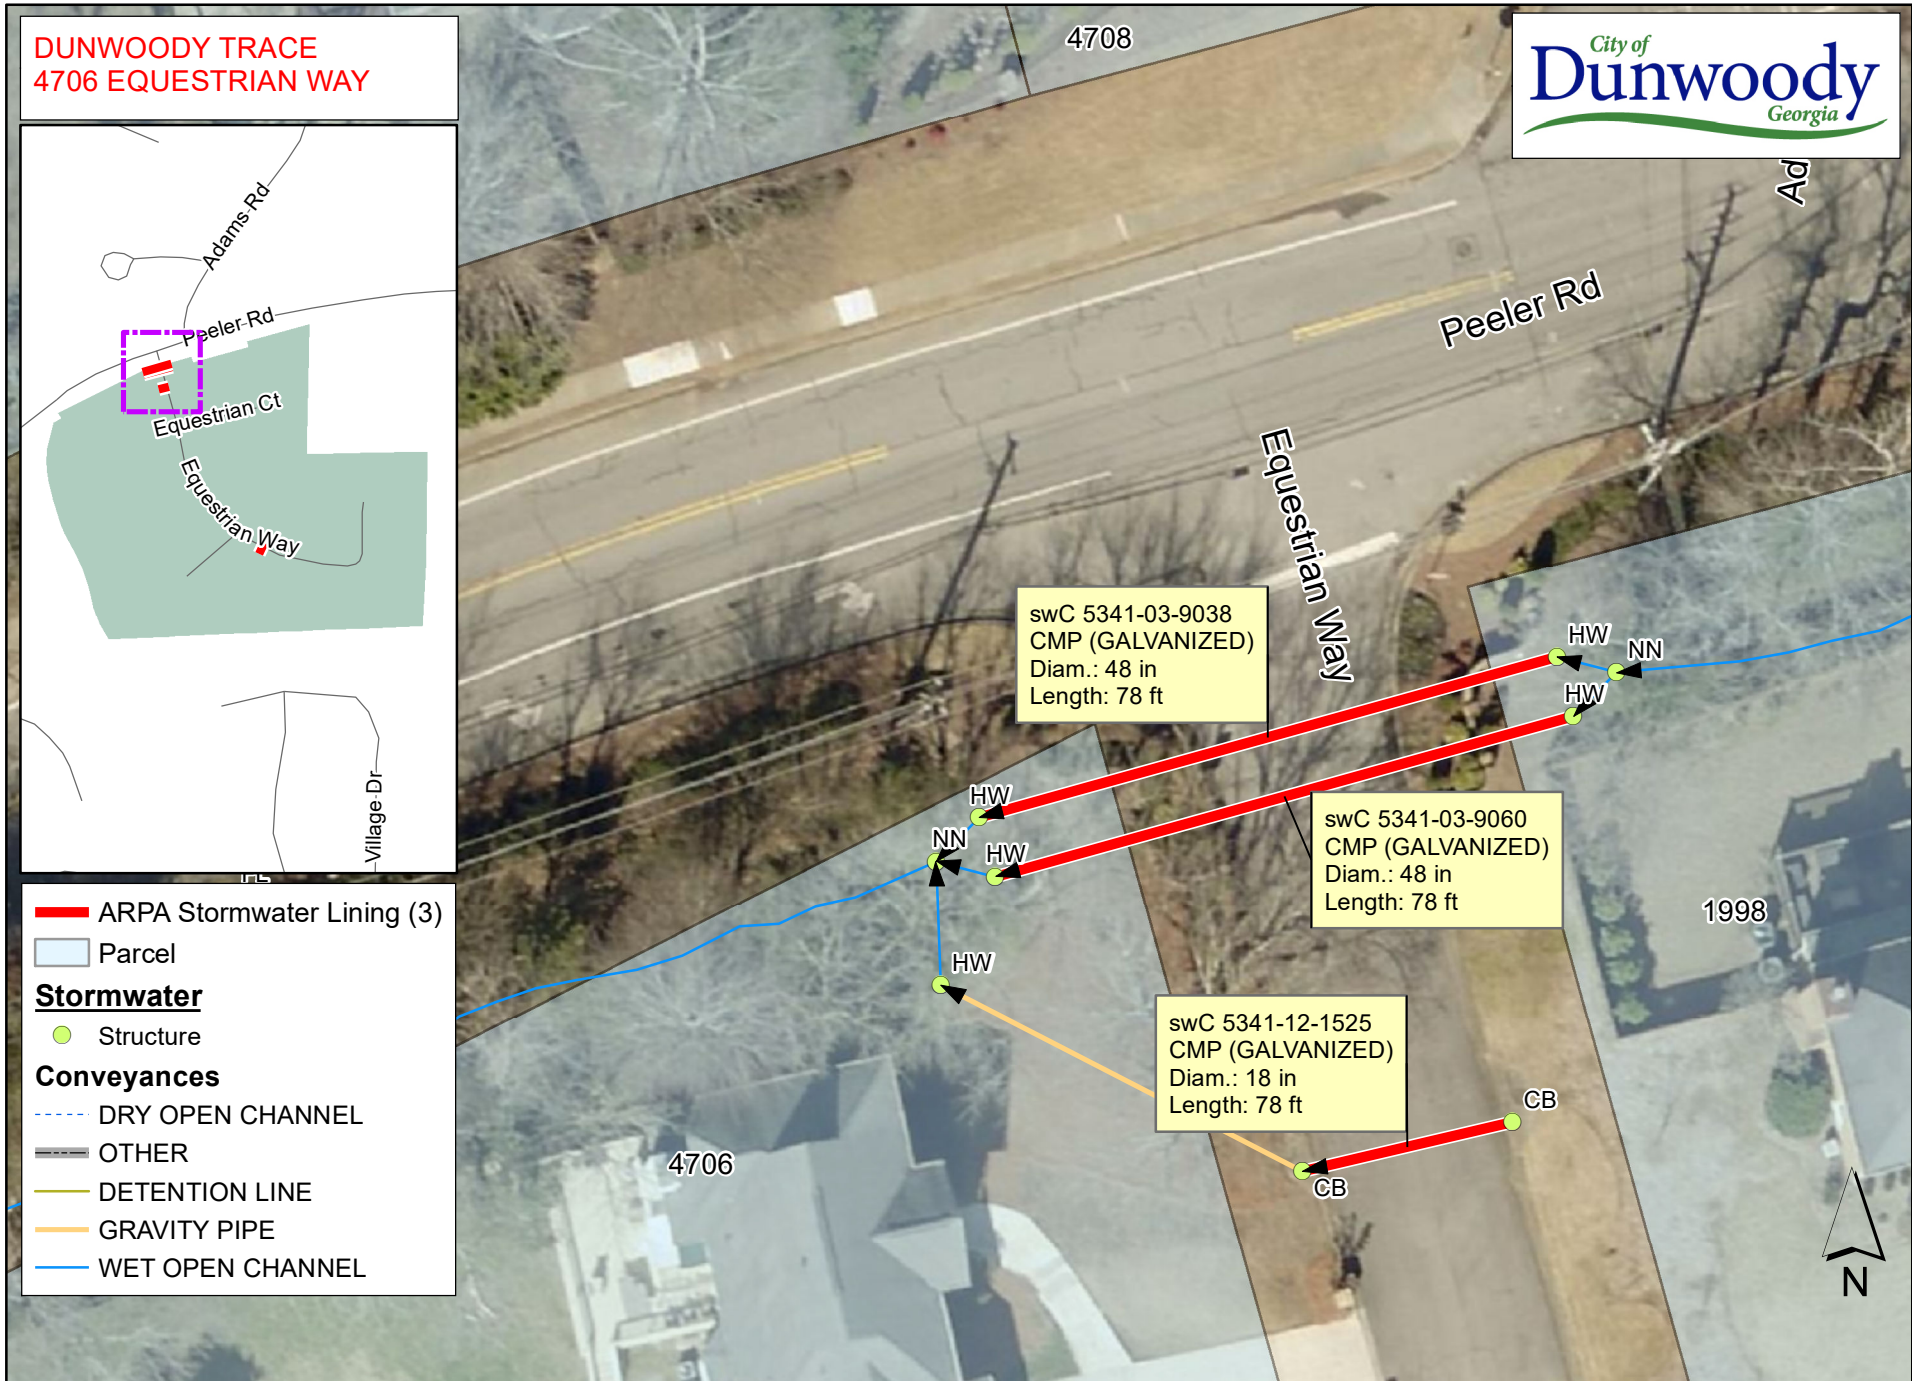
**DUNWOODY TRACE**  
**4706 EQUESTRIAN WAY**

Structural deficiencies to the storm system on Equestrian Way were identified by staff performing routine inspections. The pipe system is composed of +/- 200 linear feet (LF) of 18 and 48-inch corrugated metal pipe (CMP) that is approximately 40 years old and in poor condition. Closed-Caption Television (CCTV) footage discovered corrosion, visible holes, and water sag. Recommended repairs include:

## Severe Corrosion with visible holes Water Sagging

- Repair +/- 40 LF of 18-inch CMP with Cured-In-Place Pipe (CIPP) liner
- Repair +/- 160 LF of 48-inch CMP with Spray-On Spincast Liner
- 60 hours bypass pumping
- 10 days Minor traffic control

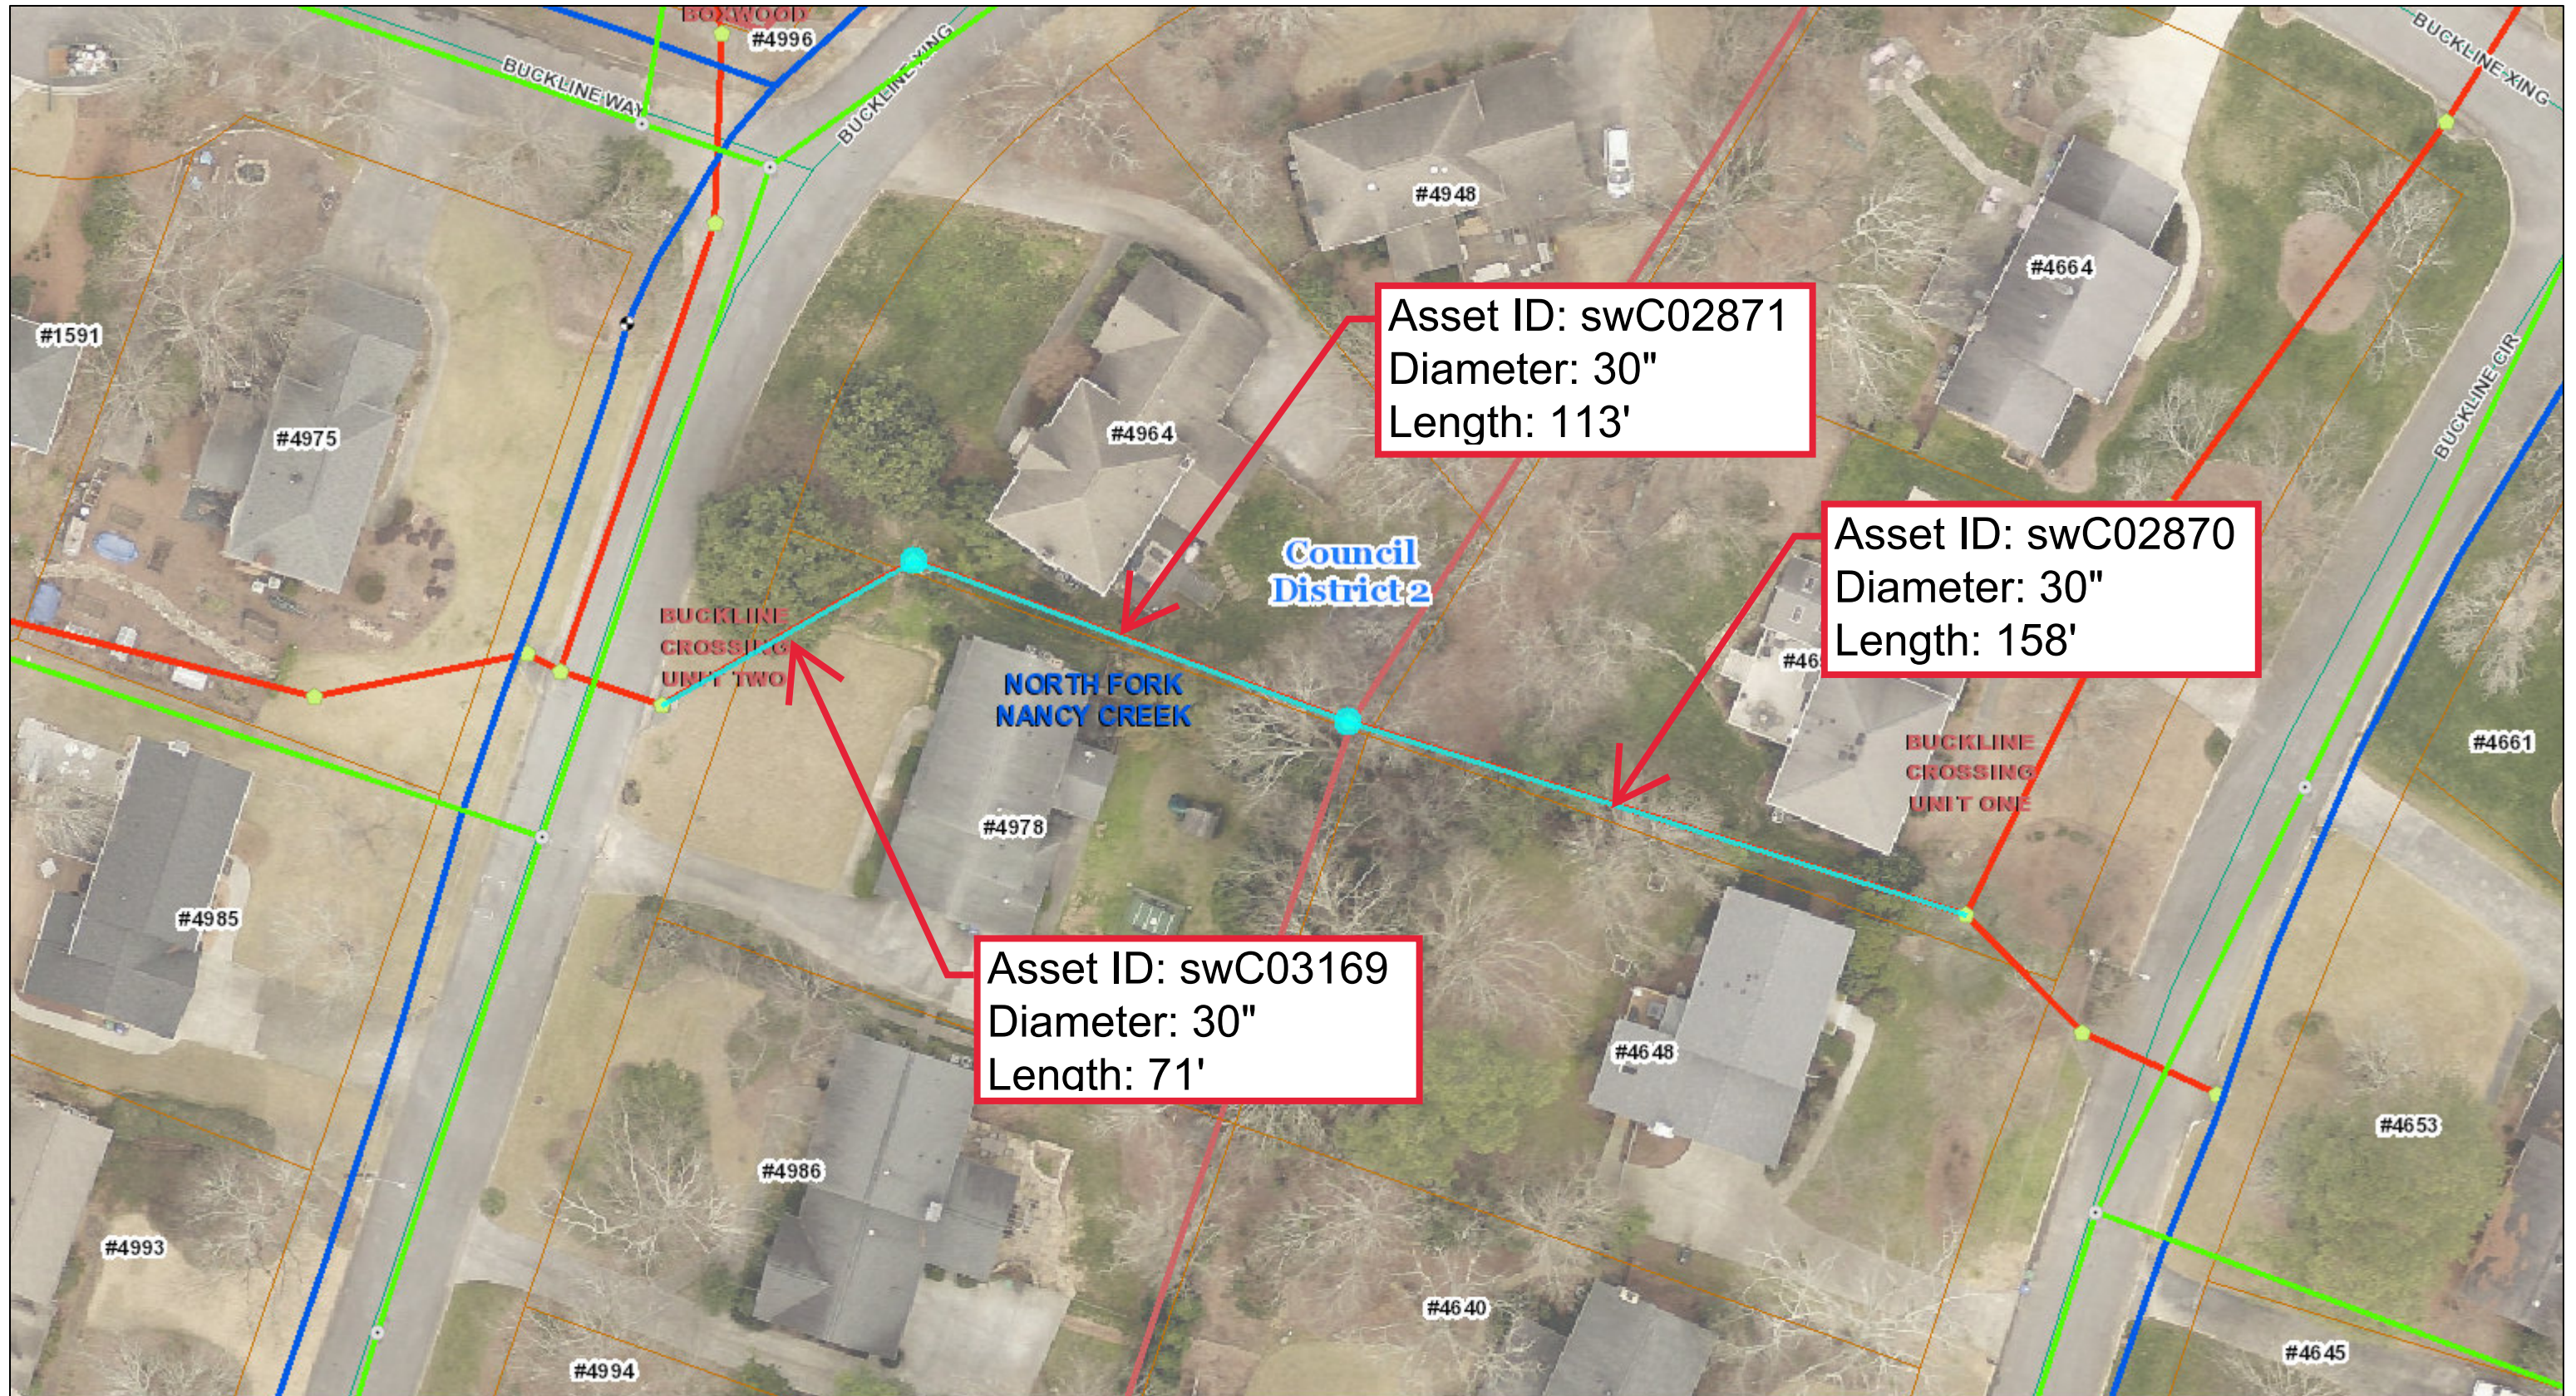
Structural deficiencies to the storm system on Buckline Crossing were identified responding to a sinkhole reported by the homeowner. The pipe system is composed of +/- 350 linear feet (LF) of 30-inch corrugated metal pipe (CMP) that is approximately 45 years old and in poor condition. Closed-Caption Television (CCTV) footage discovered corrosion, multiple private tie-ins, visible holes, and minor joint separation. Recommended repairs include:

## Corrosion with visible holes Multiple private drain tie-ins

- Repair +/- 350 LF of 30-inch CMP with Cured-In-Place Pipe (CIPP) liner
- Install three (3) 4-foot brick manholes with pedestal tops/grates
- Seven (7) days of Minor Traffic Control

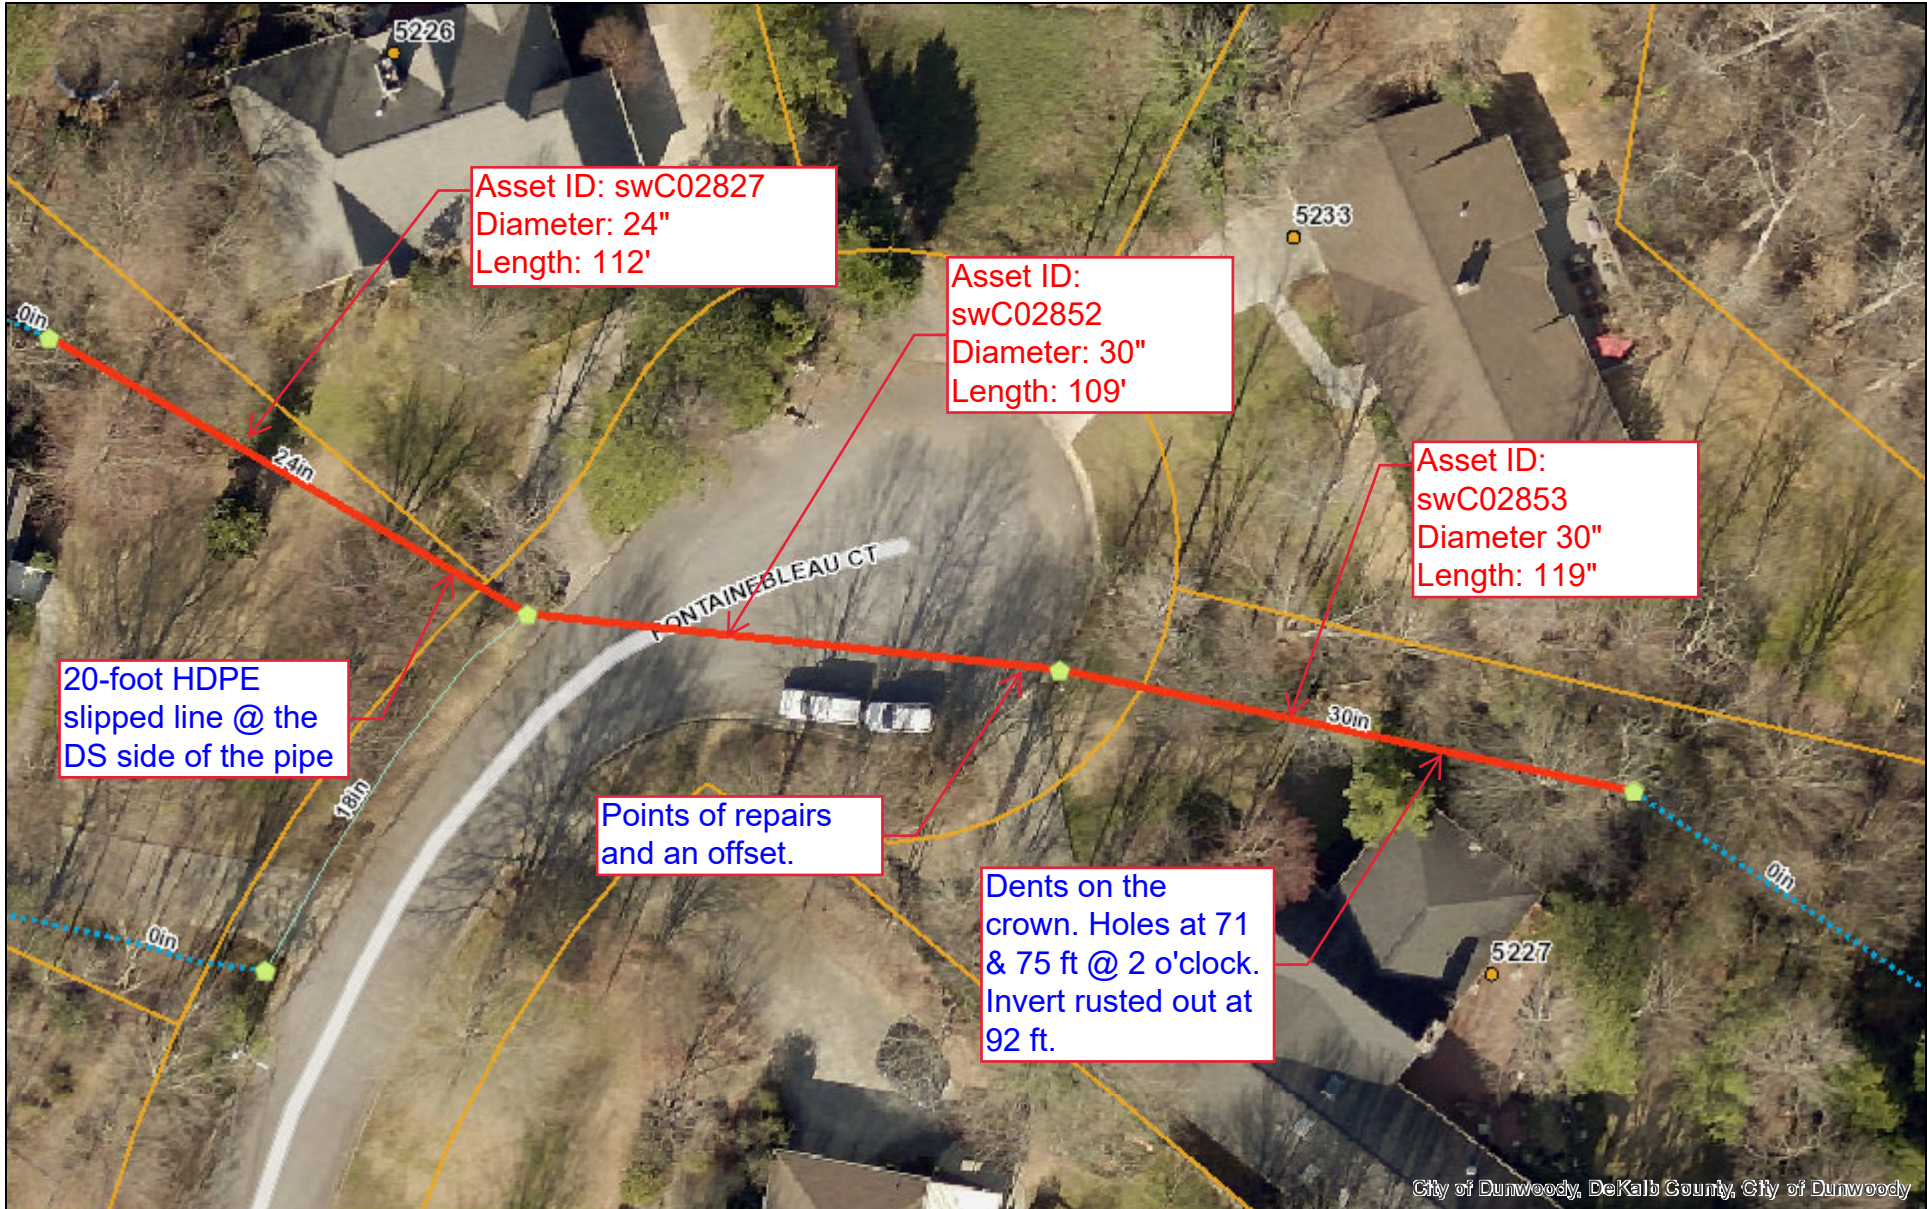
Structural deficiencies to the storm system on Fontainebleau Ct were identified responding to a sinkhole reported by the homeowner. The pipe system is composed of +/- 360 linear feet (LF) of 30-inch corrugated metal pipe (CMP) that is approximately 60 years old and in poor condition. Closed-Caption Television (CCTV) footage discovered corrosion, visible holes, deformities, and minor joint separation. Recommended repairs include:

## Corrosion With Visible Holes Minor Deformities To Pipe Crown

- Repair +/- 360 LF of 30-inch CMP with Cured-In-Place Pipe (CIPP) liner
- Dig and Replace 20 LF of Corrugated Metal Pipe (CMP)
- 133 SY Zoysia Sod replacement

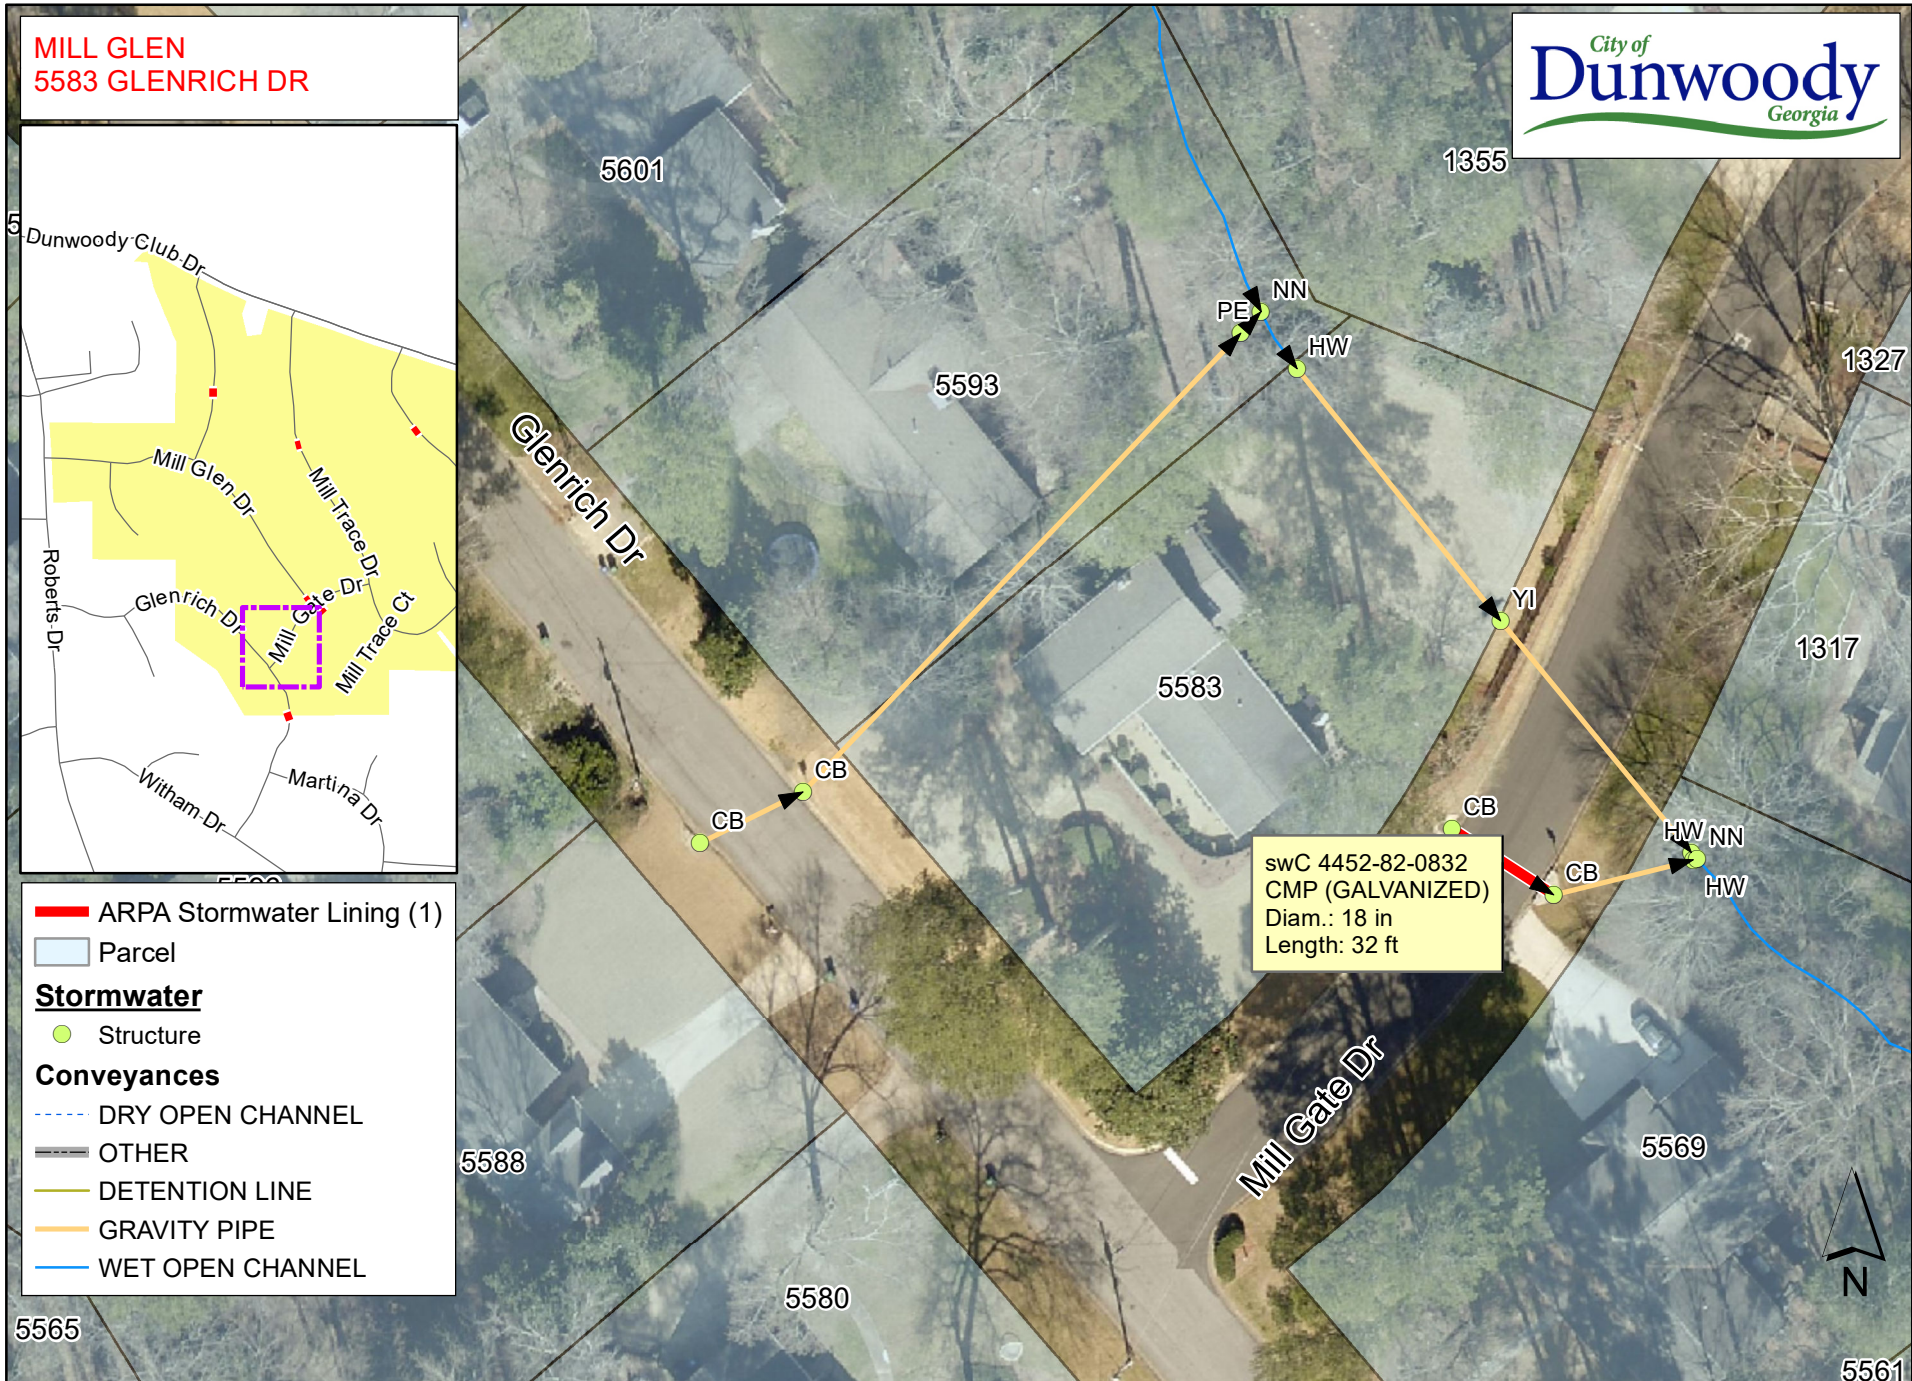
**MILL GLEN**  
**5583 GLENRICH DR**

Structural deficiencies to the storm system on Glenrich Drive were identified by staff performing routine inspections. The pipe system is composed of +/- 70 linear feet (LF) of 18-inch corrugated metal pipe (CMP) that is approximately 53 years old and in poor condition. Closed-Caption Television (CCTV) footage discovered moderate corrosion, sedimentation obstructing the pipe catch/basin, and minor deformities. Recommended repairs include:

## Invert corrosion, Deformed Crown, Moderate/Heavy Debris Accumulation

- Repair +/- 70 LF of 18-inch CMP with Cured-In-Place Pipe (CIPP) liner
- 8 LF of point repairs
- 4 catch basin top slabs and throats (cast in place)
