**RE: Pre-Demolition Property Conditions & Hazardous Materials Assessment
Brook Run Property— C.E.R.M. Project No. 11-0862-034
4770 North Peachtree Road
Dunwoody, Georgia**

DEMOLITION & FACILITY ASSESSMENT PLANS

for BROOK RUN PARK

DEKALB COUNTY PARKS AND RECREATIONS 4770 N PEACHTREE RD. & BROOK RUN AVE. DeKalb County, Georgia 30338 Commissioner District: 4

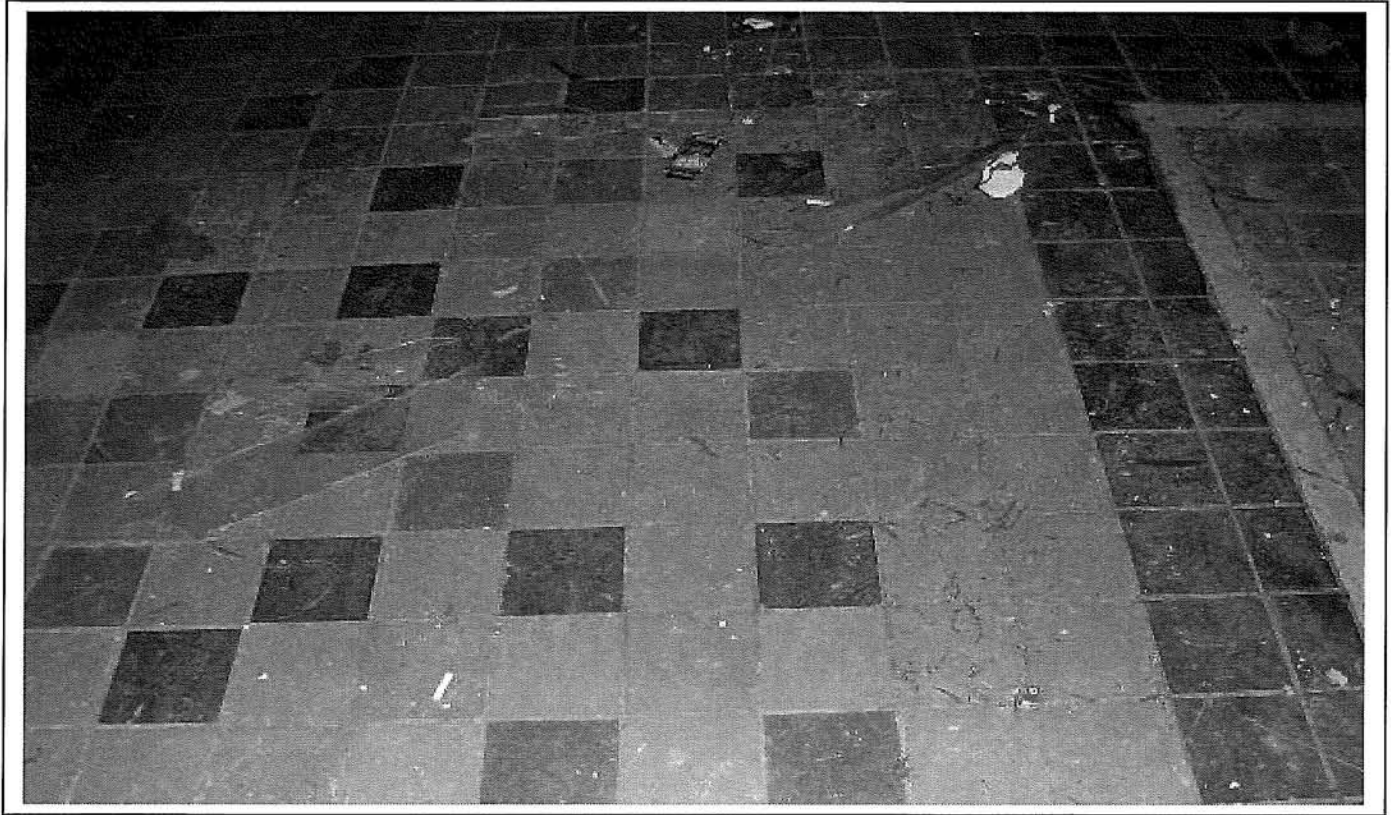
Photo 45: Typical ceramic floor covering in kitchen area Therapy Building
